Profile/Photo Observation Report

Street:	ALLEY BETWEEN N WILSON ST & N G	Flow Control:	Not Controlled
City:	Hobart, IN	Year Renewed:	
Location:	Other	Tape/Media #:	
Purpose:	Not Known	Dia/Height:	10"
Use:	Sanitary	Material:	VCP
Drain Area:	NA	Lining:	
Category:	NA		
Comment:

Location Details:		Direction of Survey:	Downstream
US MH:	M-503-086	DS MH:	M-503-087
		Total Length Surveyed (ft):	94.4

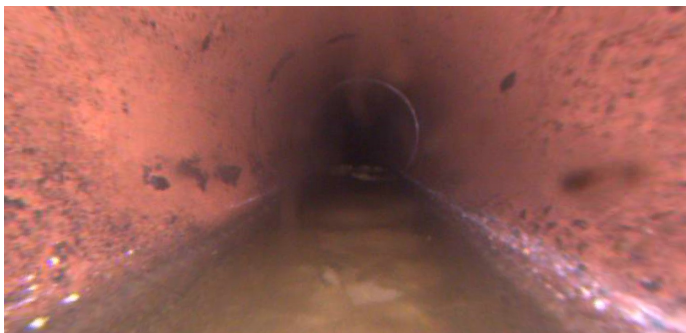
Code: **AMH**
Description: **Manhole**

Distance (ft): **.0**
Structural Grade: **0**
O&M Grade: **0**
Clock Start/From:
Clock To:
1st Value:
2nd Value:
Value Percent:
Continuous Index:
Within 8" of Joint: **NO**
Remarks: **M-503-086**

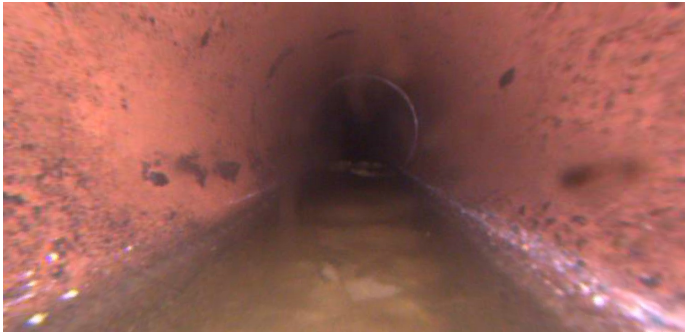
Code:	MWL
Description:	Water Level

Distance (ft):	.0
Structural Grade:	0
O&M Grade:	0
Clock Start/From:	
Clock To:	
1st Value:	
2nd Value:	
Value Percent:	20.000
Continuous Index:	
Within 8" of Joint:	NO
Remarks:

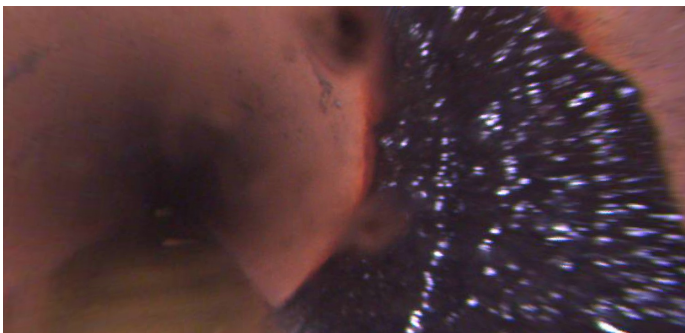
Code: **DAE**
Description: **Deposits Attached Encrustation**

Distance (ft): **68.9**
Structural Grade: **0**
O&M Grade: **2**
Clock Start/From: **1**
Clock To: **4**
1st Value:
2nd Value:
Value Percent: **5.000**
Continuous Index:
Within 8" of Joint: **YES**
Remarks:

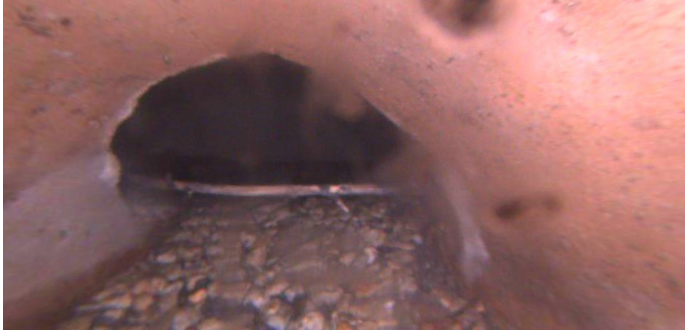
Code: **OBR**
Description: **Obstacle Rocks**

Distance (ft): **93.0**
Structural Grade: **0**
O&M Grade: **5**
Clock Start/From: **3**
Clock To: **9**
1st Value:
2nd Value:
Value Percent: **40.000**
Continuous Index:
Within 8" of Joint: **NO**
Remarks:

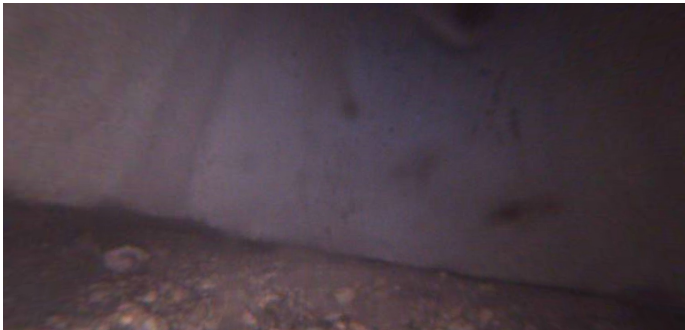
Code: **AMH**
Description: **Manhole**

Distance (ft): **94.4**
Structural Grade: **0**
O&M Grade: **0**
Clock Start/From:
Clock To:
1st Value:
2nd Value:
Value Percent:
Continuous Index:
Within 8" of Joint: **NO**
Remarks: **M-503-087**
