Profile/Photo Observation Report

Date:	04/13/2018	Weather:		Coding:	PACP 6.0
Pipe Length (ft):	107.6	Owner:	NA	Pre Clean:	Not Known
P.O.#:		Surveyor:	Jen Costello	PSR:	P-503-087-086
Customer:		Clean Date:	01/01/1900	Shape:	C

Street:	W 40th ave	Flow Control:	Not Controlled
City:	Hobart, IN	Year Renewed:	
Location:	Other	Tape/Media #:	
Purpose:	Not Known	Dia/Height:	10"
Use:	Sanitary	Material:	VCP
Drain Area:	NA	Lining:	
Category:	NA		
Comment:

Location Details:		Direction of Survey:	Downstream
US MH:	M-503-086	DS MH:	M-503-087
		Total Length Surveyed (ft):	94.4

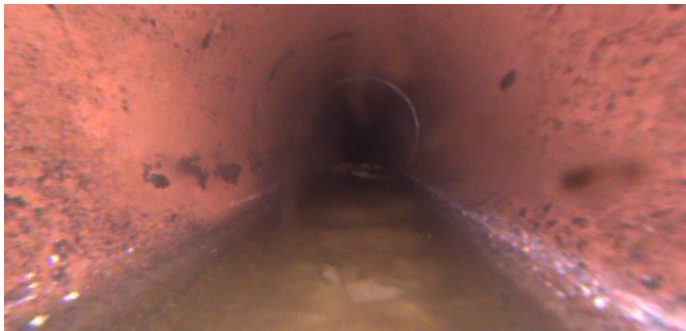
Code: **AMH**
Description: **Manhole**

Distance (ft): **.0**
Structural Grade: **0**
O&M Grade: **0**
Clock Start/From:
Clock To:
1st Value:
2nd Value:
Value Percent:
Continuous Index:
Within 8" of Joint: **NO**
Remarks: **M-503-086**

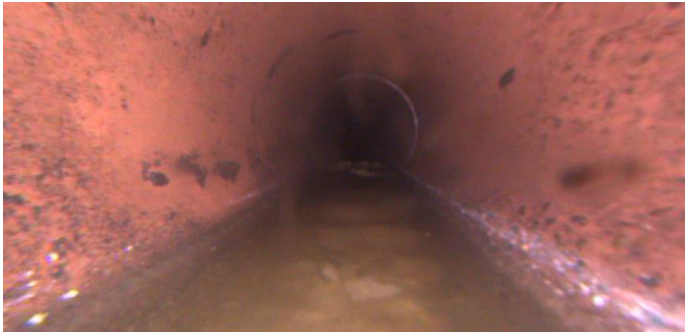
Code:	MWL
Description:	Water Level

Distance (ft):	.0
Structural Grade:	0
O&M Grade:	0
Clock Start/From:	
Clock To:	
1st Value:	
2nd Value:	
Value Percent:	20.000
Continuous Index:	
Within 8" of Joint:	NO
Remarks:

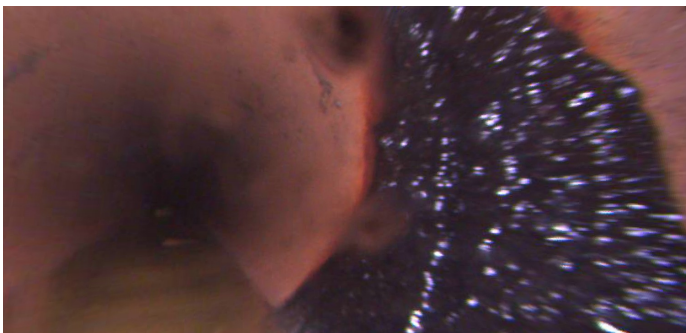
Code: **DAE**
Description: **Deposits Attached Encrustation**

Distance (ft): **68.9**
Structural Grade: **0**
O&M Grade: **2**
Clock Start/From: **1**
Clock To: **4**
1st Value:
2nd Value:
Value Percent: **5.000**
Continuous Index:
Within 8" of Joint: **YES**
Remarks:

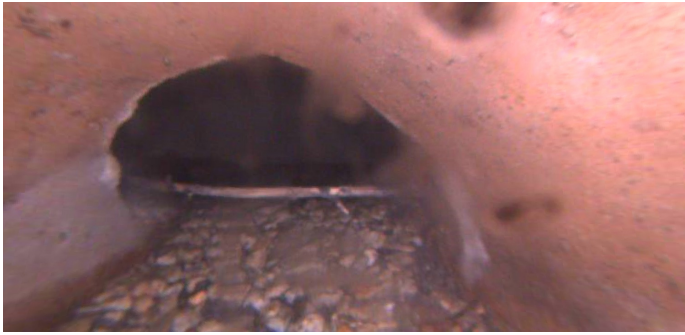
Code: **OBR**
Description: **Obstacle Rocks**

Distance (ft): **93.0**
Structural Grade: **0**
O&M Grade: **5**
Clock Start/From: **3**
Clock To: **9**
1st Value:
2nd Value:
Value Percent: **40.000**
Continuous Index:
Within 8" of Joint: **NO**
Remarks:

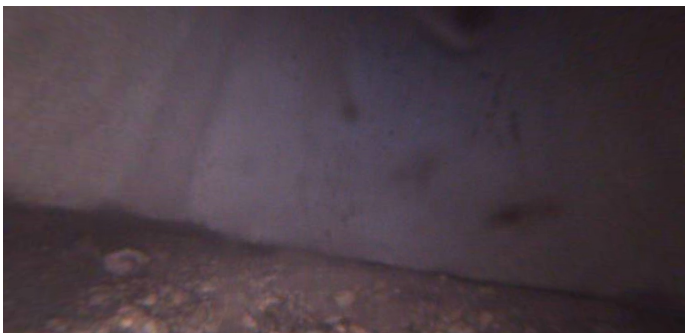
Code: **AMH**
Description: **Manhole**

Distance (ft): **94.4**
Structural Grade: **0**
O&M Grade: **0**
Clock Start/From:
Clock To:
1st Value:
2nd Value:
Value Percent:
Continuous Index:
Within 8" of Joint: **NO**
Remarks: **M-503-087**
