## Profile/Photo Observation Report

Street:	<b>W 40TH AVE &amp; N GUYER ST</b>	Flow Control:	<b>Not Controlled</b>
City:	<b>Hobart, IN</b>	Year Renewed:	
Location:	<b>Other</b>	Tape/Media #:	
Purpose:	<b>Not Known</b>	Dia/Height:	<b>8"</b>
Use:	<b>Sanitary</b>	Material:	<b>PVC</b>
Drain Area:	<b>NA</b>	Lining:	
Category:	<b>NA</b>		
Comment:

Location Details:		Direction of Survey:	<b>Upstream</b>
US MH:	<b>M-503-088</b>	DS MH:	<b>M-503-089</b>
		Total Length Surveyed (ft):	<b>306.0</b>

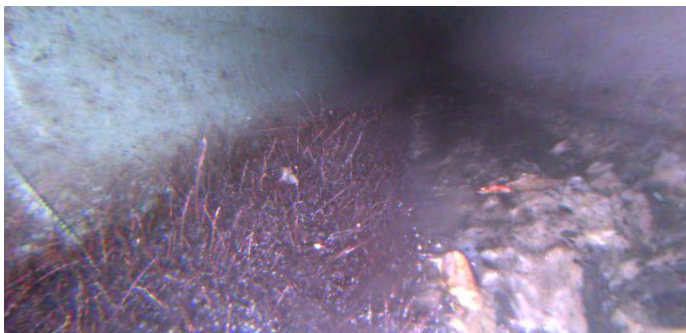
Code: **RMB**  
Description: **Roots Medium Barrel**

Distance (ft): **.0**  
Structural Grade: **0**  
O&M Grade: **4**  
Clock Start/From: **6**  
Clock To: **7**  
1st Value:  
2nd Value:  
Value Percent: **10.000**  
Continuous Index:  
Within 8" of Joint: **NO**  
Remarks:

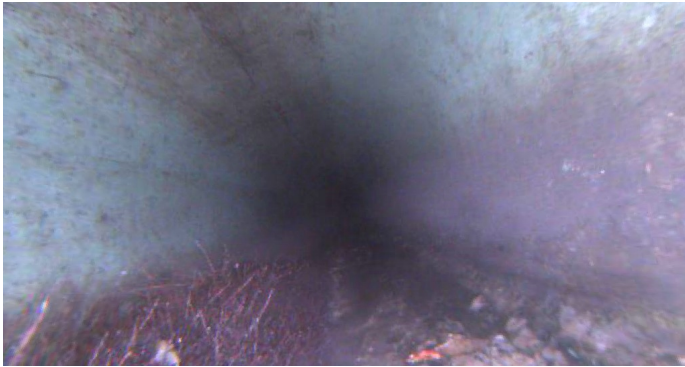
Code:	<b>AMH</b>
Description:	<b>Manhole</b>

Distance (ft):	<b>.0</b>
Structural Grade:	<b>0</b>
O&M Grade:	<b>0</b>
Clock Start/From:	
Clock To:	
1st Value:	
2nd Value:	
Value Percent:	
Continuous Index:	
Within 8" of Joint:	<b>NO</b>
Remarks:	<b>M-503-089</b>

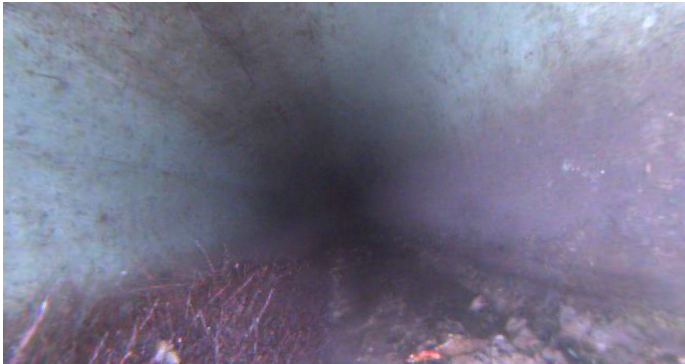
Code:	<b>MWL</b>
Description:	<b>Water Level</b>

Distance (ft):	<b>.0</b>
Structural Grade:	<b>0</b>
O&M Grade:	<b>0</b>
Clock Start/From:	
Clock To:	
1st Value:	
2nd Value:	
Value Percent:	<b>10.000</b>
Continuous Index:	
Within 8" of Joint:	<b>NO</b>
Remarks:

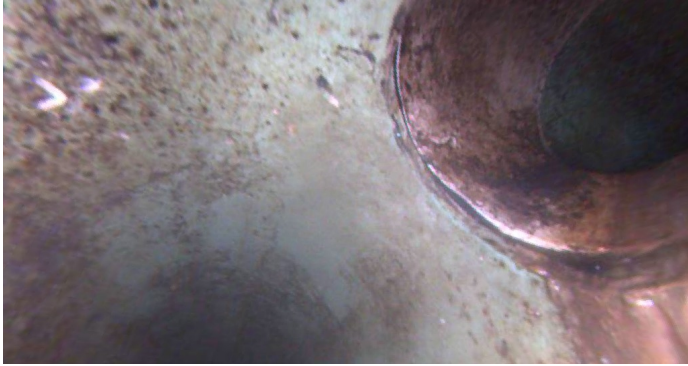
Code: **TFA**  
Description: **Tap Factory Active**

Distance (ft): **275.0**  
Structural Grade: **0**  
O&M Grade: **0**  
Clock Start/From: **2**  
Clock To:  
1st Value: **4.000**  
2nd Value:  
Value Percent:  
Continuous Index:  
Within 8" of Joint:  
Remarks:

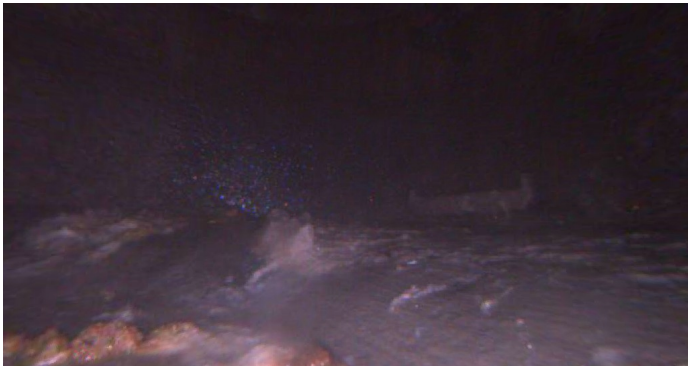
Code: **AMH**  
Description: **Manhole**

Distance (ft): **306.0**  
Structural Grade: **0**  
O&M Grade: **0**  
Clock Start/From:  
Clock To:  
1st Value:  
2nd Value:  
Value Percent:  
Continuous Index:  
Within 8" of Joint: **NO**  
Remarks: **M-503-088**
