Profile/Photo Observation Report

Street:	guyer st	Flow Control:	Not Controlled
City:	Hobart, IN	Year Renewed:	
Location:	Other	Tape/Media #:	
Purpose:	Not Known	Dia/Height:	8"
Use:	Sanitary	Material:	PVC
Drain Area:	NA	Lining:	
Category:	NA		
Comment:

Location Details:		Direction of Survey:	Upstream
US MH:	M-503-088	DS MH:	M-503-089
		Total Length Surveyed (ft):	306.0

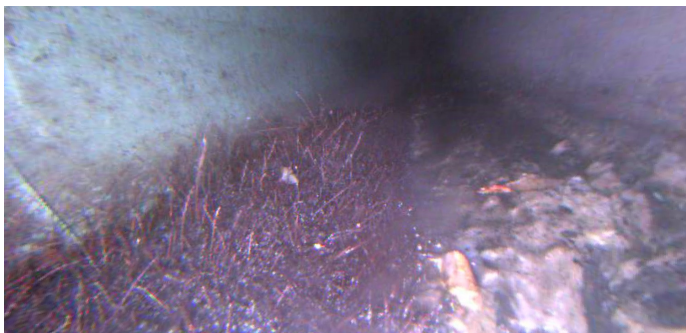
Code: **RMB**
Description: **Roots Medium Barrel**

Distance (ft): **.0**
Structural Grade: **0**
O&M Grade: **4**
Clock Start/From: **6**
Clock To: **7**
1st Value:
2nd Value:
Value Percent: **10.000**
Continuous Index:
Within 8" of Joint: **NO**
Remarks:

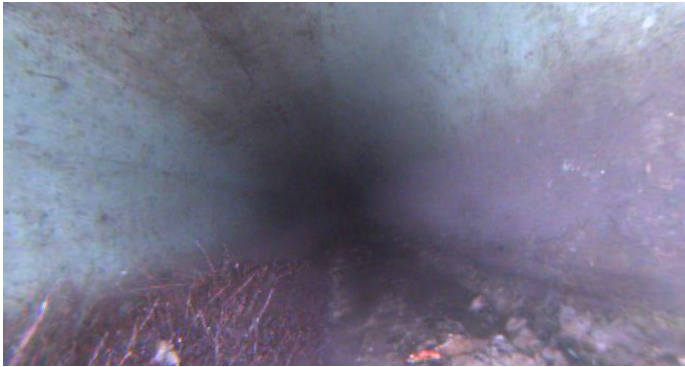
Code:	AMH
Description:	Manhole

Distance (ft):	.0
Structural Grade:	0
O&M Grade:	0
Clock Start/From:	
Clock To:	
1st Value:	
2nd Value:	
Value Percent:	
Continuous Index:	
Within 8" of Joint:	NO
Remarks:	M-503-089

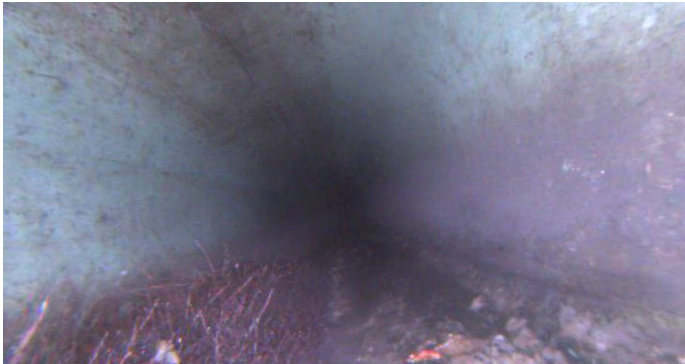
Code:	MWL
Description:	Water Level

Distance (ft):	.0
Structural Grade:	0
O&M Grade:	0
Clock Start/From:	
Clock To:	
1st Value:	
2nd Value:	
Value Percent:	10.000
Continuous Index:	
Within 8" of Joint:	NO
Remarks:

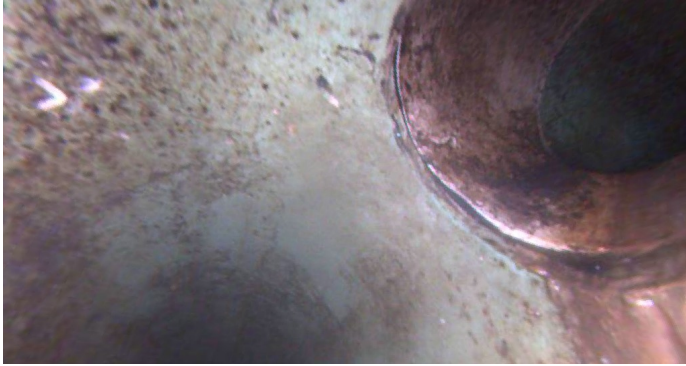
Code: **TFA**
Description: **Tap Factory Active**

Distance (ft): **275.0**
Structural Grade: **0**
O&M Grade: **0**
Clock Start/From: **2**
Clock To:
1st Value: **4.000**
2nd Value:
Value Percent:
Continuous Index:
Within 8" of Joint:
Remarks:

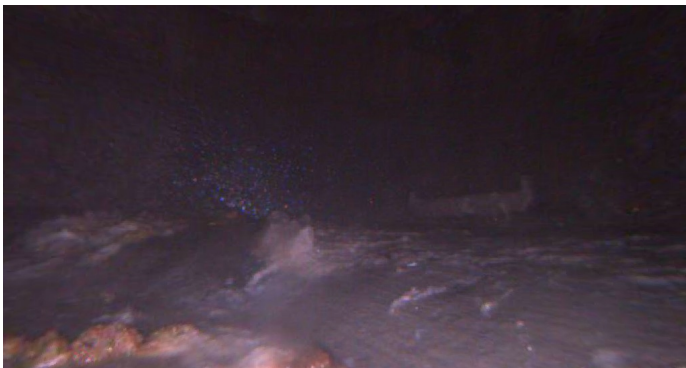
Code: **AMH**
Description: **Manhole**

Distance (ft): **306.0**
Structural Grade: **0**
O&M Grade: **0**
Clock Start/From:
Clock To:
1st Value:
2nd Value:
Value Percent:
Continuous Index:
Within 8" of Joint: **NO**
Remarks: **M-503-088**
