## Profile/Photo Observation Report

Date:	<b>04/07/2018</b>	Weather:		Coding:	<b>PACP 6.0</b>
Pipe Length (ft):	<b>547.5</b>	Owner:	<b>NA</b>	Pre Clean:	<b>Not Known</b>
P.O.#:		Surveyor:	<b>Jen Costello</b>	PSR:	<b>P-503-090-089</b>
Customer:		Clean Date:	<b>01/01/1900</b>	Shape:	<b>C</b>

Street:	<b>guyer st</b>	Flow Control:	<b>Not Controlled</b>
City:	<b>Hobart, IN</b>	Year Renewed:	
Location:	<b>Other</b>	Tape/Media #:	
Purpose:	<b>Not Known</b>	Dia/Height:	<b>8"</b>
Use:	<b>Sanitary</b>	Material:	<b>PVC</b>
Drain Area:	<b>NA</b>	Lining:	
Category:	<b>NA</b>		
Comment:

Location Details:		Direction of Survey:	<b>Upstream</b>
US MH:	<b>M-503-089</b>	DS MH:	<b>M-503-090</b>
		Total Length Surveyed (ft):	<b>7.9</b>

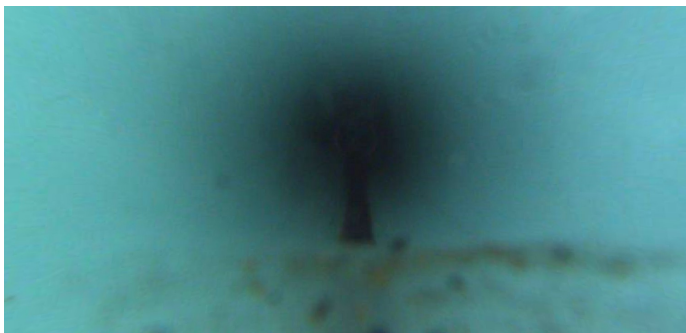
Code: **AMH**  
Description: **Manhole**

Distance (ft): **.0**  
Structural Grade: **0**  
O&M Grade: **0**  
Clock Start/From:  
Clock To:  
1st Value:  
2nd Value:  
Value Percent:  
Continuous Index:  
Within 8" of Joint: **NO**  
Remarks: **M-503-090**

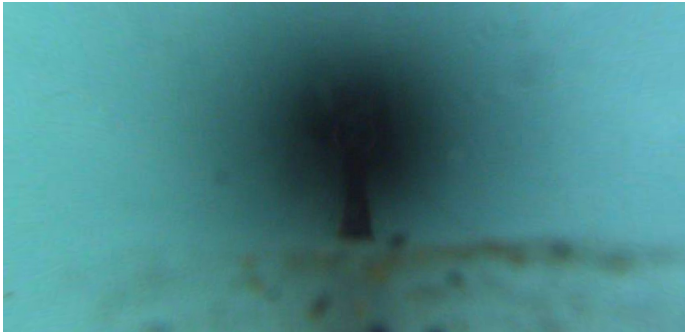
Code:	<b>MWL</b>
Description:	<b>Water Level</b>

Distance (ft):	<b>.0</b>
Structural Grade:	<b>0</b>
O&M Grade:	<b>0</b>
Clock Start/From:	
Clock To:	
1st Value:	
2nd Value:	
Value Percent:	<b>5.000</b>
Continuous Index:	
Within 8" of Joint:	<b>NO</b>
Remarks:

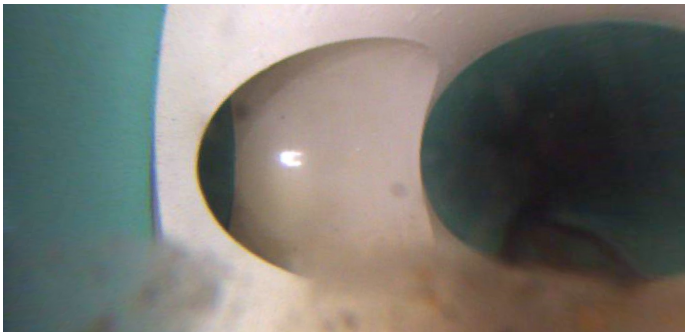
Code:	<b>TF</b>
Description:	<b>Tap Factory</b>

Distance (ft):	<b>5.6</b>
Structural Grade:	<b>0</b>
O&M Grade:	<b>0</b>
Clock Start/From:	<b>9</b>
Clock To:	
1st Value:	<b>4.000</b>
2nd Value:	
Value Percent:	
Continuous Index:	
Within 8" of Joint:	
Remarks:

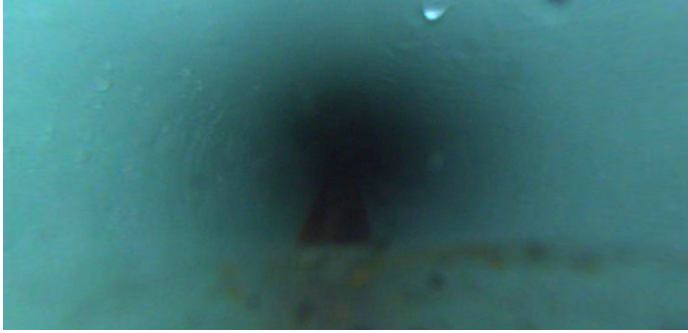
Code:	<b>MSA</b>
Description:	<b>Abandoned Survey</b>
Distance (ft):	<b>7.9</b>
Structural Grade:	<b>0</b>
O&M Grade:	<b>0</b>
Clock Start/From:	
Clock To:	
1st Value:	
2nd Value:	
Value Percent:	
Continuous Index:	
Within 8" of Joint:	<b>NO</b>
Remarks:	<b>UNKNOWN</b>
