Profile/Photo Observation Report

Street:	W 40TH AVE	Flow Control:	Not Controlled
City:	Hobart, IN	Year Renewed:	
Location:	Other	Tape/Media #:	
Purpose:	Not Known	Dia/Height:	8"
Use:	Sanitary	Material:	PVC
Drain Area:	NA	Lining:	
Category:	NA		
Comment:			
Location Details:		Direction of Survey:	Downstream
US MH:	M-503-089	DS MH:	M-503-090
		Total Length Surveyed (ft):	463.4

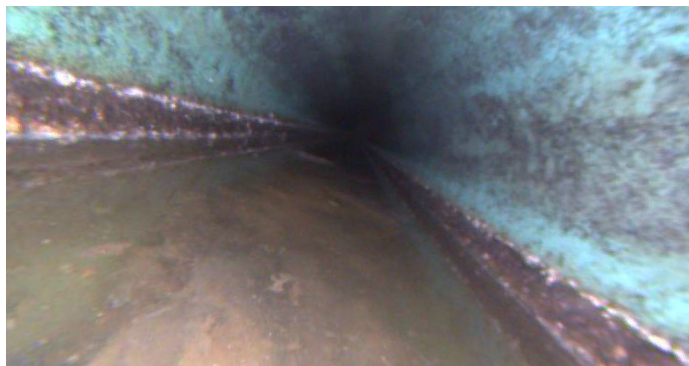
Code: **AMH**
 Description: **Manhole**

Distance (ft): **.0**
 Structural Grade: **0**
 O&M Grade: **0**
 Clock Start/From:
 Clock To:
 1st Value:
 2nd Value:
 Value Percent:
 Continuous Index:
 Within 8" of Joint: **NO**
 Remarks: **M-503-089**

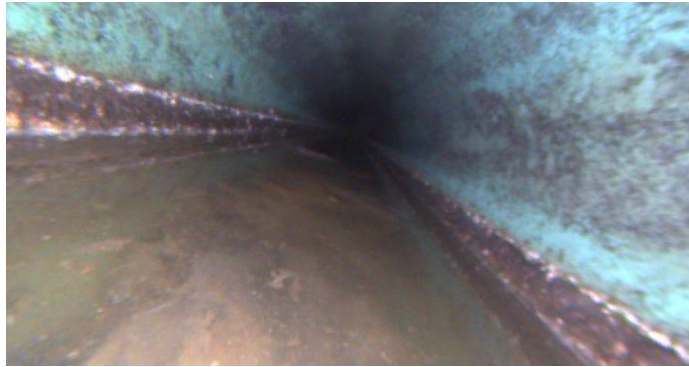
Code: **MWL**
Description: **Water Level**

Distance (ft): **.0**
Structural Grade: **0**
O&M Grade: **0**
Clock Start/From:
Clock To:
1st Value:
2nd Value:
Value Percent: **10.000**
Continuous Index:
Within 8" of Joint: **NO**
Remarks:

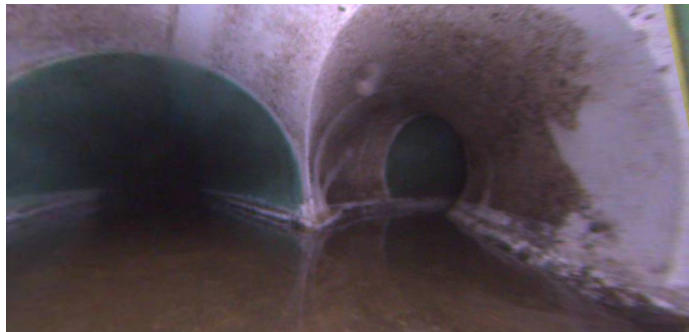
Code: **TFA**
Description: **Tap Factory Active**

Distance (ft): **17.1**
Structural Grade: **0**
O&M Grade: **0**
Clock Start/From: **3**
Clock To:
1st Value: **4.000**
2nd Value:
Value Percent:
Continuous Index:
Within 8" of Joint:
Remarks:

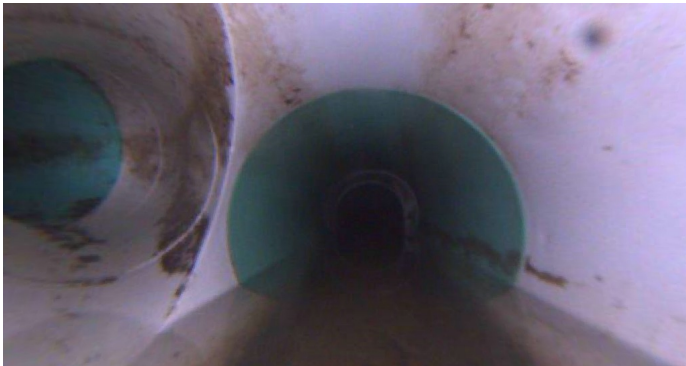
Code: **TF**
Description: **Tap Factory**

Distance (ft): **107.0**
Structural Grade: **0**
O&M Grade: **0**
Clock Start/From: **9**
Clock To:
1st Value: **4.000**
2nd Value:
Value Percent:
Continuous Index:
Within 8" of Joint:
Remarks:

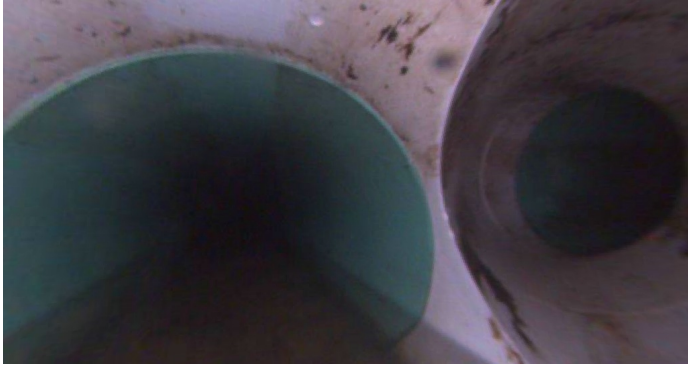
Code: **TF**
Description: **Tap Factory**

Distance (ft): **109.6**
Structural Grade: **0**
O&M Grade: **0**
Clock Start/From: **4**
Clock To:
1st Value: **4.000**
2nd Value:
Value Percent:
Continuous Index:
Within 8" of Joint:
Remarks:

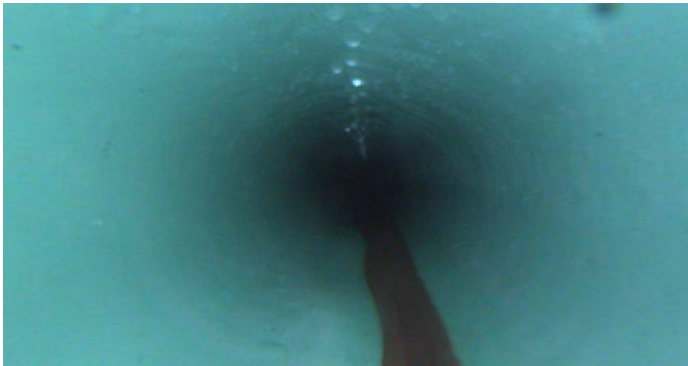
Code: **MSA**
Description: **Abandoned Survey**

Distance (ft): **463.4**
Structural Grade: **0**
O&M Grade: **0**
Clock Start/From:
Clock To:
1st Value:
2nd Value:
Value Percent:
Continuous Index:
Within 8" of Joint: **NO**
Remarks: **max tether**
