## Profile/Photo Observation Report

Street:	<b>guyer st</b>	Flow Control:	<b>Not Controlled</b>
City:	<b>Hobart, IN</b>	Year Renewed:	
Location:	<b>Other</b>	Tape/Media #:	
Purpose:	<b>Not Known</b>	Dia/Height:	<b>8"</b>
Use:	<b>Sanitary</b>	Material:	<b>PVC</b>
Drain Area:	<b>NA</b>	Lining:	
Category:	<b>NA</b>		
Comment:

Location Details:		Direction of Survey:	<b>Downstream</b>
US MH:	<b>M-503-089</b>	DS MH:	<b>M-503-090</b>
		Total Length Surveyed (ft):	<b>463.4</b>

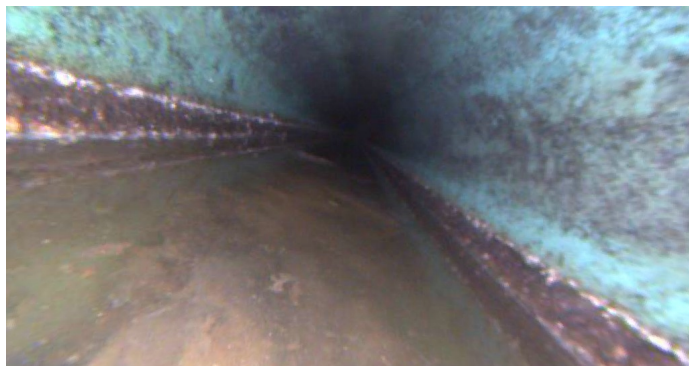
Code: **AMH**  
 Description: **Manhole**

Distance (ft): **.0**  
 Structural Grade: **0**  
 O&M Grade: **0**  
 Clock Start/From:  
 Clock To:  
 1st Value:  
 2nd Value:  
 Value Percent:  
 Continuous Index:  
 Within 8" of Joint: **NO**  
 Remarks: **M-503-089**

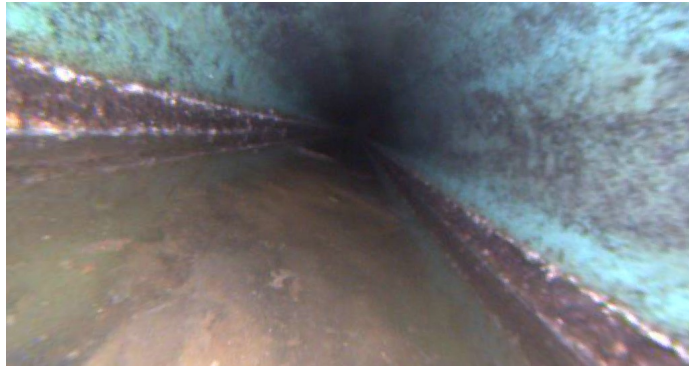
Code: **MWL**  
Description: **Water Level**

Distance (ft): **.0**  
Structural Grade: **0**  
O&M Grade: **0**  
Clock Start/From:  
Clock To:  
1st Value:  
2nd Value:  
Value Percent: **10.000**  
Continuous Index:  
Within 8" of Joint: **NO**  
Remarks:

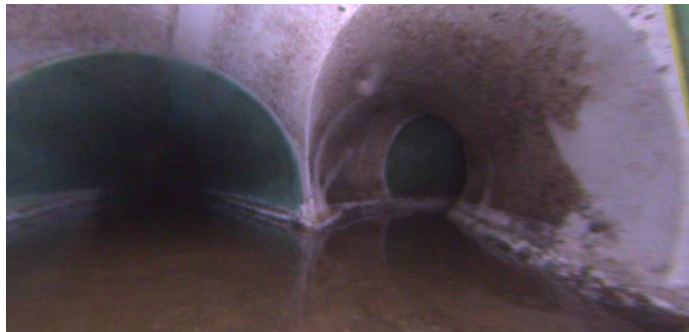
Code: **TFA**  
Description: **Tap Factory Active**

Distance (ft): **17.1**  
Structural Grade: **0**  
O&M Grade: **0**  
Clock Start/From: **3**  
Clock To:  
1st Value: **4.000**  
2nd Value:  
Value Percent:  
Continuous Index:  
Within 8" of Joint:  
Remarks:

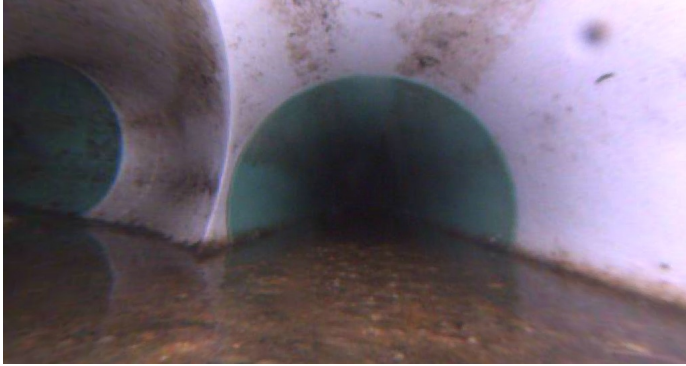
Code: **TF**  
Description: **Tap Factory**

Distance (ft): **26.2**  
Structural Grade: **0**  
O&M Grade: **0**  
Clock Start/From: **8**  
Clock To:  
1st Value: **4.000**  
2nd Value:  
Value Percent:  
Continuous Index:  
Within 8" of Joint:  
Remarks:

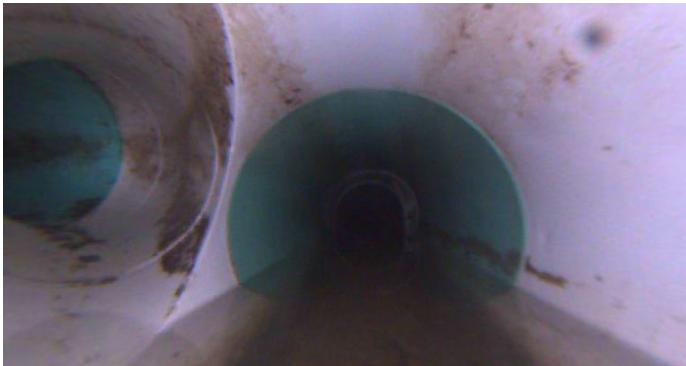
Code: **TF**  
Description: **Tap Factory**

Distance (ft): **107.0**  
Structural Grade: **0**  
O&M Grade: **0**  
Clock Start/From: **9**  
Clock To:  
1st Value: **4.000**  
2nd Value:  
Value Percent:  
Continuous Index:  
Within 8" of Joint:  
Remarks:

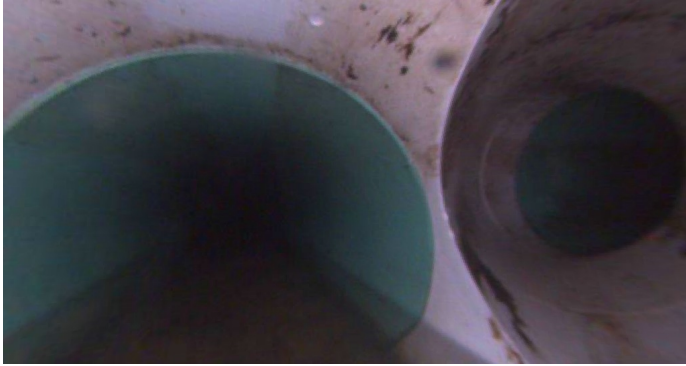
Code: **TF**  
Description: **Tap Factory**

Distance (ft): **109.6**  
Structural Grade: **0**  
O&M Grade: **0**  
Clock Start/From: **4**  
Clock To:  
1st Value: **4.000**  
2nd Value:  
Value Percent:  
Continuous Index:  
Within 8" of Joint:  
Remarks:

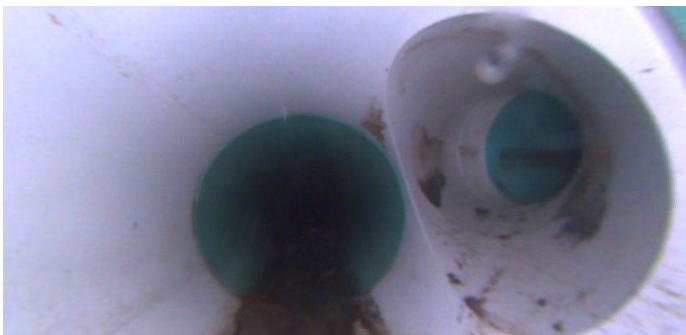
Code: **TF**  
Description: **Tap Factory**

Distance (ft): **216.0**  
Structural Grade: **0**  
O&M Grade: **0**  
Clock Start/From: **3**  
Clock To:  
1st Value: **4.000**  
2nd Value:  
Value Percent:  
Continuous Index:  
Within 8" of Joint:  
Remarks:

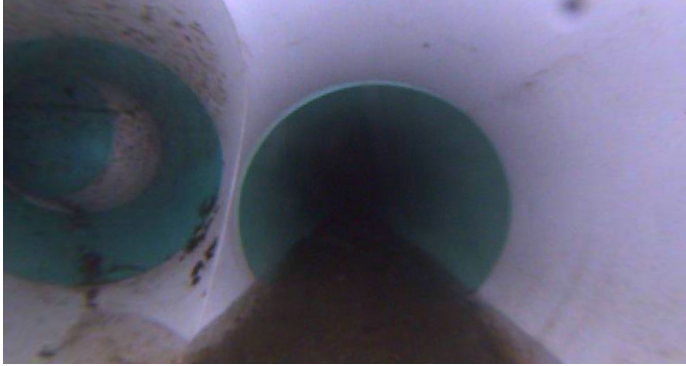
Code: **TF**  
Description: **Tap Factory**

Distance (ft): **232.5**  
Structural Grade: **0**  
O&M Grade: **0**  
Clock Start/From: **9**  
Clock To:  
1st Value: **4.000**  
2nd Value:  
Value Percent:  
Continuous Index:  
Within 8" of Joint:  
Remarks:

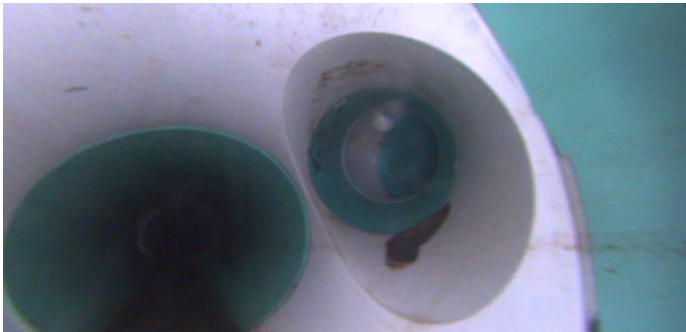
Code: **TF**  
Description: **Tap Factory**

Distance (ft): **313.1**  
Structural Grade: **0**  
O&M Grade: **0**  
Clock Start/From: **2**  
Clock To:  
1st Value: **4.000**  
2nd Value:  
Value Percent:  
Continuous Index:  
Within 8" of Joint:  
Remarks:

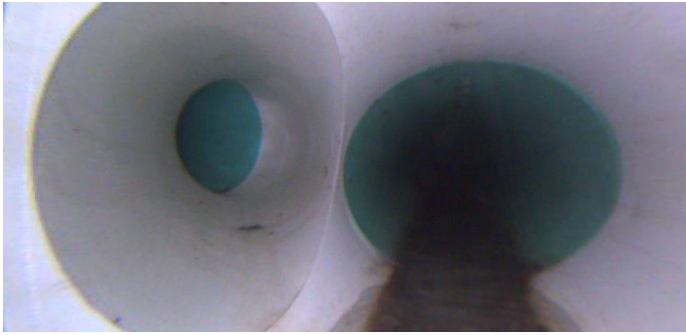
Code: **TF**  
Description: **Tap Factory**

Distance (ft): **316.0**  
Structural Grade: **0**  
O&M Grade: **0**  
Clock Start/From: **9**  
Clock To:  
1st Value: **4.000**  
2nd Value:  
Value Percent:  
Continuous Index:  
Within 8" of Joint:  
Remarks:

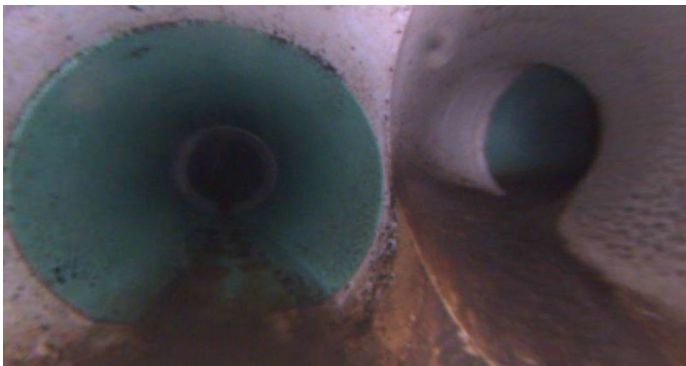
Code: **TF**  
Description: **Tap Factory**

Distance (ft): **456.5**  
Structural Grade: **0**  
O&M Grade: **0**  
Clock Start/From: **3**  
Clock To:  
1st Value: **4.000**  
2nd Value:  
Value Percent:  
Continuous Index:  
Within 8" of Joint:  
Remarks:

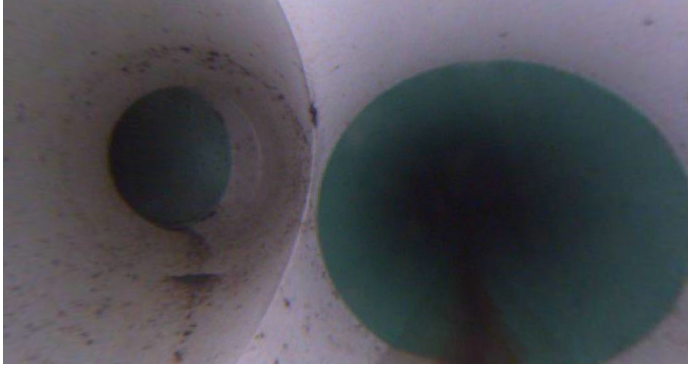
Code: **TF**  
Description: **Tap Factory**

Distance (ft): **458.8**  
Structural Grade: **0**  
O&M Grade: **0**  
Clock Start/From: **9**  
Clock To:  
1st Value: **4.000**  
2nd Value:  
Value Percent:  
Continuous Index:  
Within 8" of Joint:  
Remarks:

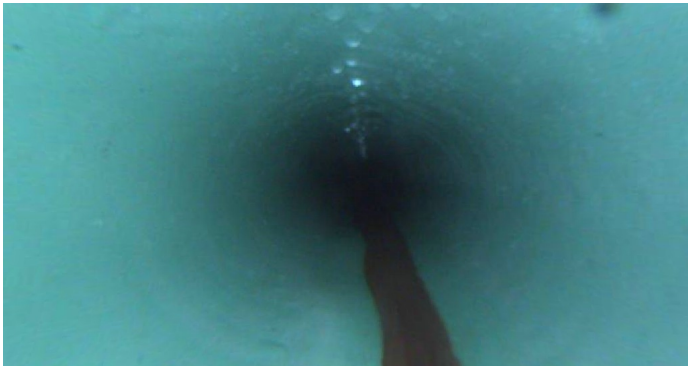
Code: **MSA**  
Description: **Abandoned Survey**

Distance (ft): **463.4**  
Structural Grade: **0**  
O&M Grade: **0**  
Clock Start/From:  
Clock To:  
1st Value:  
2nd Value:  
Value Percent:  
Continuous Index:  
Within 8" of Joint: **NO**  
Remarks: **max tether**
