Profile/Photo Observation Report

Street:	W 40TH AVE	Flow Control:	Not Controlled
City:	Hobart, IN	Year Renewed:	
Location:	Light Highway	Tape/Media #:	
Purpose:	Routine Assessment	Dia/Height:	8"
Use:	Sanitary	Material:	PVC
Drain Area:	NA	Lining:	
Category:	NA		
Comment:

Location Details:		Direction of Survey:	Downstream
US MH:	M-503-089	DS MH:	M-503-090
		Total Length Surveyed (ft):	365.8

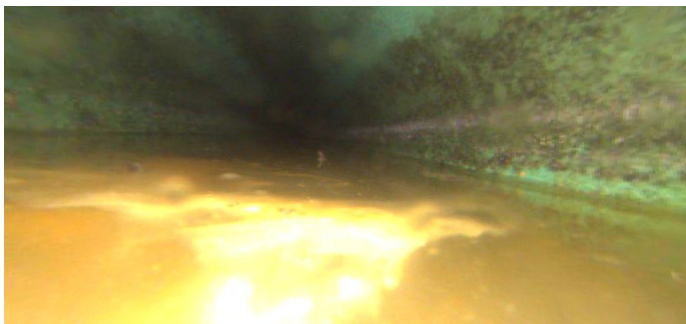
Code: **AMH**
Description: **Manhole**

Distance (ft): **.0**
Structural Grade: **0**
O&M Grade: **0**
Clock Start/From:
Clock To:
1st Value:
2nd Value:
Value Percent:
Continuous Index:
Within 8" of Joint: **NO**
Remarks: **M-503-089**

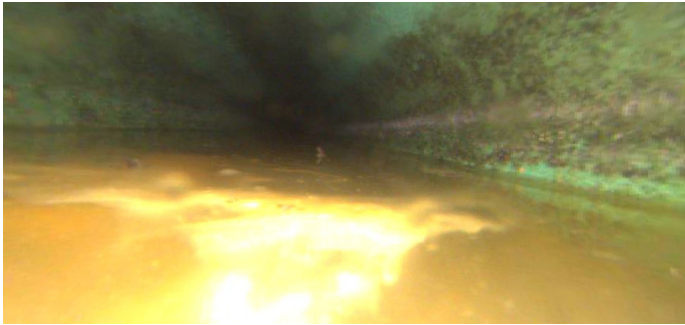
Code:	MWL
Description:	Water Level

Distance (ft):	.0
Structural Grade:	0
O&M Grade:	0
Clock Start/From:	
Clock To:	
1st Value:	
2nd Value:	
Value Percent:	15.000
Continuous Index:	
Within 8" of Joint:	NO
Remarks:

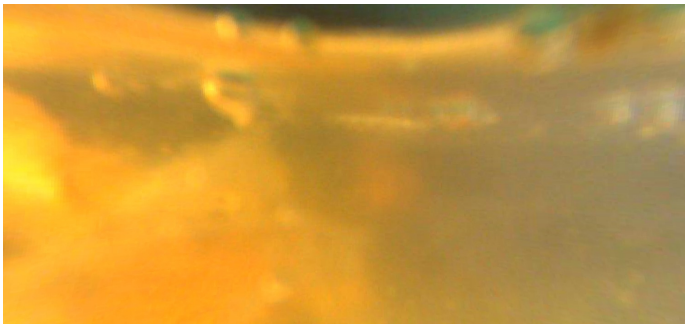
Code:	MCU
Description:	Camera Underwater

Distance (ft):	10.9
Structural Grade:	0
O&M Grade:	4
Clock Start/From:	
Clock To:	
1st Value:	
2nd Value:	
Value Percent:	
Continuous Index:	
Within 8" of Joint:	NO
Remarks:

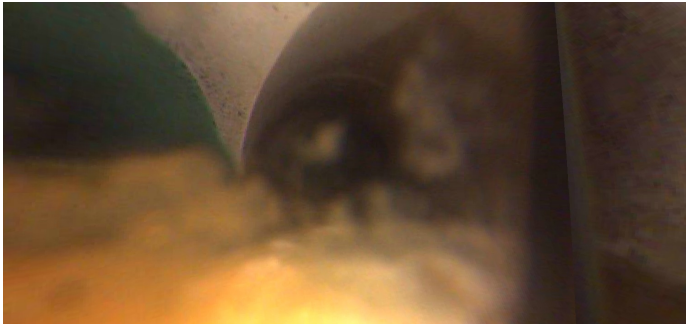
Code: **TFA**
Description: **Tap Factory Active**

Distance (ft): **16.9**
Structural Grade: **0**
O&M Grade: **0**
Clock Start/From: **3**
Clock To:
1st Value: **6.000**
2nd Value:
Value Percent:
Continuous Index:
Within 8" of Joint:
Remarks:

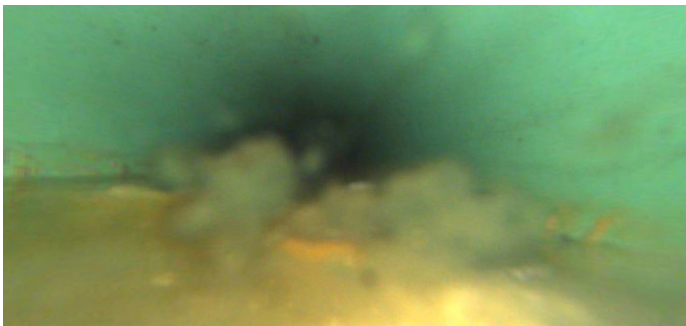
Code: **MGO**
Description: **General Observation**

Distance (ft): **22.9**
Structural Grade: **0**
O&M Grade: **0**
Clock Start/From:
Clock To:
1st Value:
2nd Value:
Value Percent:
Continuous Index:
Within 8" of Joint: **NO**
Remarks: **DEPOSITS ON FRONT LENS**

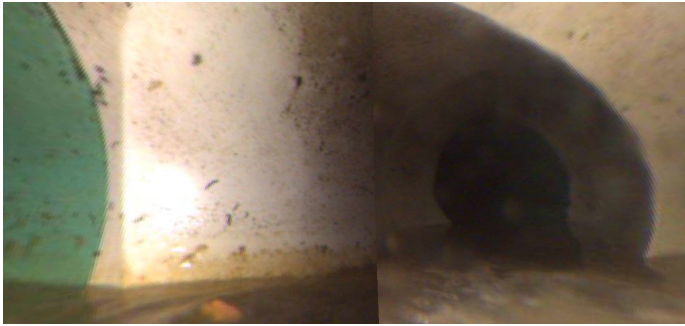
Code: **TFA**
Description: **Tap Factory Active**

Distance (ft): **26.0**
Structural Grade: **0**
O&M Grade: **0**
Clock Start/From: **9**
Clock To:
1st Value: **6.000**
2nd Value:
Value Percent:
Continuous Index:
Within 8" of Joint:
Remarks:

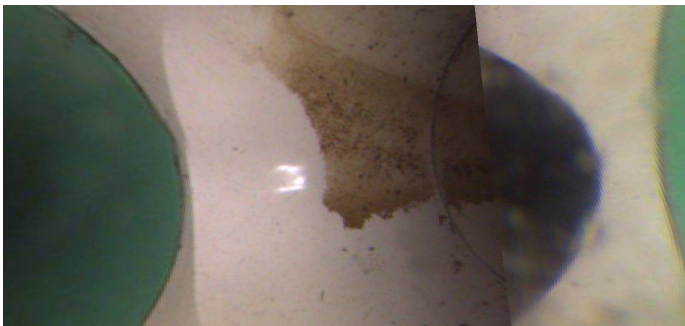
Code: **TF**
Description: **Tap Factory**

Distance (ft): **106.5**
Structural Grade: **0**
O&M Grade: **0**
Clock Start/From: **9**
Clock To:
1st Value: **6.000**
2nd Value:
Value Percent:
Continuous Index:
Within 8" of Joint:
Remarks:

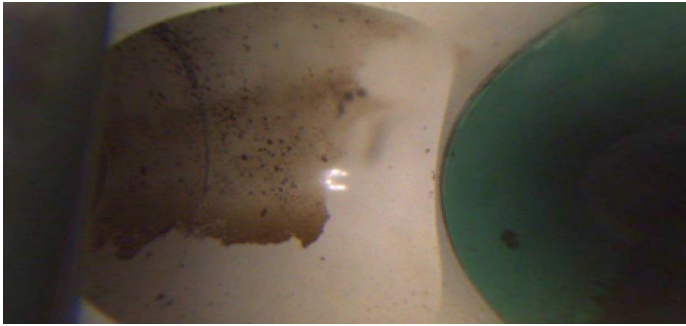
Code: **TF**
Description: **Tap Factory**

Distance (ft): **108.9**
Structural Grade: **0**
O&M Grade: **0**
Clock Start/From: **3**
Clock To:
1st Value: **6.000**
2nd Value:
Value Percent:
Continuous Index:
Within 8" of Joint:
Remarks:

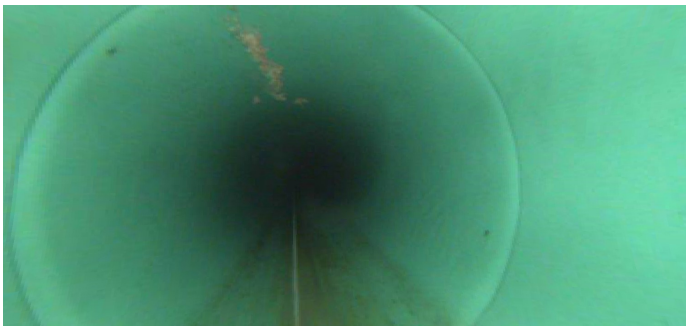
Code: **DAGS**
Description: **Deposits Attached Grease**

Distance (ft): **200.0**
Structural Grade: **0**
O&M Grade: **2**
Clock Start/From: **1**
Clock To:
1st Value:
2nd Value:
Value Percent: **5.000**
Continuous Index:
Within 8" of Joint: **YES**
Remarks:

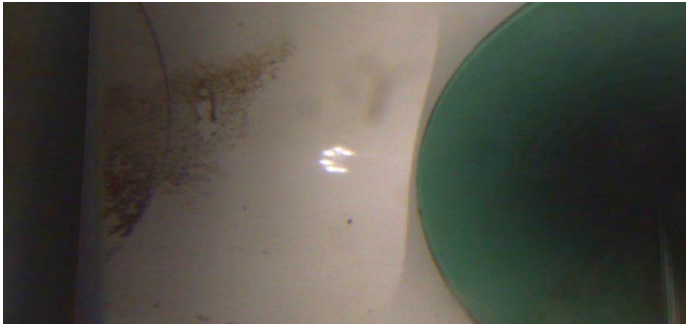
Code: **TF**
Description: **Tap Factory**

Distance (ft): **215.3**
Structural Grade: **0**
O&M Grade: **0**
Clock Start/From: **3**
Clock To:
1st Value: **6.000**
2nd Value:
Value Percent:
Continuous Index:
Within 8" of Joint:
Remarks:

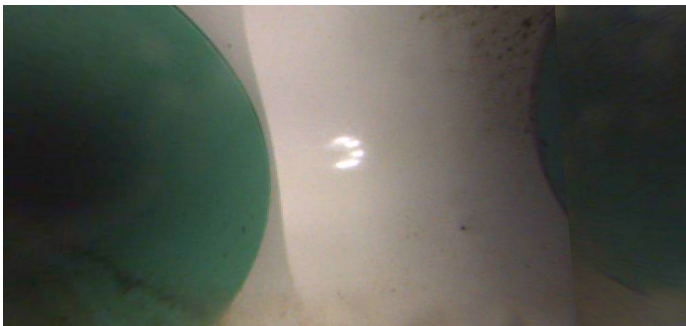
Code: **TF**
Description: **Tap Factory**

Distance (ft): **231.6**
Structural Grade: **0**
O&M Grade: **0**
Clock Start/From: **9**
Clock To:
1st Value: **6.000**
2nd Value:
Value Percent:
Continuous Index:
Within 8" of Joint:
Remarks:

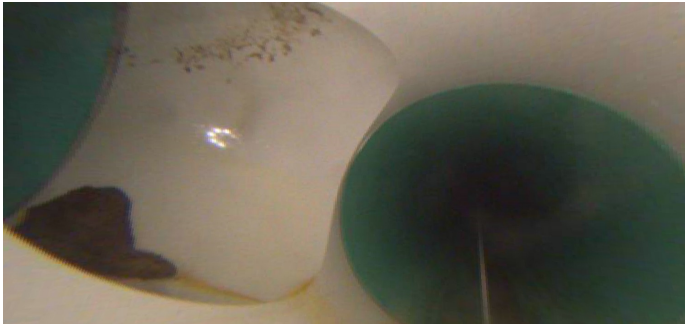
Code: **TF**
Description: **Tap Factory**

Distance (ft): **312.4**
Structural Grade: **0**
O&M Grade: **0**
Clock Start/From: **3**
Clock To:
1st Value: **6.000**
2nd Value:
Value Percent:
Continuous Index:
Within 8" of Joint:
Remarks:

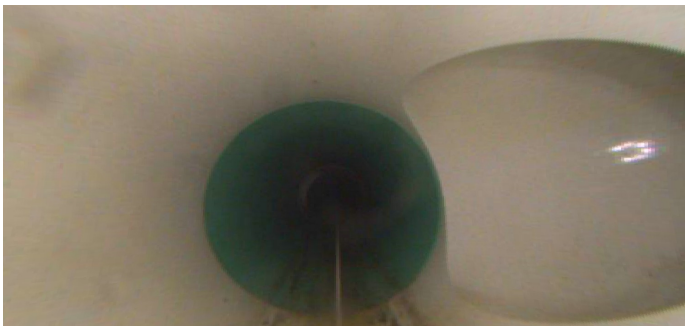
Code: **TF**
Description: **Tap Factory**

Distance (ft): **315.4**
Structural Grade: **0**
O&M Grade: **0**
Clock Start/From: **9**
Clock To:
1st Value: **6.000**
2nd Value:
Value Percent:
Continuous Index:
Within 8" of Joint:
Remarks:

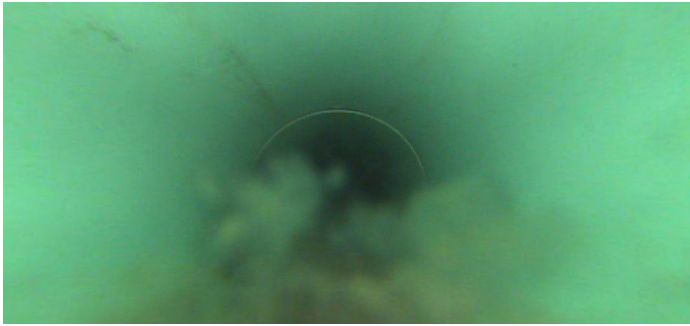
Code:	MSA
Description:	Abandoned Survey
Distance (ft):	365.8
Structural Grade:	0
O&M Grade:	0
Clock Start/From:	
Clock To:	
1st Value:	
2nd Value:	
Value Percent:	
Continuous Index:	
Within 8" of Joint:	NO
Remarks:	ROBOT HAS STOPPED
