Profile/Photo Observation Report

Street:	OFF N COLORADO ST	Flow Control:	Not Controlled
City:	Hobart, IN	Year Renewed:	
Location:	Other	Tape/Media #:	
Purpose:	Not Known	Dia/Height:	8"
Use:	Sanitary	Material:	PVC
Drain Area:	NA	Lining:	
Category:	NA		
Comment:

Location Details:		Direction of Survey:	Downstream
US MH:	M-503-091	DS MH:	M-503-092
		Total Length Surveyed (ft):	125.3

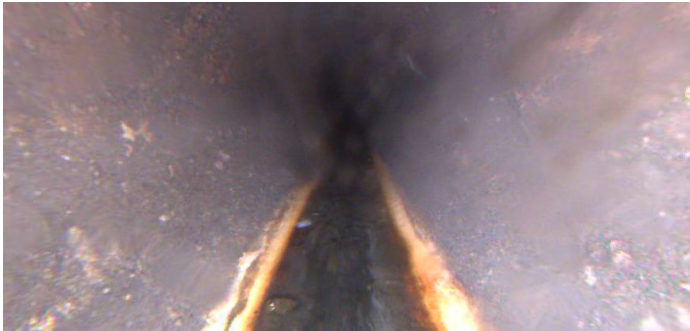
125.3	AMH	Manhole	305	NA
<div> <div> <div>Code:</div> <div>AMH</div> </div> <div> <div>Description:</div> <div>Manhole</div> </div> </div> <div>

<div> <div>Distance (ft):</div> <div>.0</div> </div> <div> <div>Structural Grade:</div> <div>0</div> </div> <div> <div>O&M Grade:</div> <div>0</div> </div> <div> <div>Clock Start/From:</div> <div></div> </div> <div> <div>Clock To:</div> <div></div> </div> <div> <div>1st Value:</div> <div></div> </div> <div> <div>2nd Value:</div> <div></div> </div> <div> <div>Value Percent:</div> <div></div> </div> <div> <div>Continuous Index:</div> <div></div> </div> <div> <div>Within 8" of Joint:</div> <div>NO</div> </div> <div> <div>Remarks:</div> <div>M-503-091</div> </div> </div>

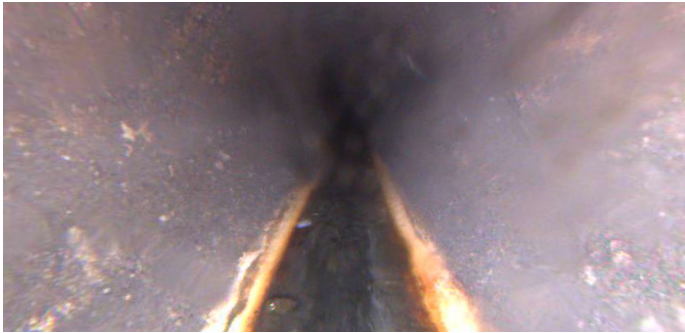
Code:	MWL
Description:	Water Level

Distance (ft):	.0
Structural Grade:	0
O&M Grade:	0
Clock Start/From:	
Clock To:	
1st Value:	
2nd Value:	
Value Percent:	5.000
Continuous Index:	
Within 8" of Joint:	NO
Remarks:

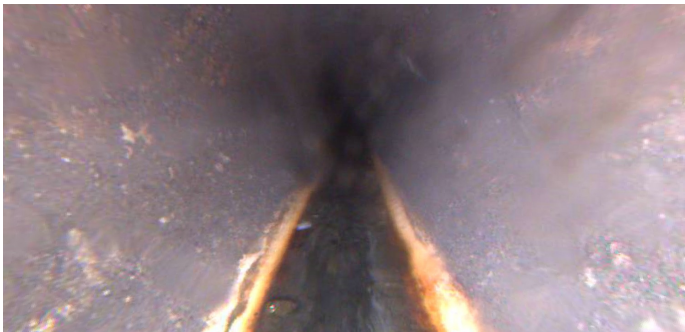
Code:	DAGS
Description:	Deposits Attached Grease

Distance (ft):	.0
Structural Grade:	0
O&M Grade:	2
Clock Start/From:	7
Clock To:	5
1st Value:	
2nd Value:	
Value Percent:	5.000
Continuous Index:	S01
Within 8" of Joint:	NO
Remarks:

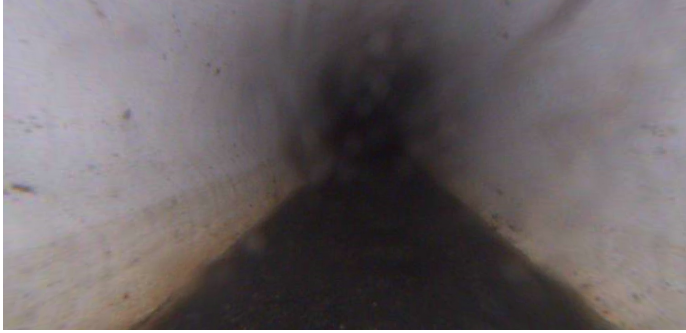
Code: **DAGS**
Description: **Deposits Attached Grease**

Distance (ft): **47.7**
Structural Grade: **0**
O&M Grade: **2**
Clock Start/From: **7**
Clock To: **5**
1st Value:
2nd Value:
Value Percent: **5.000**
Continuous Index: **F01**
Within 8" of Joint: **NO**
Remarks:

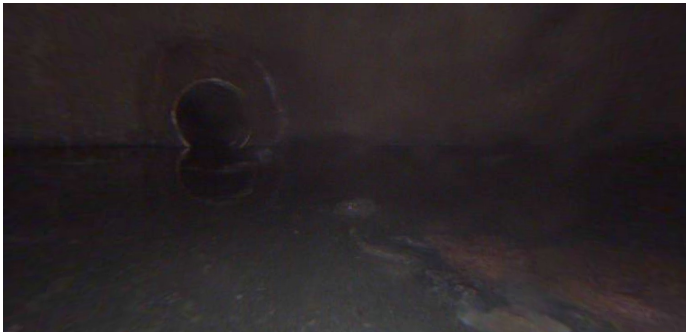
Code: **AMH**
Description: **Manhole**

Distance (ft): **125.3**
Structural Grade: **0**
O&M Grade: **0**
Clock Start/From:
Clock To:
1st Value:
2nd Value:
Value Percent:
Continuous Index:
Within 8" of Joint: **NO**
Remarks: **M-503-092**
