Profile/Photo Observation Report

Street:	N COLORADO ST	Flow Control:	Not Controlled
City:	Hobart, IN	Year Renewed:	
Location:	Other	Tape/Media #:	
Purpose:	Not Known	Dia/Height:	8"
Use:	Sanitary	Material:	PVC
Drain Area:	NA	Lining:	
Category:	NA		
Comment:

Location Details:		Direction of Survey:	Downstream
US MH:	M-503-092	DS MH:	M-503-075
		Total Length Surveyed (ft):	78.4

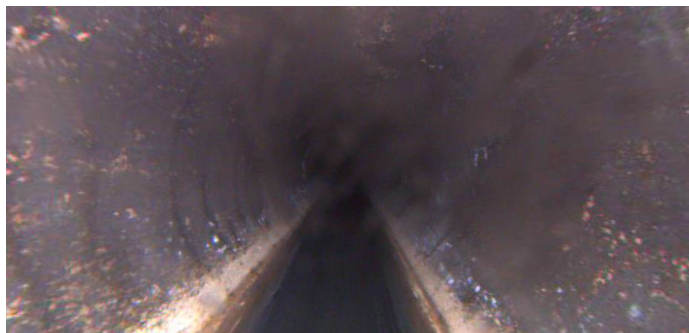
Code: **AMH**
Description: **Manhole**

Distance (ft): **.0**
Structural Grade: **0**
O&M Grade: **0**
Clock Start/From:
Clock To:
1st Value:
2nd Value:
Value Percent:
Continuous Index:
Within 8" of Joint: **NO**
Remarks: **M-503-092**

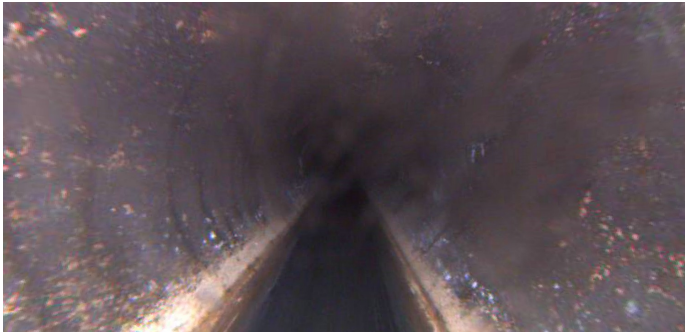
Code:	MWL
Description:	Water Level

Distance (ft):	.0
Structural Grade:	0
O&M Grade:	0
Clock Start/From:	
Clock To:	
1st Value:	
2nd Value:	
Value Percent:	5.000
Continuous Index:	
Within 8" of Joint:	NO
Remarks:

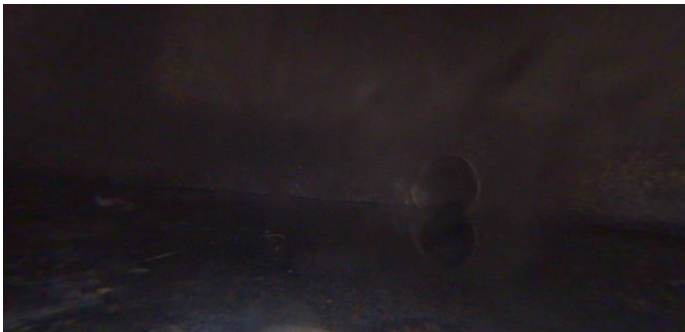
Code:	AMH
Description:	Manhole

Distance (ft):	78.4
Structural Grade:	0
O&M Grade:	0
Clock Start/From:	
Clock To:	
1st Value:	
2nd Value:	
Value Percent:	
Continuous Index:	
Within 8" of Joint:	NO
Remarks:	M-503-075
