Profile/Photo Observation Report

Street:	Wisconsin Street	Flow Control:	Not Controlled
City:	Hobart, IN	Year Renewed:	
Location:	Light Highway	Tape/Media #:	DEP 67
Purpose:	Routine Assessment	Dia/Height:	18"
Use:	Sanitary	Material:	VCP
Drain Area:		Lining:	
Category:	NA		
Comment:	YES501824 Submittal 2		
Location Details:		Direction of Survey:	Downstream
US MH:	M-504-002	DS MH:	M-504-001
		Total Length Surveyed (ft):	220.5

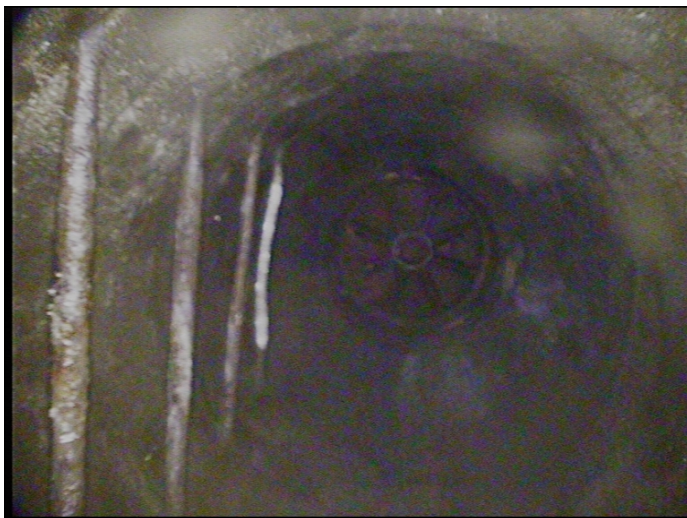
Code: **AMH**
 Description: **Manhole**

Distance (ft): **.0**
 Structural Grade: **0**
 O&M Grade: **0**
 Clock Start/From:
 Clock To:
 1st Value:
 2nd Value:
 Value Percent:
 Continuous Index:
 Within 8" of Joint: **NO**
 Remarks: **M-504-002**

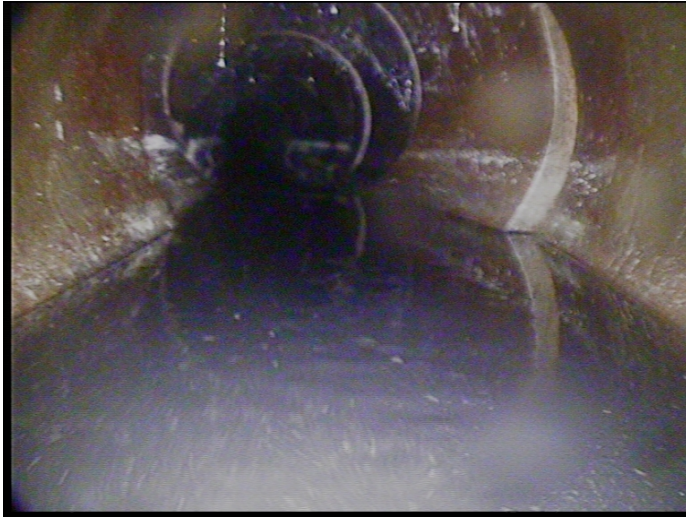
Code:	MWL
Description:	Water Level
Distance (ft):	.0
Structural Grade:	0
O&M Grade:	0
Clock Start/From:	
Clock To:	
1st Value:	
2nd Value:	
Value Percent:	10.000
Continuous Index:	
Within 8" of Joint:	NO
Remarks:

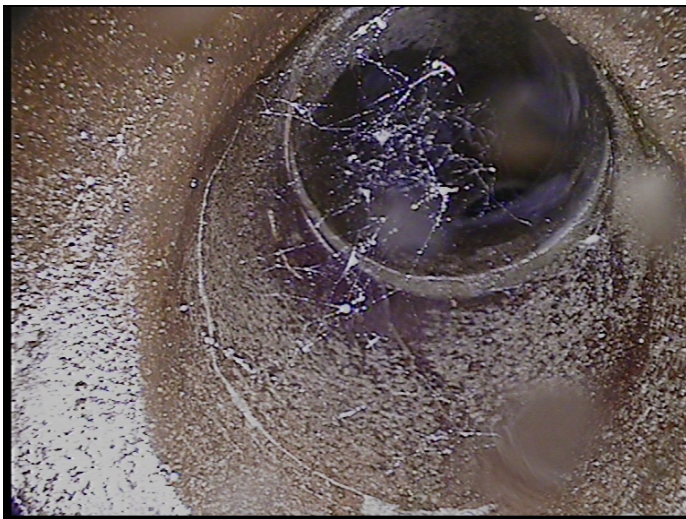
Code:	TF
Description:	Tap Factory
Distance (ft):	10.0
Structural Grade:	0
O&M Grade:	0
Clock Start/From:	2
Clock To:	
1st Value:	4.000
2nd Value:	
Value Percent:	
Continuous Index:	
Within 8" of Joint:	NO
Remarks:

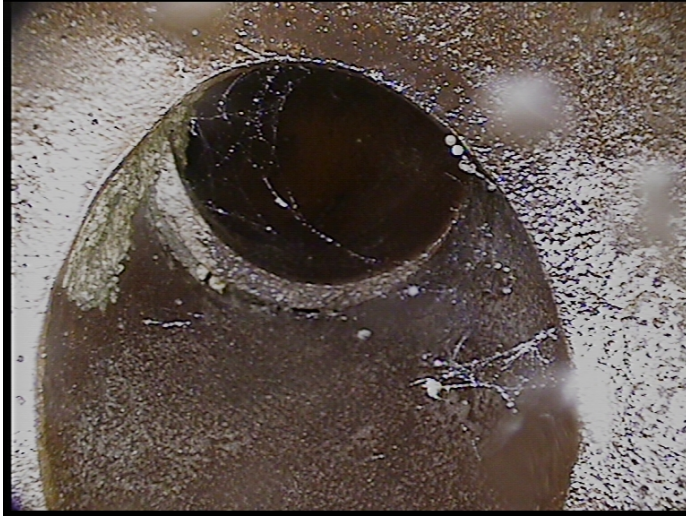
Code: **TF**
Description: **Tap Factory**

Distance (ft): **28.1**
Structural Grade: **0**
O&M Grade: **0**
Clock Start/From: **10**
Clock To:
1st Value: **4.000**
2nd Value:
Value Percent:
Continuous Index:
Within 8" of Joint: **NO**
Remarks:

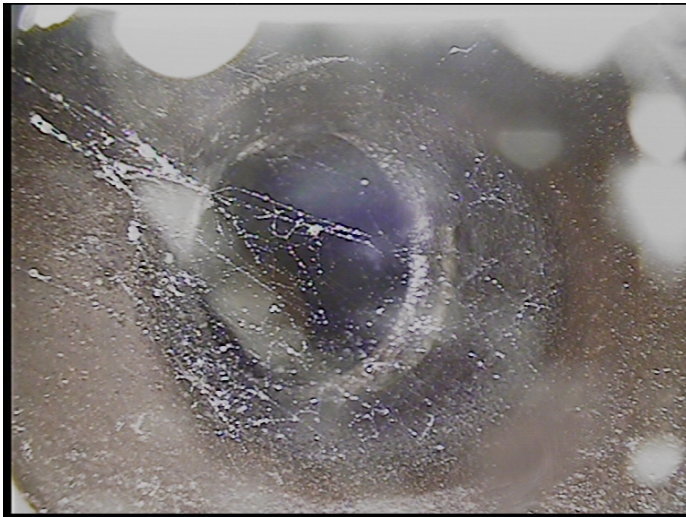
Code: **TF**
Description: **Tap Factory**

Distance (ft): **75.3**
Structural Grade: **0**
O&M Grade: **0**
Clock Start/From: **10**
Clock To:
1st Value: **4.000**
2nd Value:
Value Percent:
Continuous Index:
Within 8" of Joint: **NO**
Remarks:

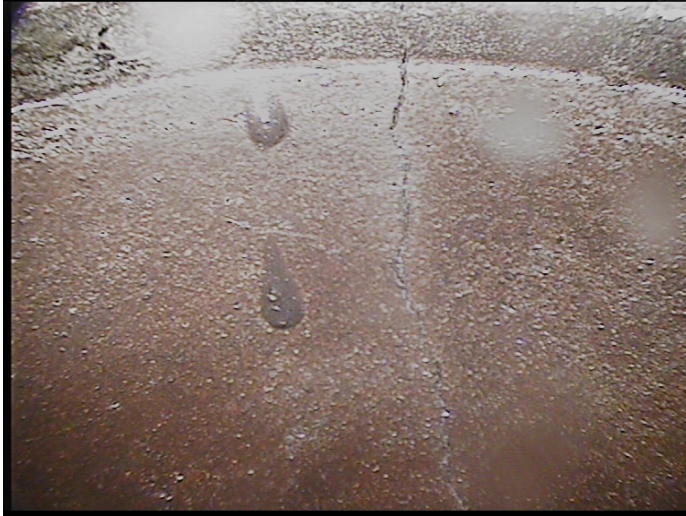
Code: **CL**
Description: **Crack Longitudinal**

Distance (ft): **108.0**
Structural Grade: **2**
O&M Grade: **0**
Clock Start/From: **12**
Clock To:
1st Value:
2nd Value:
Value Percent:
Continuous Index:
Within 8" of Joint: **YES**
Remarks:

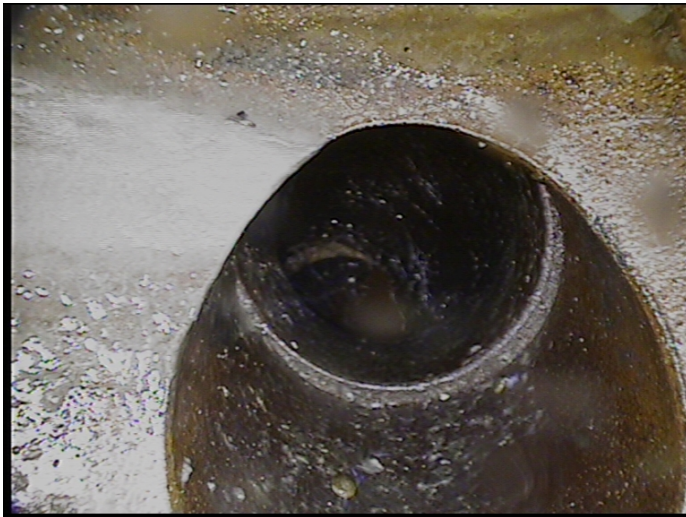
Code: **TFA**
Description: **Tap Factory Active**

Distance (ft): **123.8**
Structural Grade: **0**
O&M Grade: **0**
Clock Start/From: **10**
Clock To:
1st Value: **4.000**
2nd Value:
Value Percent:
Continuous Index:
Within 8" of Joint: **NO**
Remarks:

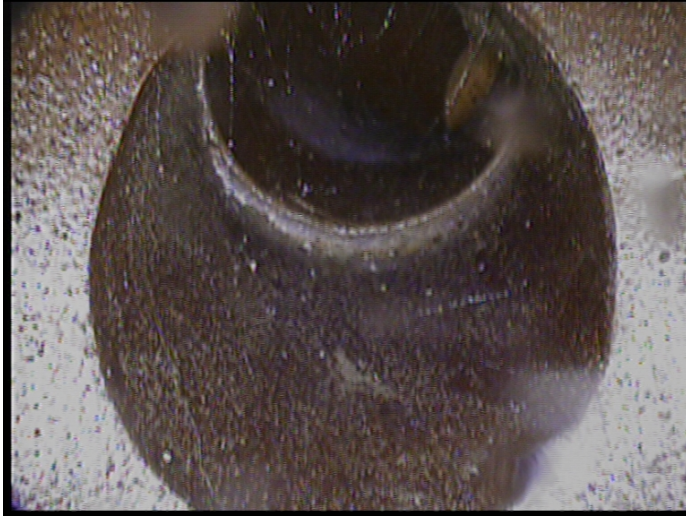
Code: **TF**
Description: **Tap Factory**

Distance (ft): **127.7**
Structural Grade: **0**
O&M Grade: **0**
Clock Start/From: **2**
Clock To:
1st Value: **4.000**
2nd Value:
Value Percent:
Continuous Index:
Within 8" of Joint: **NO**
Remarks:

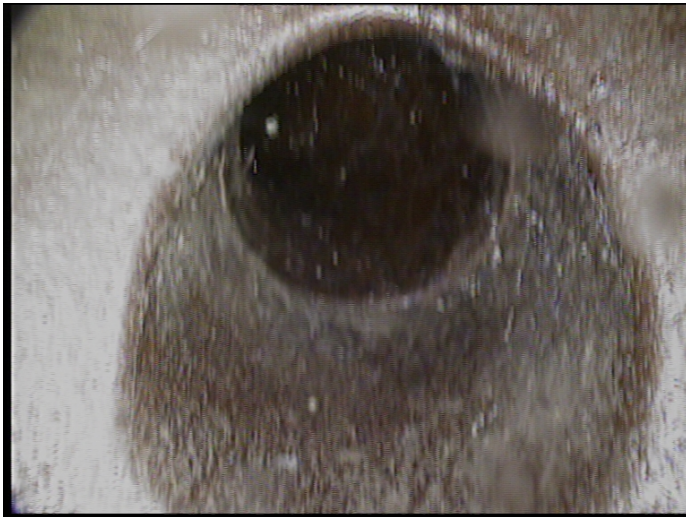
Code: **TF**
Description: **Tap Factory**

Distance (ft): **168.4**
Structural Grade: **0**
O&M Grade: **0**
Clock Start/From: **10**
Clock To:
1st Value: **4.000**
2nd Value:
Value Percent:
Continuous Index:
Within 8" of Joint: **NO**
Remarks:

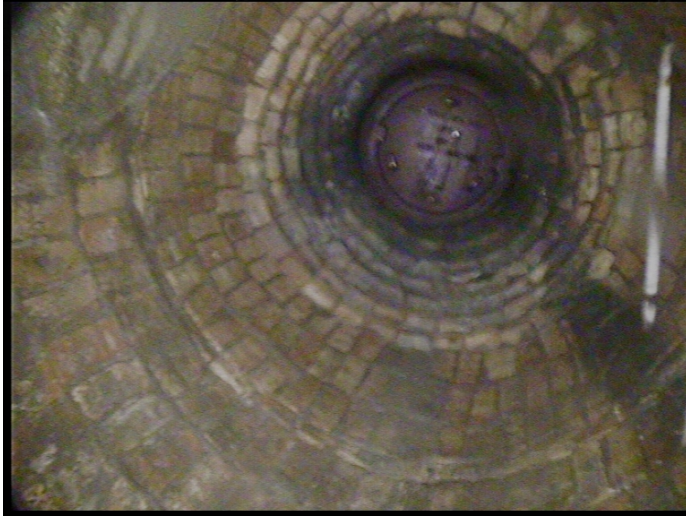
Code:	AMH
Description:	Manhole
Distance (ft):	220.5
Structural Grade:	0
O&M Grade:	0
Clock Start/From:	
Clock To:	
1st Value:	
2nd Value:	
Value Percent:	
Continuous Index:	
Within 8" of Joint:	NO
Remarks:	M-504-001
