Profile/Photo Observation Report

Date:	04/24/2018	Weather:		Coding:	PACP 6.0
Pipe Length (ft):		Owner:	City of Hobart	Pre Clean:	No Pre-Cleaning
P.O.#:	67	Surveyor:	M. Pielacha	PSR:	P-504-003-002
Customer:	City of Hobart	Clean Date:		Shape:	C

Street:	Wisconsin Street	Flow Control:	Not Controlled
City:	Hobart, IN	Year Renewed:	
Location:	Light Highway	Tape/Media #:	DEP 67
Purpose:	Routine Assessment	Dia/Height:	18"
Use:	Sanitary	Material:	VCP
Drain Area:		Lining:	
Category:	NA		
Comment:	YES501824 Submittal 2		
Location Details:		Direction of Survey:	Downstream
US MH:	M-504-003	DS MH:	M-504-002
		Total Length Surveyed (ft):	219.4

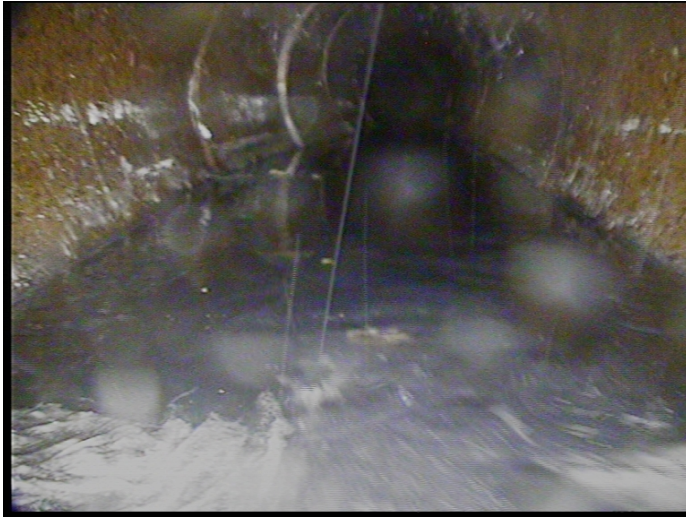
Code:	MWL
Description:	Water Level
Distance (ft):	.0
Structural Grade:	0
O&M Grade:	0
Clock Start/From:	
Clock To:	
1st Value:	
2nd Value:	
Value Percent:	10.000
Continuous Index:	
Within 8" of Joint:	NO
Remarks:

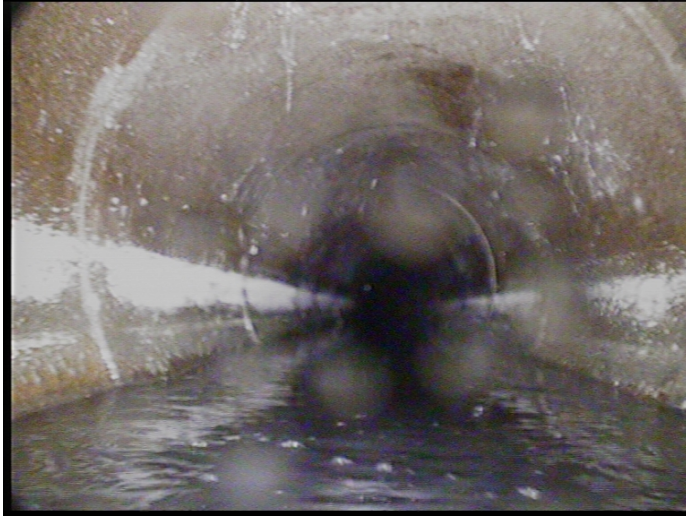
Code: **DSF**
Description: **Deposits Settled Fine**

Distance (ft): **40.3**
Structural Grade: **0**
O&M Grade: **2**
Clock Start/From: **5**
Clock To: **7**
1st Value:
2nd Value:
Value Percent: **10.000**
Continuous Index: **S01**
Within 8" of Joint: **YES**
Remarks:

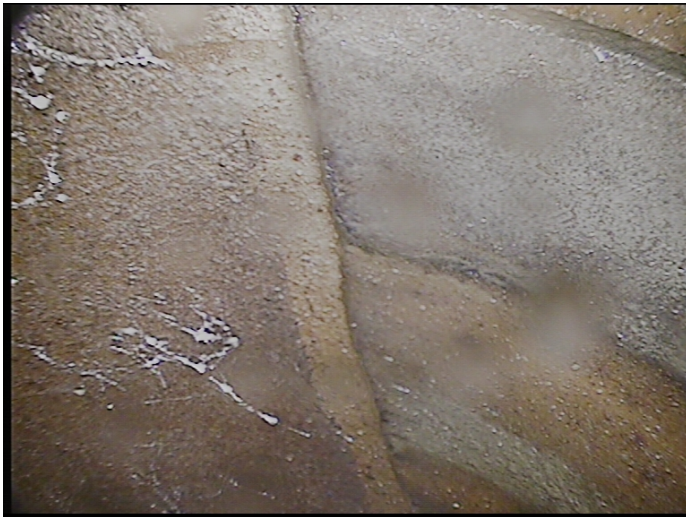
Code: **CL**
Description: **Crack Longitudinal**

Distance (ft): **68.0**
Structural Grade: **2**
O&M Grade: **0**
Clock Start/From: **1**
Clock To:
1st Value:
2nd Value:
Value Percent:
Continuous Index:
Within 8" of Joint: **YES**
Remarks:

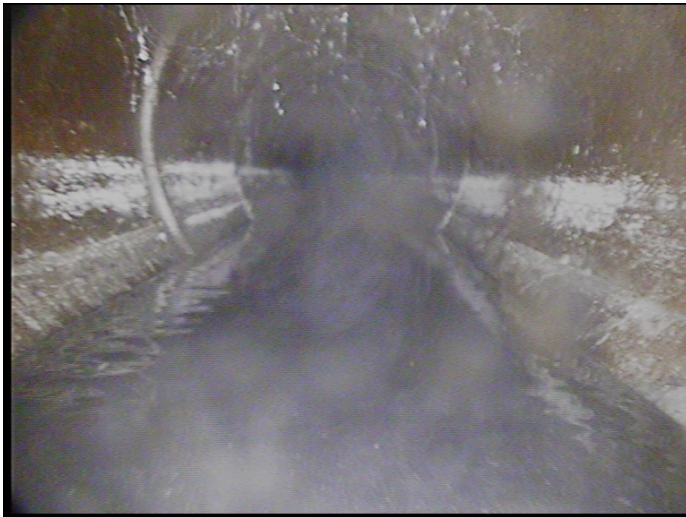
Code: **DSF**
Description: **Deposits Settled Fine**

Distance (ft): **73.4**
Structural Grade: **0**
O&M Grade: **2**
Clock Start/From: **5**
Clock To: **7**
1st Value:
2nd Value:
Value Percent: **10.000**
Continuous Index: **F01**
Within 8" of Joint: **NO**
Remarks:

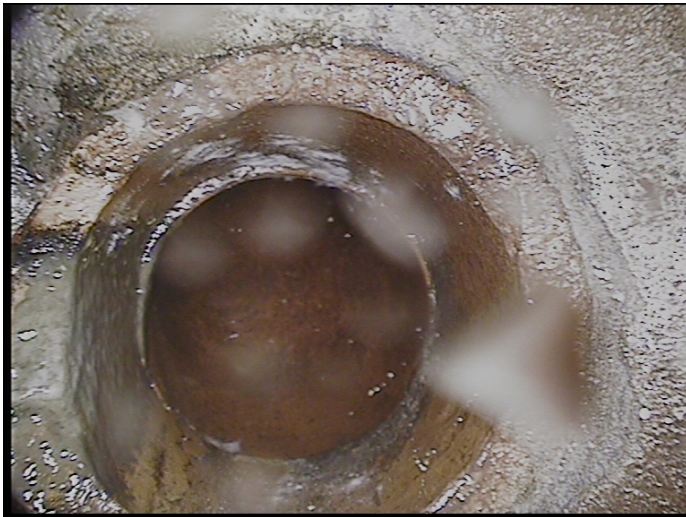
Code: **TB**
Description: **Tap Break-in**

Distance (ft): **111.3**
Structural Grade: **0**
O&M Grade: **0**
Clock Start/From: **10**
Clock To:
1st Value: **4.000**
2nd Value:
Value Percent:
Continuous Index:
Within 8" of Joint: **NO**
Remarks:

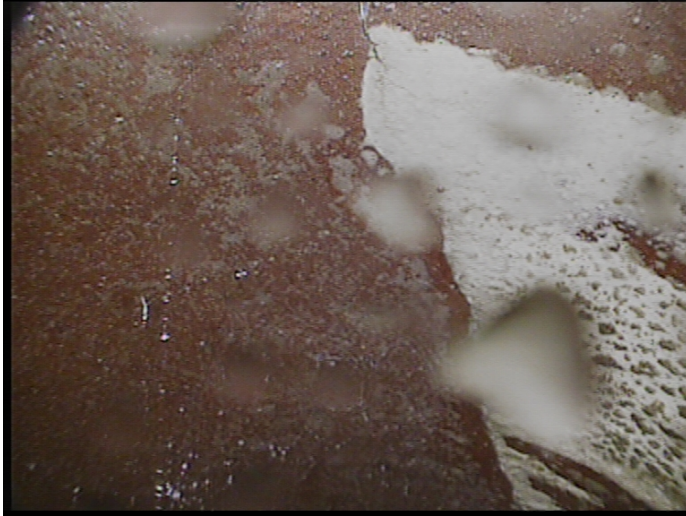
Code: **CL**
Description: **Crack Longitudinal**

Distance (ft): **112.4**
Structural Grade: **2**
O&M Grade: **0**
Clock Start/From: **2**
Clock To:
1st Value:
2nd Value:
Value Percent:
Continuous Index:
Within 8" of Joint: **YES**
Remarks:

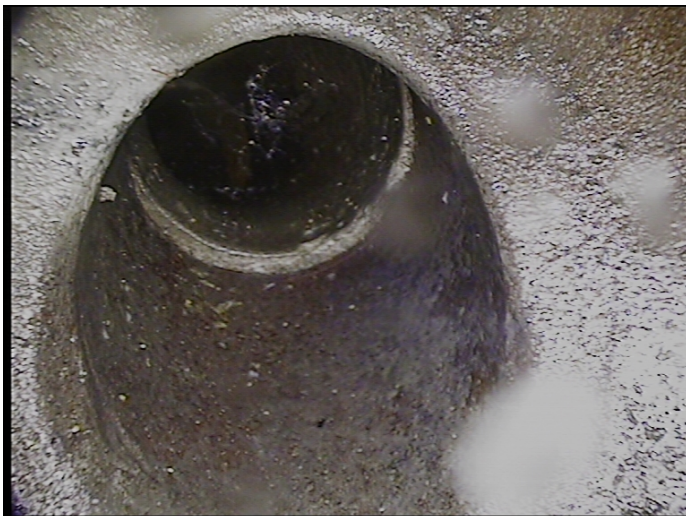
Code: **TF**
Description: **Tap Factory**

Distance (ft): **156.7**
Structural Grade: **0**
O&M Grade: **0**
Clock Start/From: **10**
Clock To:
1st Value: **4.000**
2nd Value:
Value Percent:
Continuous Index:
Within 8" of Joint: **NO**
Remarks:

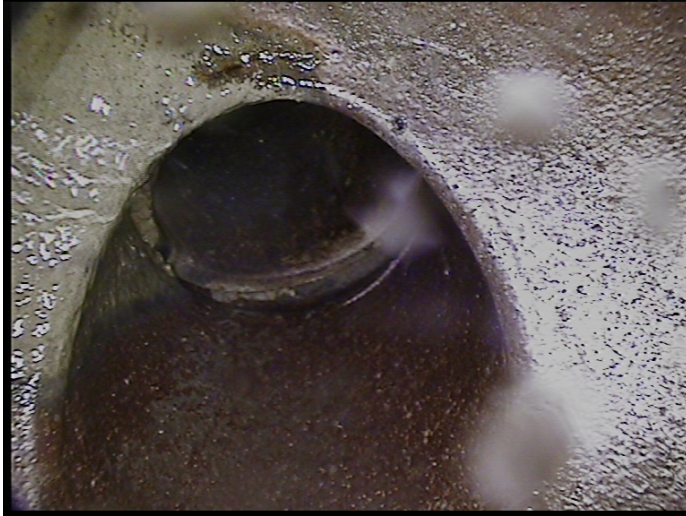
Code: **TF**
Description: **Tap Factory**

Distance (ft): **200.6**
Structural Grade: **0**
O&M Grade: **0**
Clock Start/From: **10**
Clock To:
1st Value: **4.000**
2nd Value:
Value Percent:
Continuous Index:
Within 8" of Joint: **NO**
Remarks:

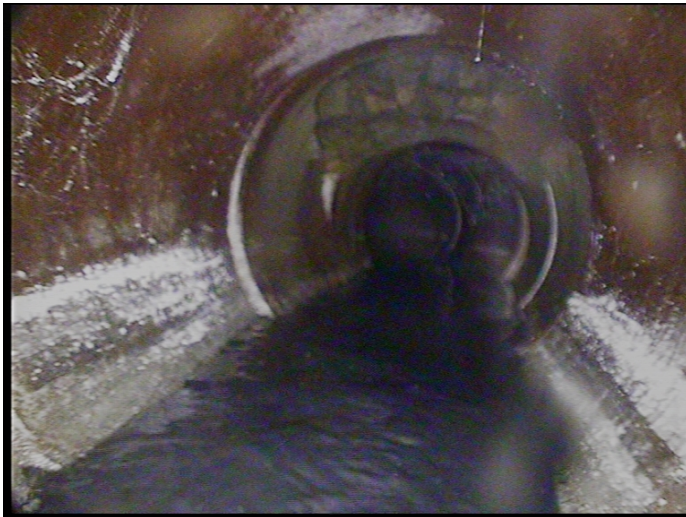
Code: **DSF**
Description: **Deposits Settled Fine**

Distance (ft): **215.1**
Structural Grade: **0**
O&M Grade: **3**
Clock Start/From: **5**
Clock To: **7**
1st Value:
2nd Value:
Value Percent: **15.000**
Continuous Index: **F02**
Within 8" of Joint: **NO**
Remarks:

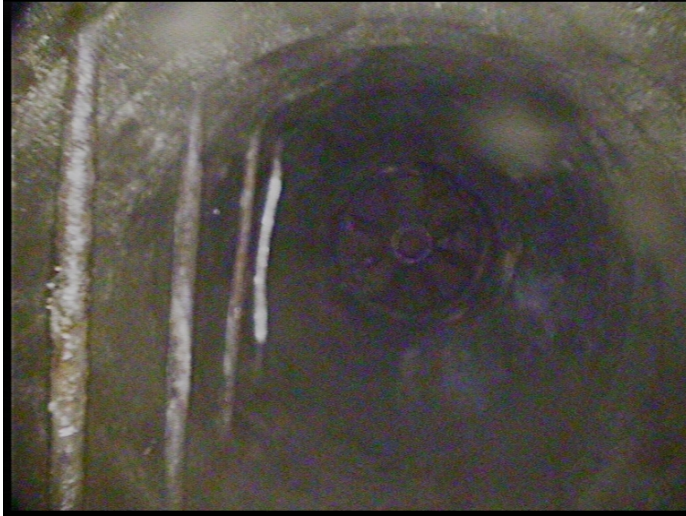
Code:	AMH
Description:	Manhole
Distance (ft):	219.4
Structural Grade:	0
O&M Grade:	0
Clock Start/From:	
Clock To:	
1st Value:	
2nd Value:	
Value Percent:	
Continuous Index:	
Within 8" of Joint:	NO
Remarks:	M-504-002
