Profile/Photo Observation Report

Date:	04/25/2018	Weather:		Coding:	PACP 6.0
Pipe Length (ft):	161.3	Owner:	NA	Pre Clean:	Not Known
P.O.#:		Surveyor:	Jen Costello	PSR:	P-504-005-004
Customer:		Clean Date:	01/01/1900	Shape:	C

Street:	N WISCONSIN ST & W HOME AVE	Flow Control:	Not Controlled
City:	Hobart, IN	Year Renewed:	
Location:	Light Highway	Tape/Media #:	
Purpose:	Not Known	Dia/Height:	12"
Use:	Sanitary	Material:	VCP
Drain Area:	NA	Lining:	
Category:	NA		
Comment:

Location Details:		Direction of Survey:	Downstream
US MH:	M-504-004	DS MH:	M-504-005
		Total Length Surveyed (ft):	143.9

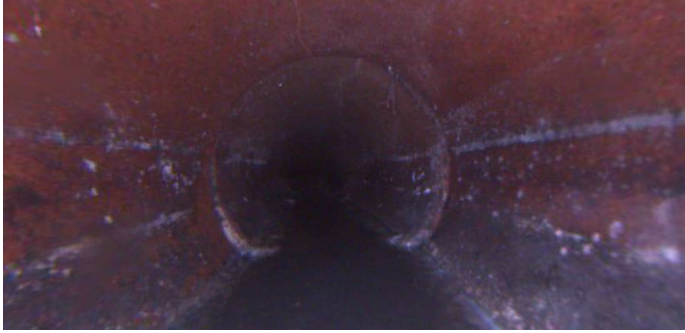
Code: **AMH**
Description: **Manhole**

Distance (ft): **.0**
Structural Grade: **0**
O&M Grade: **0**
Clock Start/From:
Clock To:
1st Value:
2nd Value:
Value Percent:
Continuous Index:
Within 8" of Joint: **NO**
Remarks: **M-504-004**

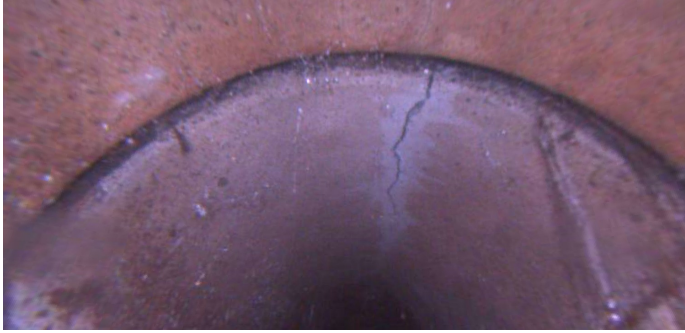
Code: **FM**
Description: **Fracture Multiple**

Distance (ft): **4.0**
Structural Grade: **4**
O&M Grade: **0**
Clock Start/From: **8**
Clock To: **4**
1st Value:
2nd Value:
Value Percent:
Continuous Index: **S01**
Within 8" of Joint: **YES**
Remarks:

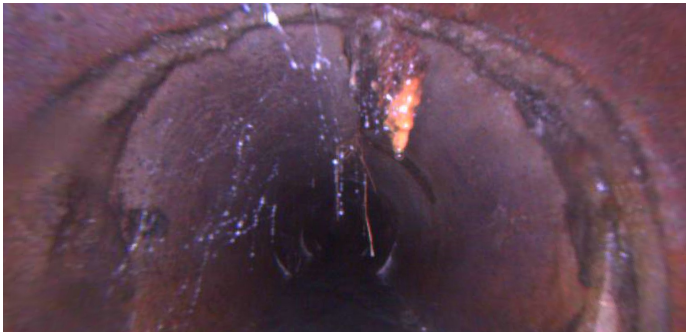
Code: **ID**
Description: **Infil Dripper**

Distance (ft): **18.8**
Structural Grade: **0**
O&M Grade: **3**
Clock Start/From: **12**
Clock To:
1st Value:
2nd Value:
Value Percent:
Continuous Index:
Within 8" of Joint: **YES**
Remarks:

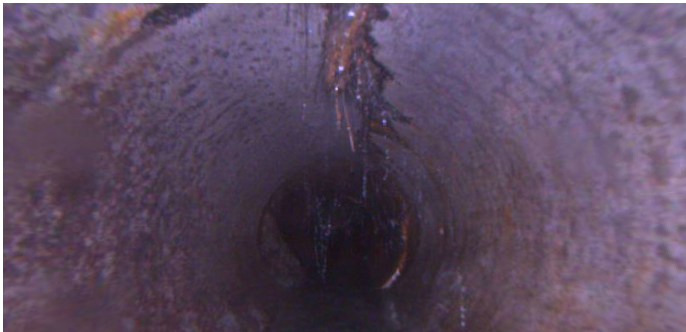
Code: **ID**
Description: **Infil Dripper**

Distance (ft): **25.1**
Structural Grade: **0**
O&M Grade: **3**
Clock Start/From: **12**
Clock To:
1st Value:
2nd Value:
Value Percent:
Continuous Index:
Within 8" of Joint:
Remarks:

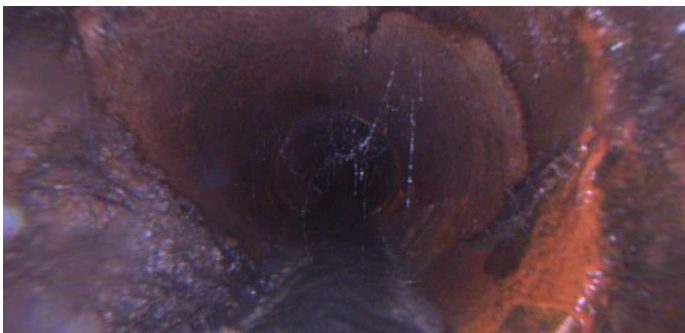
Code: **DAZ**
Description: **Deposits Attached Other**

Distance (ft): **26.6**
Structural Grade: **0**
O&M Grade: **2**
Clock Start/From: **8**
Clock To: **10**
1st Value:
2nd Value:
Value Percent: **10.000**
Continuous Index:
Within 8" of Joint: **YES**
Remarks:

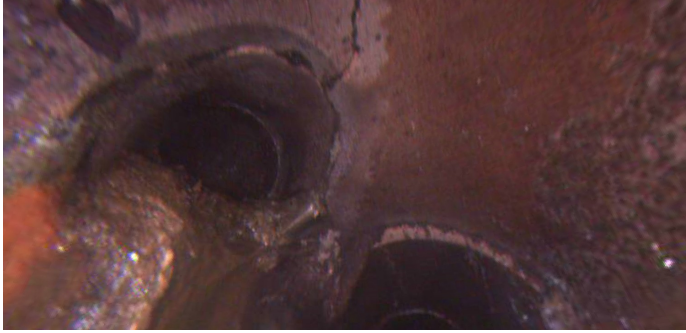
Code: **TFD**
Description: **Tap Factory Defective**

Distance (ft): **34.2**
Structural Grade: **0**
O&M Grade: **2**
Clock Start/From: **2**
Clock To:
1st Value: **4.000**
2nd Value:
Value Percent:
Continuous Index:
Within 8" of Joint:
Remarks: **fractured**

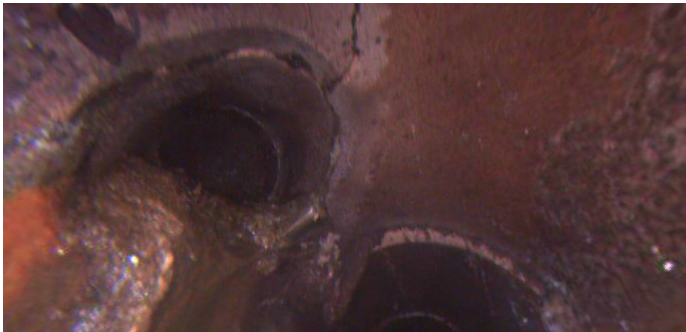
Code: **DAE**
Description: **Deposits Attached Encrustation**

Distance (ft): **34.2**
Structural Grade: **0**
O&M Grade: **2**
Clock Start/From: **1**
Clock To: **3**
1st Value:
2nd Value:
Value Percent: **10.000**
Continuous Index:
Within 8" of Joint: **NO**
Remarks:

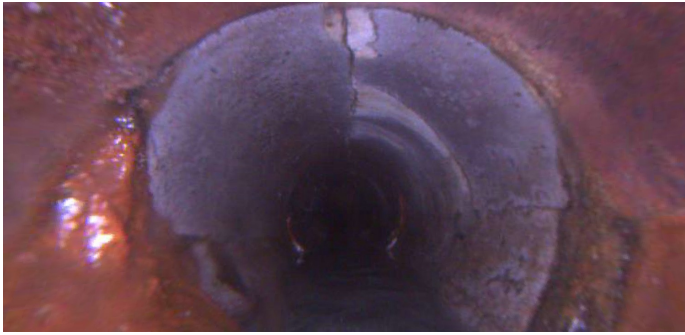
Code: **RMJ**
Description: **Roots Medium Joint**

Distance (ft): **34.3**
Structural Grade: **0**
O&M Grade: **3**
Clock Start/From: **8**
Clock To: **4**
1st Value:
2nd Value:
Value Percent: **10.000**
Continuous Index: **F02**
Within 8" of Joint: **YES**
Remarks:

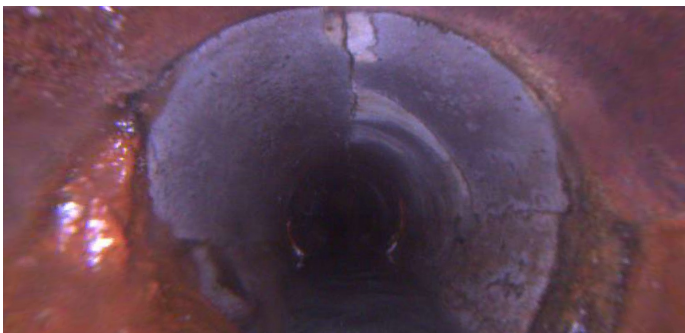
Code: **DAE**
Description: **Deposits Attached Encrustation**

Distance (ft): **34.3**
Structural Grade: **0**
O&M Grade: **2**
Clock Start/From: **8**
Clock To: **4**
1st Value:
2nd Value:
Value Percent: **5.000**
Continuous Index: **S06**
Within 8" of Joint: **YES**
Remarks:

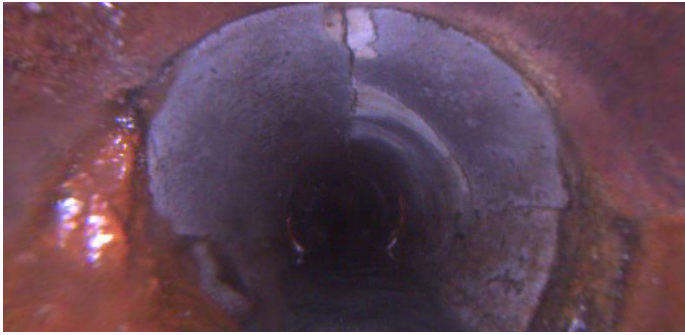
Code: **IW**
Description: **Infil Weeper**

Distance (ft): **34.3**
Structural Grade: **0**
O&M Grade: **2**
Clock Start/From: **8**
Clock To: **4**
1st Value:
2nd Value:
Value Percent:
Continuous Index: **S03**
Within 8" of Joint: **YES**
Remarks:

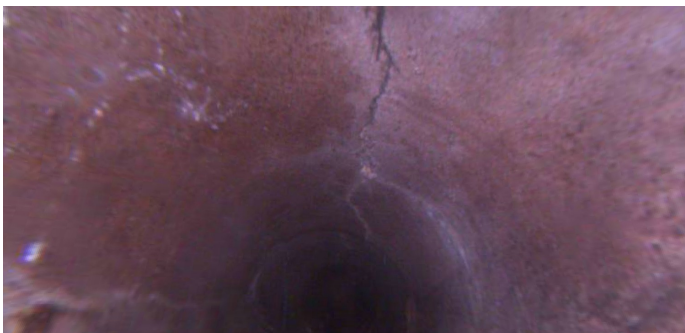
Code: **RFB**
Description: **Roots Fine Barrel**

Distance (ft): **36.6**
Structural Grade: **0**
O&M Grade: **2**
Clock Start/From: **8**
Clock To: **4**
1st Value:
2nd Value:
Value Percent:
Continuous Index: **S04**
Within 8" of Joint: **NO**
Remarks:

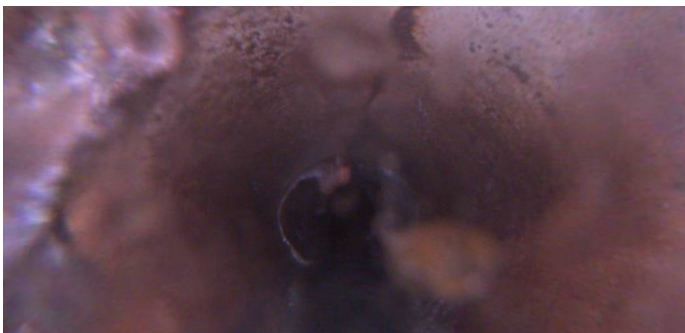
Code: **RFB**
Description: **Roots Fine Barrel**

Distance (ft): **100.6**
Structural Grade: **0**
O&M Grade: **2**
Clock Start/From: **8**
Clock To: **4**
1st Value:
2nd Value:
Value Percent:
Continuous Index: **F04**
Within 8" of Joint: **NO**
Remarks:

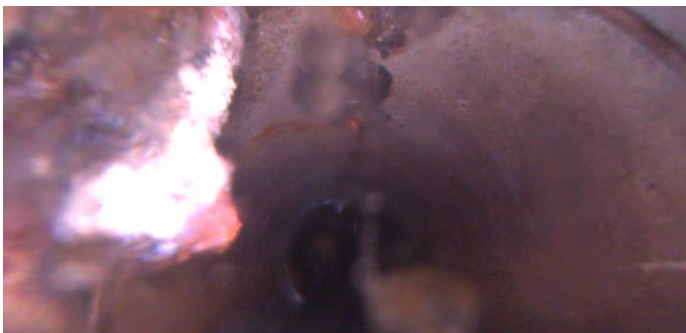
Code: **ID**
Description: **Infil Dripper**

Distance (ft): **106.3**
Structural Grade: **0**
O&M Grade: **3**
Clock Start/From: **12**
Clock To:
1st Value:
2nd Value:
Value Percent:
Continuous Index:
Within 8" of Joint:
Remarks:

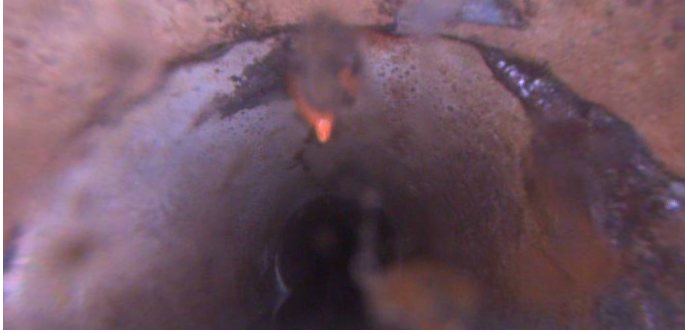
Code: ID
Description: Infil Dripper

Distance (ft): 112.0
Structural Grade: 0
O&M Grade: 3
Clock Start/From: 12
Clock To:
1st Value:
2nd Value:
Value Percent:
Continuous Index:
Within 8" of Joint: YES
Remarks:
