Profile/Photo Observation Report

Street:	N CALIFORNIA ST & W HOME AVE	Flow Control:	Not Controlled
City:	Hobart, IN	Year Renewed:	
Location:	Light Highway	Tape/Media #:	
Purpose:	Not Known	Dia/Height:	12"
Use:	Sanitary	Material:	VCP
Drain Area:	NA	Lining:	
Category:	NA		
Comment:

Location Details:		Direction of Survey:	Downstream
US MH:	M-504-005	DS MH:	M-504-006
		Total Length Surveyed (ft):	8.1

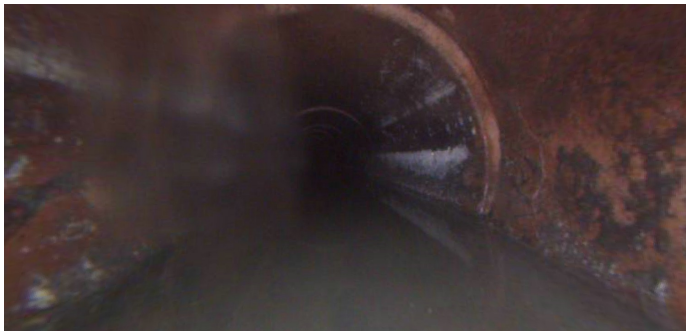
Code: **AMH**
Description: **Manhole**

Distance (ft): **.0**
Structural Grade: **0**
O&M Grade: **0**
Clock Start/From:
Clock To:
1st Value:
2nd Value:
Value Percent:
Continuous Index:
Within 8" of Joint: **NO**
Remarks: **M-504-005**

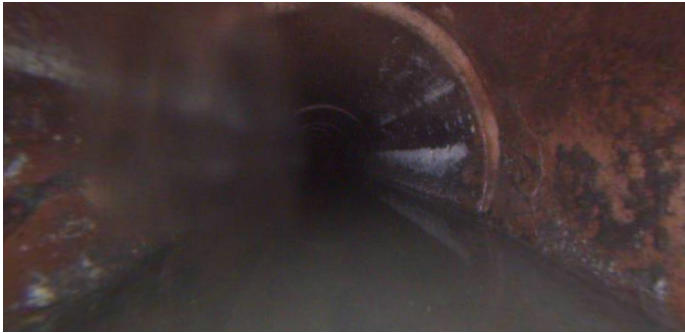
Code:	MWL
Description:	Water Level

Distance (ft):	.0
Structural Grade:	0
O&M Grade:	0
Clock Start/From:	
Clock To:	
1st Value:	
2nd Value:	
Value Percent:	40.000
Continuous Index:	
Within 8" of Joint:	NO
Remarks:

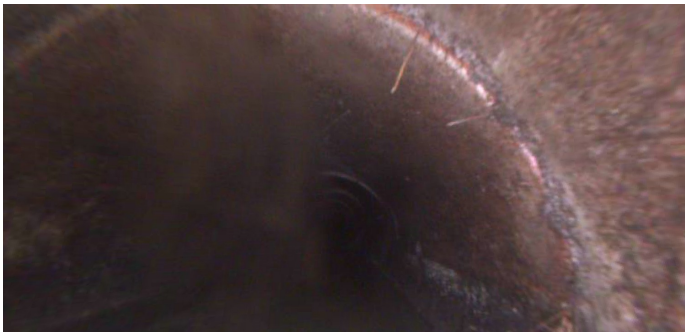
Code:	RFJ
Description:	Roots Fine Joint

Distance (ft):	3.6
Structural Grade:	0
O&M Grade:	1
Clock Start/From:	8
Clock To:	4
1st Value:	
2nd Value:	
Value Percent:	
Continuous Index:	
Within 8" of Joint:	YES
Remarks:

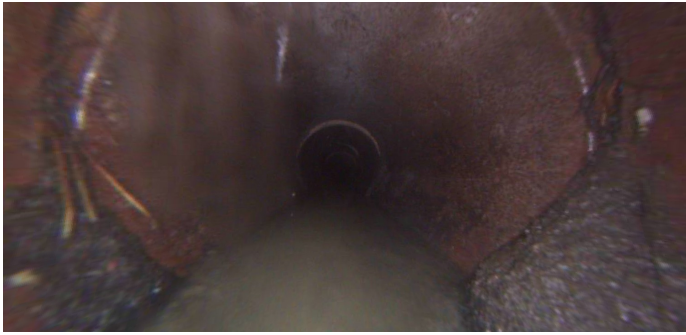
Code: **RMJ**
Description: **Roots Medium Joint**

Distance (ft): **7.5**
Structural Grade: **0**
O&M Grade: **3**
Clock Start/From: **8**
Clock To: **4**
1st Value:
2nd Value:
Value Percent: **5.000**
Continuous Index:
Within 8" of Joint: **YES**
Remarks:

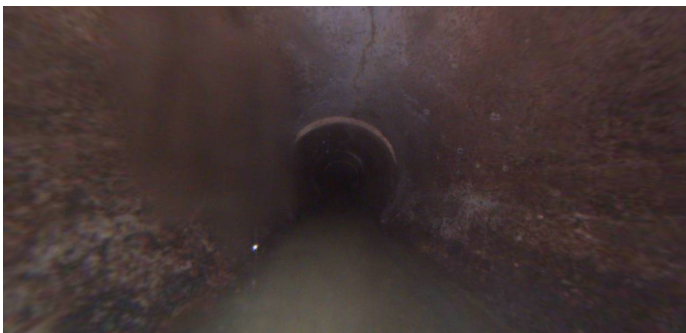
Code: **MSA**
Description: **Abandoned Survey**

Distance (ft): **8.1**
Structural Grade: **0**
O&M Grade: **0**
Clock Start/From:
Clock To:
1st Value:
2nd Value:
Value Percent:
Continuous Index:
Within 8" of Joint: **NO**
Remarks: **roots**
