## Profile/Photo Observation Report

Street:	<b>N CALIFORNIA ST &amp; W HOME AVE</b>	Flow Control:	<b>Not Controlled</b>
City:	<b>Hobart, IN</b>	Year Renewed:	
Location:	<b>Light Highway</b>	Tape/Media #:	
Purpose:	<b>Not Known</b>	Dia/Height:	<b>12"</b>
Use:	<b>Sanitary</b>	Material:	<b>VCP</b>
Drain Area:	<b>NA</b>	Lining:	
Category:	<b>NA</b>		
Comment:

Location Details:		Direction of Survey:	<b>Upstream</b>
US MH:	<b>M-504-005</b>	DS MH:	<b>M-504-006</b>
		Total Length Surveyed (ft):	<b>106.3</b>

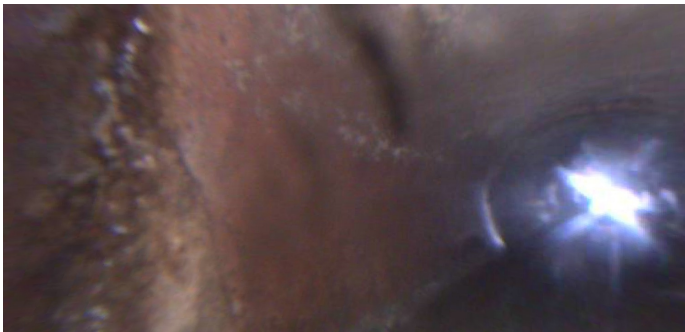
Code:	<b>DAE</b>
Description:	<b>Deposits Attached Encrustation</b>

Distance (ft):	<b>6.1</b>
Structural Grade:	<b>0</b>
O&M Grade:	<b>2</b>
Clock Start/From:	<b>1</b>
Clock To:	<b>4</b>
1st Value:	
2nd Value:	
Value Percent:	<b>5.000</b>
Continuous Index:	
Within 8" of Joint:	<b>YES</b>
Remarks:

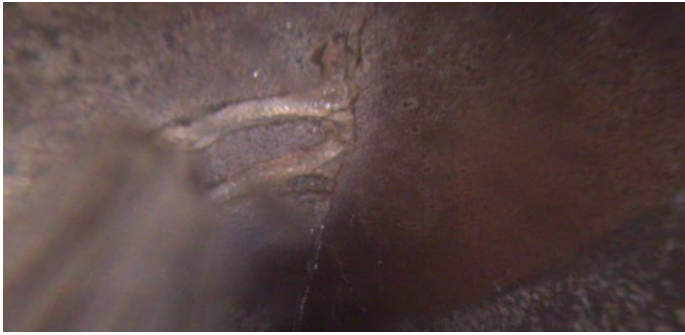
Code: **FL**  
Description: **Fracture Longitudinal**

Distance (ft): **10.2**  
Structural Grade: **3**  
O&M Grade: **0**  
Clock Start/From: **12**  
Clock To:  
1st Value:  
2nd Value:  
Value Percent:  
Continuous Index:  
Within 8" of Joint:  
Remarks:

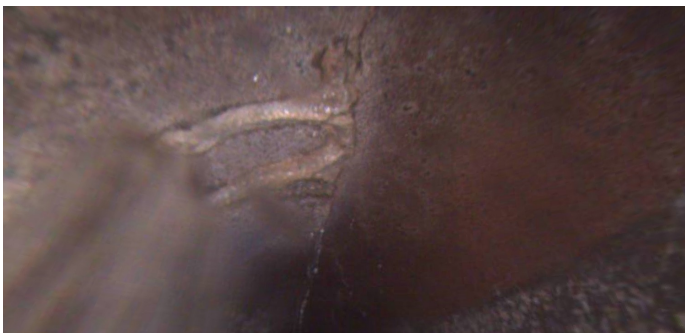
Code: **DAE**  
Description: **Deposits Attached Encrustation**

Distance (ft): **10.2**  
Structural Grade: **0**  
O&M Grade: **2**  
Clock Start/From: **10**  
Clock To: **12**  
1st Value:  
2nd Value:  
Value Percent: **5.000**  
Continuous Index:  
Within 8" of Joint: **NO**  
Remarks:

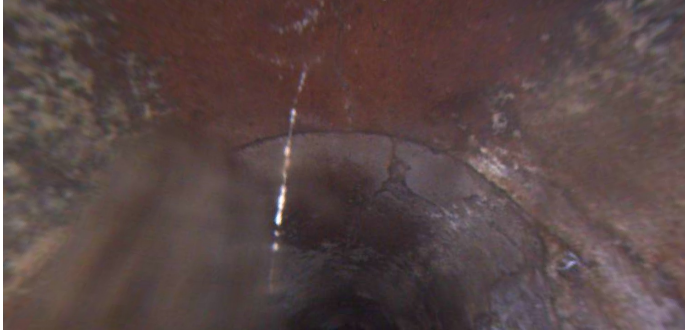
Code: **FL**  
Description: **Fracture Longitudinal**

Distance (ft): **13.7**  
Structural Grade: **3**  
O&M Grade: **0**  
Clock Start/From: **12**  
Clock To:  
1st Value:  
2nd Value:  
Value Percent:  
Continuous Index: **S01**  
Within 8" of Joint: **YES**  
Remarks:

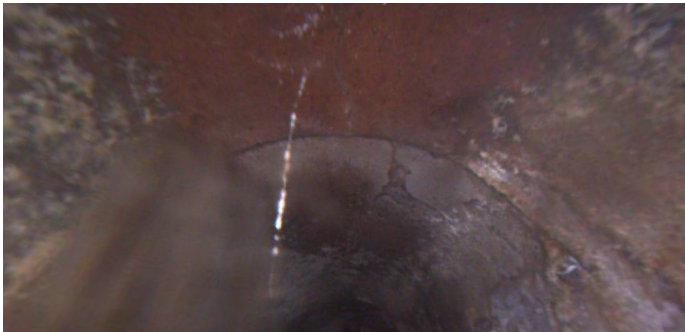
Code: **DAE**  
Description: **Deposits Attached Encrustation**

Distance (ft): **13.7**  
Structural Grade: **0**  
O&M Grade: **2**  
Clock Start/From: **8**  
Clock To: **4**  
1st Value:  
2nd Value:  
Value Percent: **5.000**  
Continuous Index: **S02**  
Within 8" of Joint: **YES**  
Remarks:

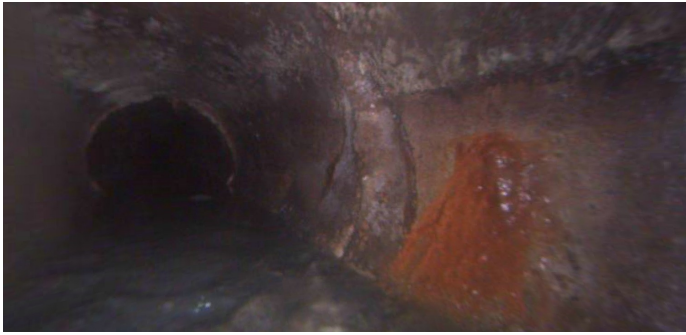
Code: **IW**  
Description: **Infil Weeper**

Distance (ft): **15.5**  
Structural Grade: **0**  
O&M Grade: **2**  
Clock Start/From: **3**  
Clock To:  
1st Value:  
2nd Value:  
Value Percent:  
Continuous Index:  
Within 8" of Joint:  
Remarks:

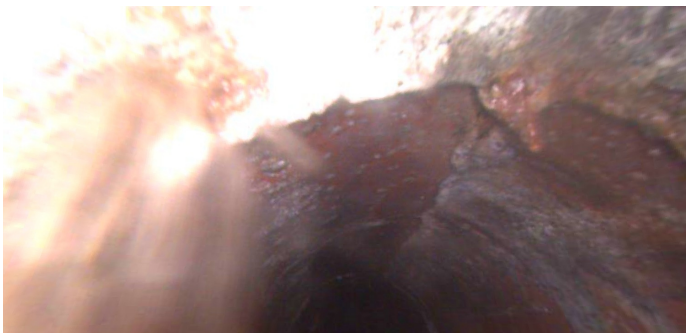
Code: **ID**  
Description: **Infil Dripper**

Distance (ft): **18.0**  
Structural Grade: **0**  
O&M Grade: **3**  
Clock Start/From: **12**  
Clock To:  
1st Value:  
2nd Value:  
Value Percent:  
Continuous Index:  
Within 8" of Joint: **YES**  
Remarks:

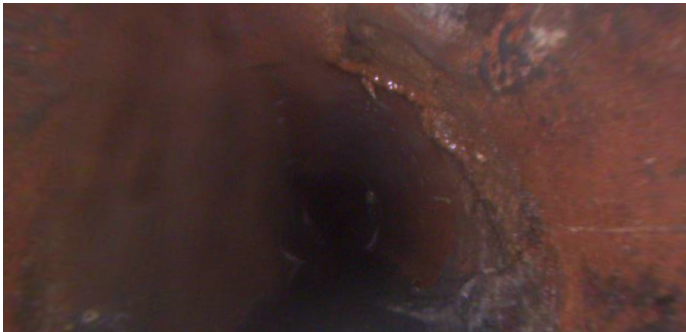
Code: **RMJ**  
Description: **Roots Medium Joint**

Distance (ft): **23.6**  
Structural Grade: **0**  
O&M Grade: **3**  
Clock Start/From: **8**  
Clock To: **4**  
1st Value:  
2nd Value:  
Value Percent: **10.000**  
Continuous Index: **S04**  
Within 8" of Joint: **YES**  
Remarks:

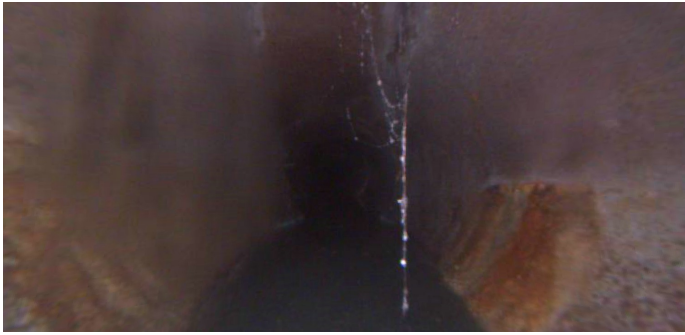
Code: **IW**  
Description: **Infil Weeper**

Distance (ft): **76.4**  
Structural Grade: **0**  
O&M Grade: **2**  
Clock Start/From: **8**  
Clock To: **4**  
1st Value:  
2nd Value:  
Value Percent:  
Continuous Index:  
Within 8" of Joint:  
Remarks:

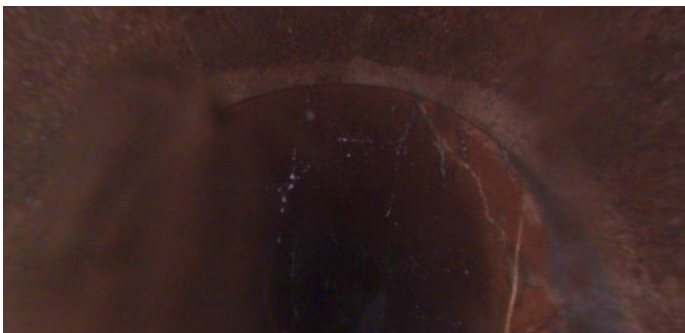
Code: **FM**  
Description: **Fracture Multiple**

Distance (ft): **90.1**  
Structural Grade: **4**  
O&M Grade: **0**  
Clock Start/From: **8**  
Clock To: **4**  
1st Value:  
2nd Value:  
Value Percent:  
Continuous Index:  
Within 8" of Joint: **YES**  
Remarks:

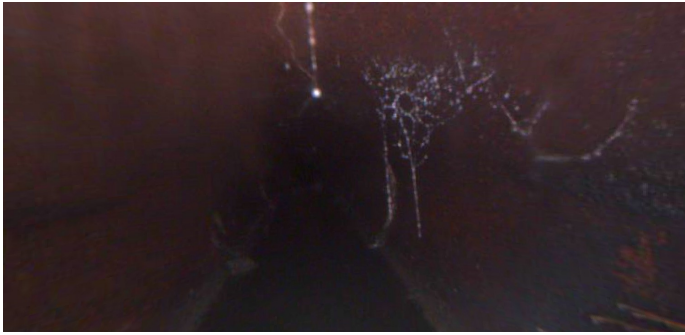
Code: **IW**  
Description: **Infil Weeper**

Distance (ft): **106.3**  
Structural Grade: **0**  
O&M Grade: **2**  
Clock Start/From: **8**  
Clock To: **4**  
1st Value:  
2nd Value:  
Value Percent:  
Continuous Index: **F03**  
Within 8" of Joint: **YES**  
Remarks:

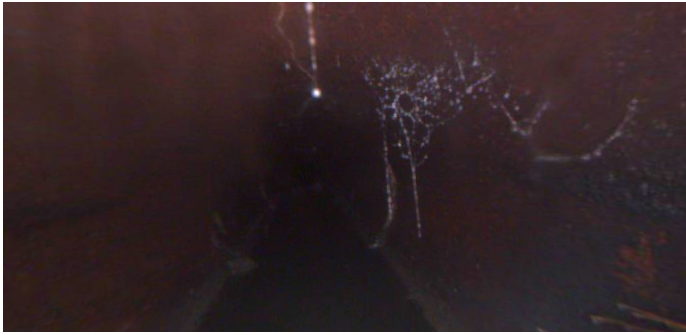
Code: **FL**  
Description: **Fracture Longitudinal**

Distance (ft): **106.3**  
Structural Grade: **3**  
O&M Grade: **0**  
Clock Start/From: **12**  
Clock To:  
1st Value:  
2nd Value:  
Value Percent:  
Continuous Index: **F01**  
Within 8" of Joint: **YES**  
Remarks:
