Profile/Photo Observation Report

| Street: | N CALIFORNIA ST & W HOME AVE | Flow Control: | Not Controlled |
| City: | Hobart, IN | Year Renewed: | |

| US MH: | M-504-006 | DS MH: | M-504-010 |

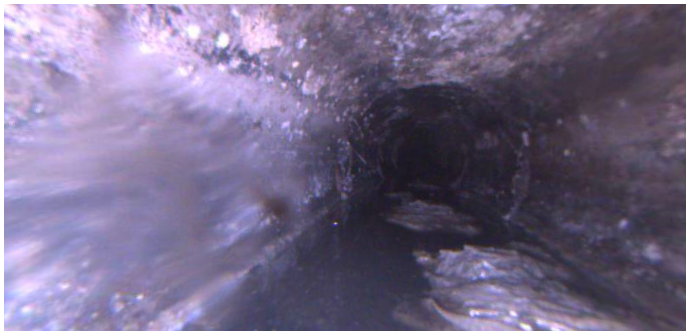
Code: **AMH**
Description: **Manhole**

Distance (ft): **.0**
Structural Grade: **0**
O&M Grade: **0**
Clock Start/From:
Clock To:
1st Value:
2nd Value:
Value Percent:
Continuous Index:
Within 8" of Joint: **NO**
Remarks: **M-504-006**

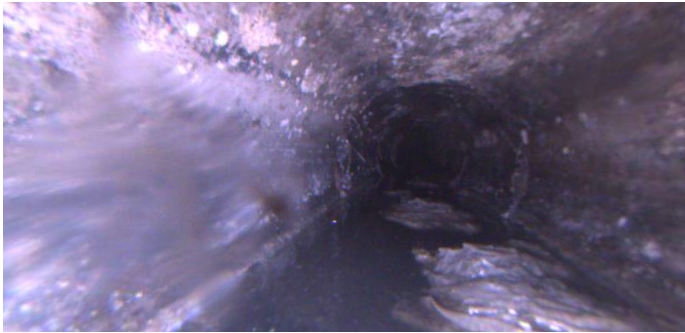
| Code: | MWL |
| Description: | Water Level |

| Value Percent: | 10.000 |

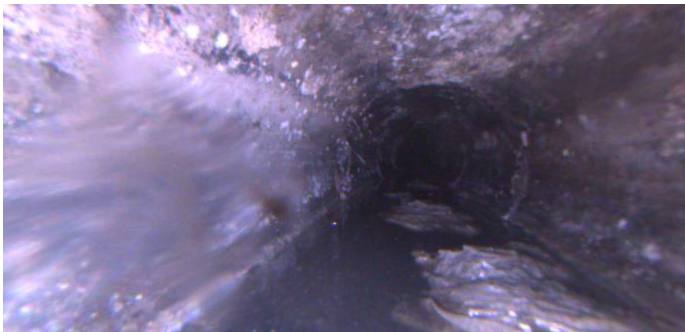
| Code: | DAGS |
| Description: | Deposits Attached Grease |

| O&M Grade: | 2 |
| Clock Start/From: | 8 |
| Clock To: | 4 |
| Value Percent: | 5.000 |

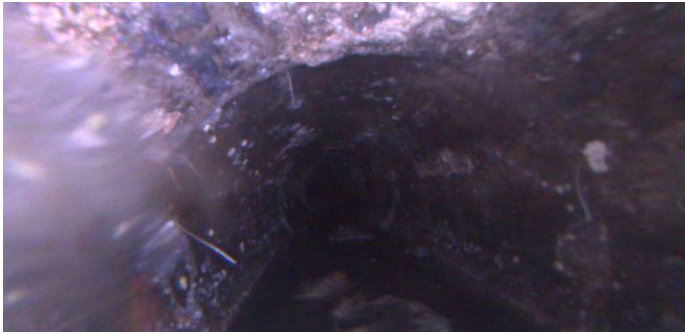
Code: **RFJ**
Description: **Roots Fine Joint**

Distance (ft): **2.3**
Structural Grade: **0**
O&M Grade: **1**
Clock Start/From: **8**
Clock To: **4**
1st Value:
2nd Value:
Value Percent:
Continuous Index:
Within 8" of Joint: **YES**
Remarks:

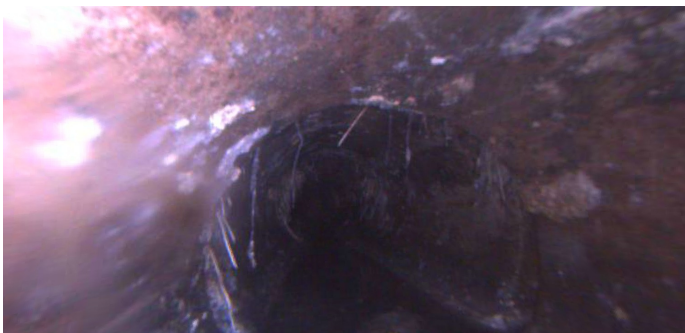
Code: **RFJ**
Description: **Roots Fine Joint**

Distance (ft): **3.6**
Structural Grade: **0**
O&M Grade: **1**
Clock Start/From: **8**
Clock To: **4**
1st Value:
2nd Value:
Value Percent:
Continuous Index:
Within 8" of Joint: **YES**
Remarks:

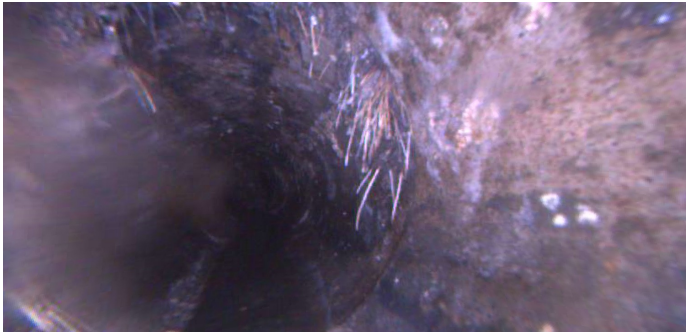
Code: **RMJ**
Description: **Roots Medium Joint**

Distance (ft): **5.7**
Structural Grade: **0**
O&M Grade: **3**
Clock Start/From: **8**
Clock To: **4**
1st Value:
2nd Value:
Value Percent: **10.000**
Continuous Index:
Within 8" of Joint: **YES**
Remarks:

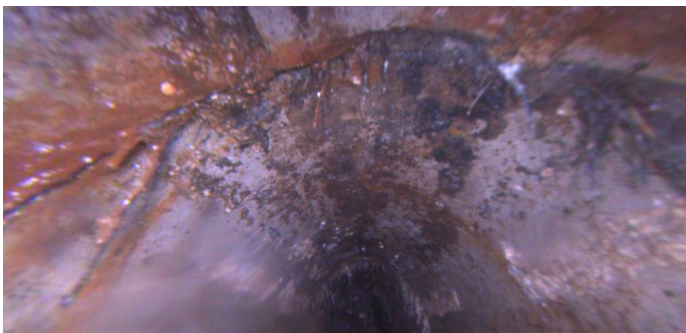
Code: **RFJ**
Description: **Roots Fine Joint**

Distance (ft): **8.1**
Structural Grade: **0**
O&M Grade: **1**
Clock Start/From: **8**
Clock To: **4**
1st Value:
2nd Value:
Value Percent:
Continuous Index:
Within 8" of Joint: **YES**
Remarks:
