Profile/Photo Observation Report

Date:	04/25/2018	Weather:		Coding:	PACP 6.0
Pipe Length (ft):	176.6	Owner:	NA	Pre Clean:	Not Known
P.O.#:		Surveyor:	Jen Costello	PSR:	P-504-010-006
Customer:		Clean Date:	01/01/1900	Shape:	C

Street:	Summerlin	Flow Control:	Not Controlled
City:	Hobart, IN	Year Renewed:	
Location:	Light Highway	Tape/Media #:	
Purpose:	Not Known	Dia/Height:	12"
Use:	Sanitary	Material:	VCP
Drain Area:	NA	Lining:	
Category:	NA		
Comment:

Location Details:		Direction of Survey:	Upstream
US MH:	M-504-006	DS MH:	M-504-010
		Total Length Surveyed (ft):	8.1

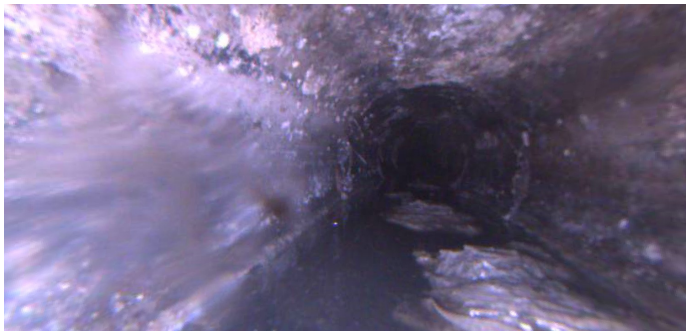
Code: **AMH**
Description: **Manhole**

Distance (ft): **.0**
Structural Grade: **0**
O&M Grade: **0**
Clock Start/From:
Clock To:
1st Value:
2nd Value:
Value Percent:
Continuous Index:
Within 8" of Joint: **NO**
Remarks: **M-504-006**

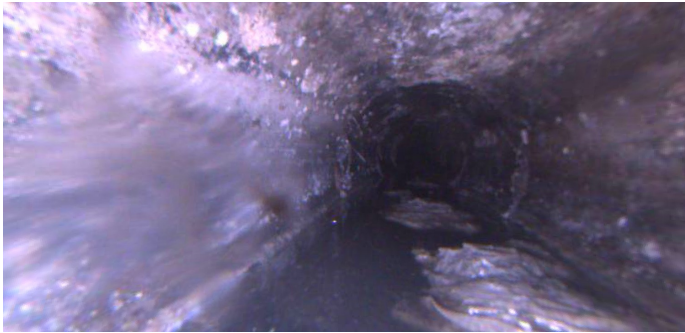
Code:	MWL
Description:	Water Level

Distance (ft):	.0
Structural Grade:	0
O&M Grade:	0
Clock Start/From:	
Clock To:	
1st Value:	
2nd Value:	
Value Percent:	10.000
Continuous Index:	
Within 8" of Joint:	NO
Remarks:

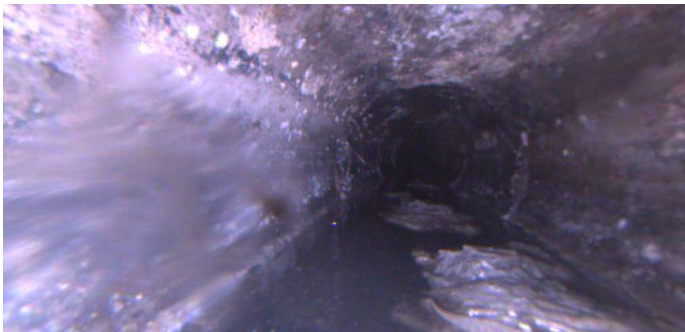
Code:	DAGS
Description:	Deposits Attached Grease

Distance (ft):	.0
Structural Grade:	0
O&M Grade:	2
Clock Start/From:	8
Clock To:	4
1st Value:	
2nd Value:	
Value Percent:	5.000
Continuous Index:	S01
Within 8" of Joint:	NO
Remarks:

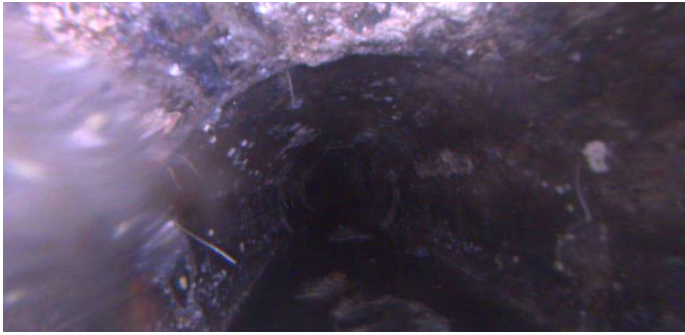
Code: **RFJ**
Description: **Roots Fine Joint**

Distance (ft): **2.3**
Structural Grade: **0**
O&M Grade: **1**
Clock Start/From: **8**
Clock To: **4**
1st Value:
2nd Value:
Value Percent:
Continuous Index:
Within 8" of Joint: **YES**
Remarks:

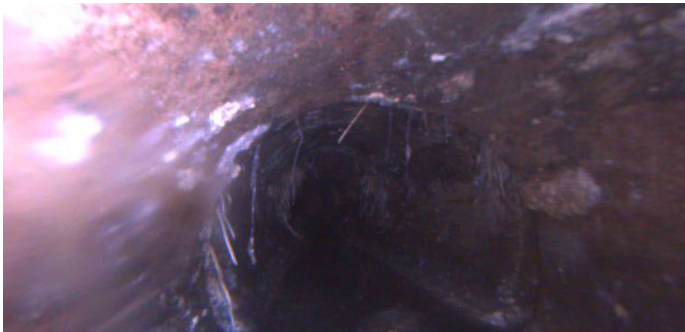
Code: **RFJ**
Description: **Roots Fine Joint**

Distance (ft): **3.6**
Structural Grade: **0**
O&M Grade: **1**
Clock Start/From: **8**
Clock To: **4**
1st Value:
2nd Value:
Value Percent:
Continuous Index:
Within 8" of Joint: **YES**
Remarks:

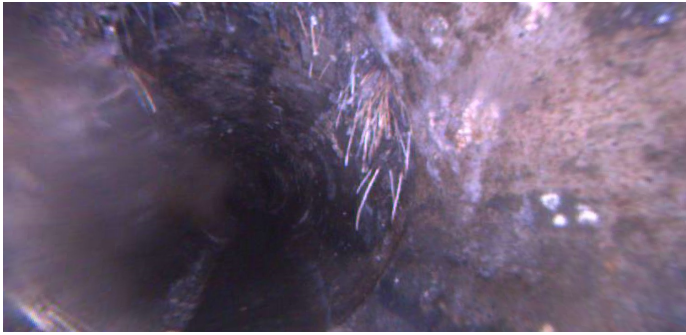
Code: **RMJ**
Description: **Roots Medium Joint**

Distance (ft): **5.7**
Structural Grade: **0**
O&M Grade: **3**
Clock Start/From: **8**
Clock To: **4**
1st Value:
2nd Value:
Value Percent: **10.000**
Continuous Index:
Within 8" of Joint: **YES**
Remarks:

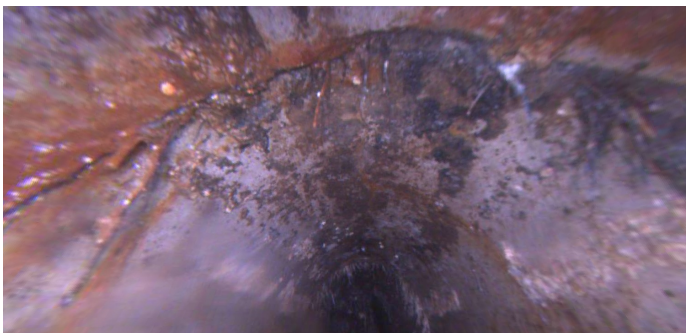
Code: **RFJ**
Description: **Roots Fine Joint**

Distance (ft): **8.1**
Structural Grade: **0**
O&M Grade: **1**
Clock Start/From: **8**
Clock To: **4**
1st Value:
2nd Value:
Value Percent:
Continuous Index:
Within 8" of Joint: **YES**
Remarks:
