Profile/Photo Observation Report

Street:	FOXCROFT STREET	Flow Control:	Not Controlled
City:	Hobart, IN	Year Renewed:	
Location:	Yard	Tape/Media #:	
Purpose:	Routine Assessment	Dia/Height:	12"
Use:	Sanitary	Material:	VCP
Drain Area:	NA	Lining:	
Category:	NA		
Comment:	P_C at 19 ft build up on the pipe. Flow direction wrong		
Location Details:		Direction of Survey:	Upstream
US MH:	M-504-011	DS MH:	M-504-012
		Total Length Surveyed (ft):	20.5

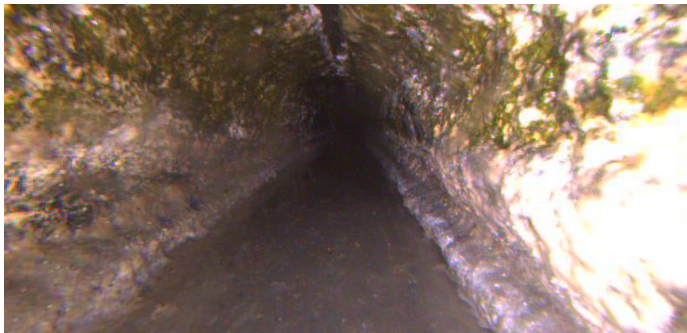
Code: **AMH**
Description: **Manhole**

Distance (ft): **.0**
Structural Grade: **0**
O&M Grade: **0**
Clock Start/From:
Clock To:
1st Value:
2nd Value:
Value Percent:
Continuous Index:
Within 8" of Joint: **NO**
Remarks: **M-504-012**

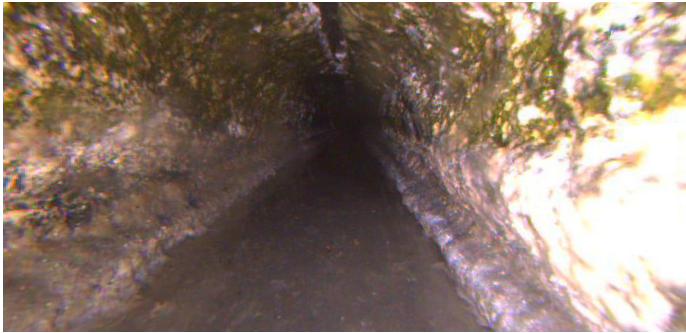
Code:	MWL
Description:	Water Level

Distance (ft):	.0
Structural Grade:	0
O&M Grade:	0
Clock Start/From:	
Clock To:	
1st Value:	
2nd Value:	
Value Percent:	10.000
Continuous Index:	
Within 8" of Joint:	NO
Remarks:

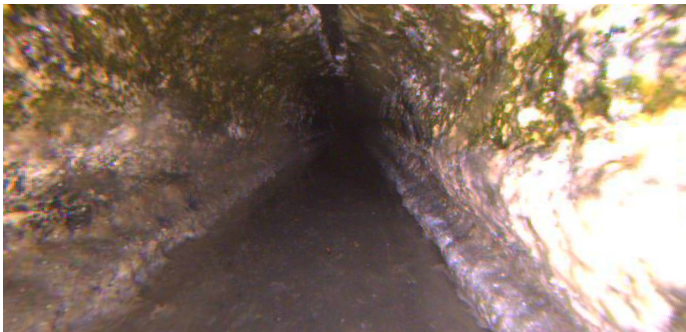
Code:	DAGS
Description:	Deposits Attached Grease

Distance (ft):	.0
Structural Grade:	0
O&M Grade:	3
Clock Start/From:	8
Clock To:	4
1st Value:	
2nd Value:	
Value Percent:	20.000
Continuous Index:	S01
Within 8" of Joint:	NO
Remarks:

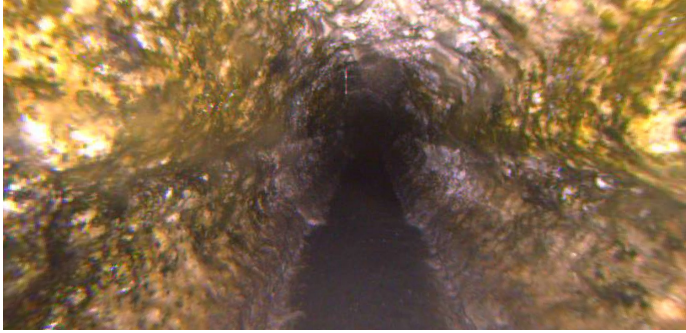
Code: **MSA**
Description: **Abandoned Survey**

Distance (ft): **20.5**
Structural Grade: **0**
O&M Grade: **0**
Clock Start/From:
Clock To:
1st Value:
2nd Value:
Value Percent:
Continuous Index:
Within 8" of Joint: **NO**
Remarks: **dags**

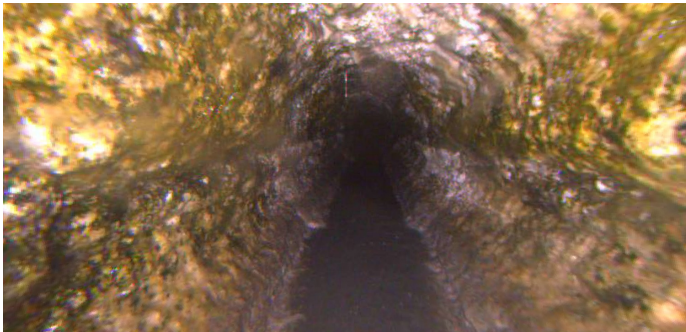
Code: **DAGS**
Description: **Deposits Attached Grease**

Distance (ft): **20.5**
Structural Grade: **0**
O&M Grade: **3**
Clock Start/From: **8**
Clock To: **4**
1st Value:
2nd Value:
Value Percent: **20.000**
Continuous Index: **F01**
Within 8" of Joint: **NO**
Remarks:
