Profile/Photo Observation Report

Street:	South California Street	Flow Control:	Not Controlled
City:	Hobart, IN	Year Renewed:	
Location:	Easement/Right of Way	Tape/Media #:	
Purpose:	Routine Assessment	Dia/Height:	6"
Use:	Sanitary Sewage Pipe	Material:	VCP
Drain Area:		Lining:	None
Category:	NA		
Comment:

Location Details:		Direction of Survey:	Downstream
US MH:	M-504-012	DS MH:	M-504-132
		Total Length Surveyed (ft):	12.6

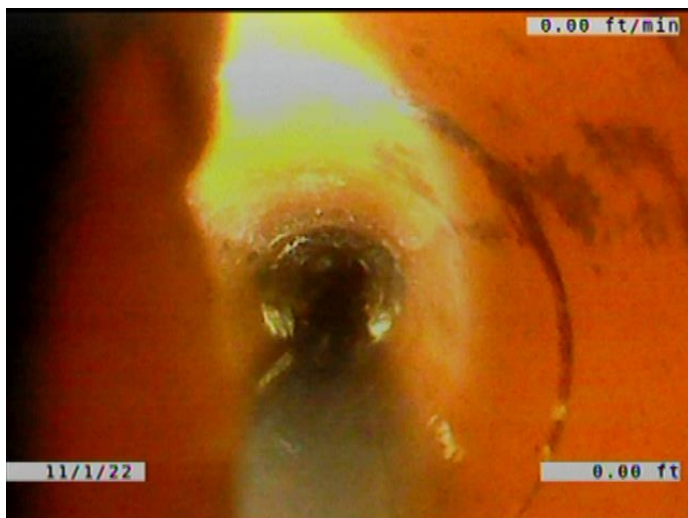
Code: **AMH**
 Description: **Manhole**

Distance (ft): **.0**
 Structural Grade: **0**
 O&M Grade: **0**
 Clock Start/From:
 Clock To:
 1st Value:
 2nd Value:
 Value Percent:
 Continuous Index:
 Within 8" of Joint: **NO**
 Remarks: **M-504-012**

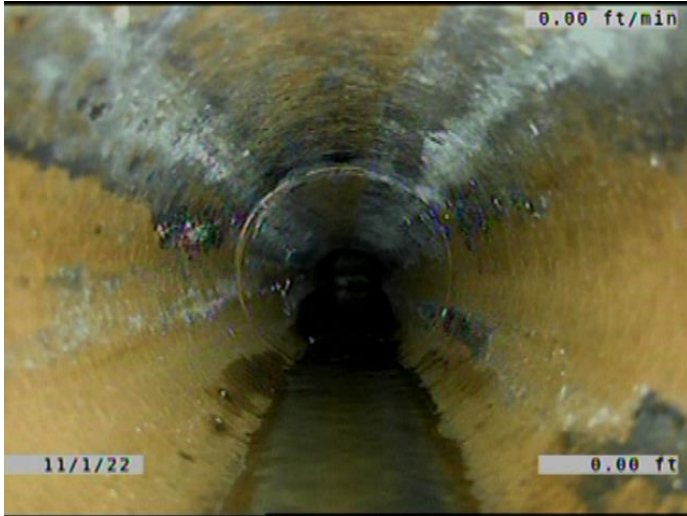
Code:	MWL
Description:	Miscellaneous Water Level
Distance (ft):	.0
Structural Grade:	0
O&M Grade:	0
Clock Start/From:	
Clock To:	
1st Value:	
2nd Value:	
Value Percent:	5.000
Continuous Index:	
Within 8" of Joint:	NO
Remarks:

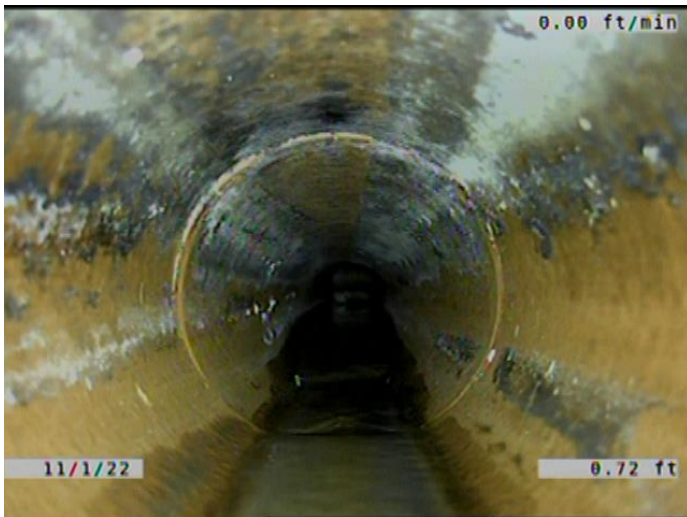
Code:	DAGS
Description:	Deposits Attached Grease
Distance (ft):	.7
Structural Grade:	0
O&M Grade:	2
Clock Start/From:	8
Clock To:	4
1st Value:	
2nd Value:	
Value Percent:	5.000
Continuous Index:	S01
Within 8" of Joint:	YES
Remarks:

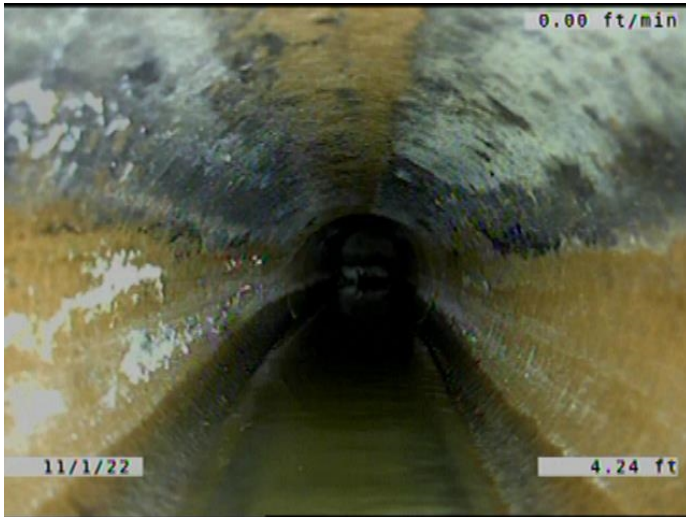
Code: **MWLS**
Description: **Miscellaneous Water Level Sag**

Distance (ft): **4.2**
Structural Grade: **2**
O&M Grade: **0**
Clock Start/From:
Clock To:
1st Value:
2nd Value:
Value Percent: **10.000**
Continuous Index: **S02**
Within 8" of Joint: **NO**
Remarks:

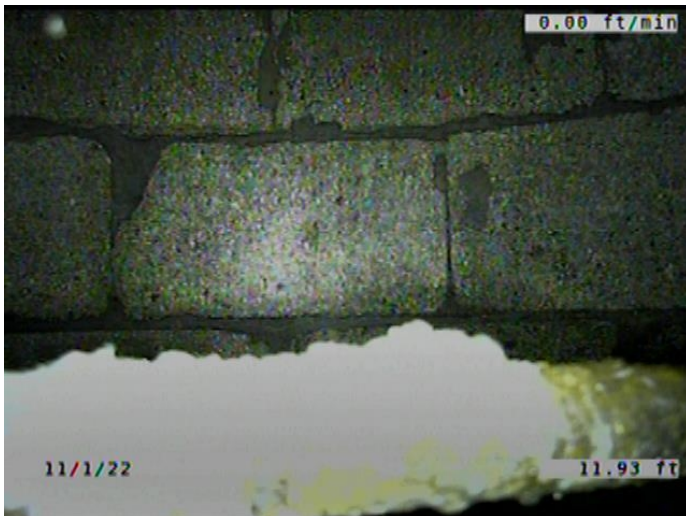
Code: **DAGS**
Description: **Deposits Attached Grease**

Distance (ft): **11.9**
Structural Grade: **0**
O&M Grade: **2**
Clock Start/From: **8**
Clock To: **4**
1st Value:
2nd Value:
Value Percent: **5.000**
Continuous Index: **F01**
Within 8" of Joint: **YES**
Remarks:

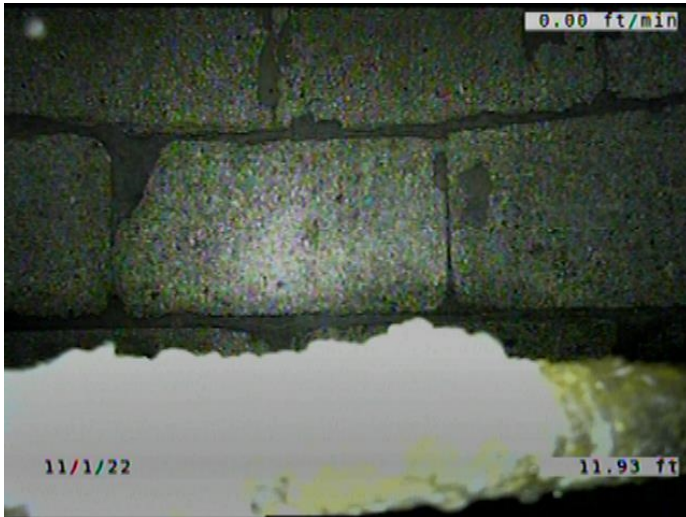
Code:	MWLS
Description:	Miscellaneous Water Level Sag
Distance (ft):	11.9
Structural Grade:	2
O&M Grade:	0
Clock Start/From:	
Clock To:	
1st Value:	
2nd Value:	
Value Percent:	10.000
Continuous Index:	F02
Within 8" of Joint:	NO
Remarks:

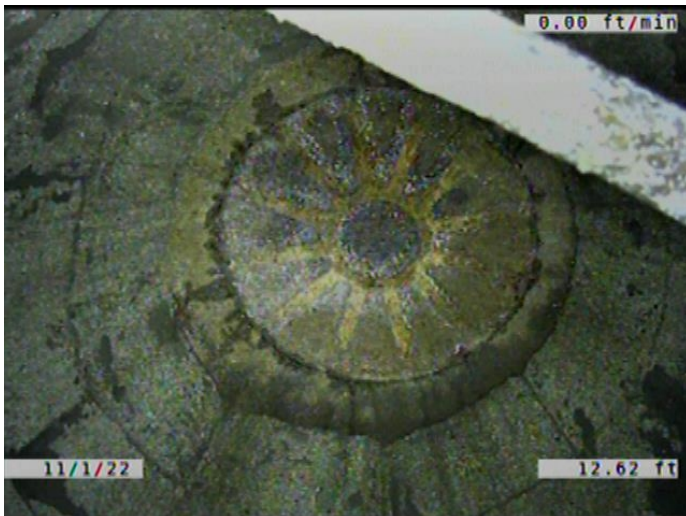
Code:	AMH
Description:	Manhole
Distance (ft):	12.6
Structural Grade:	0
O&M Grade:	0
Clock Start/From:	
Clock To:	
1st Value:	
2nd Value:	
Value Percent:	
Continuous Index:	
Within 8" of Joint:	NO
Remarks:	M-504-132
