## Profile/Photo Observation Report

Date:	<b>04/11/2018</b>	Weather:		Coding:	<b>PACP 6.0</b>
Pipe Length (ft):		Owner:	<b>City of Hobart</b>	Pre Clean:	<b>No Pre-Cleaning</b>
P.O.#:	<b>30-1</b>	Surveyor:	<b>M. Pielacha</b>	PSR:	<b>M-504-020-M-504-019</b>
Customer:	<b>City of Hobart</b>	Clean Date:		Shape:	<b>C</b>

Street:	<b>Wisconsin Street</b>	Flow Control:	<b>Not Controlled</b>
City:	<b>Hobart, IN</b>	Year Renewed:	
Location:	<b>Light Highway</b>	Tape/Media #:	<b>DEP 30</b>
Purpose:	<b>Routine Assessment</b>	Dia/Height:	<b>18"</b>
Use:	<b>Sanitary</b>	Material:	<b>VCP</b>
Drain Area:		Lining:

US MH: **M-504-020** DS MH: **M-504-019** Total Length Surveyed (ft): **172.7**

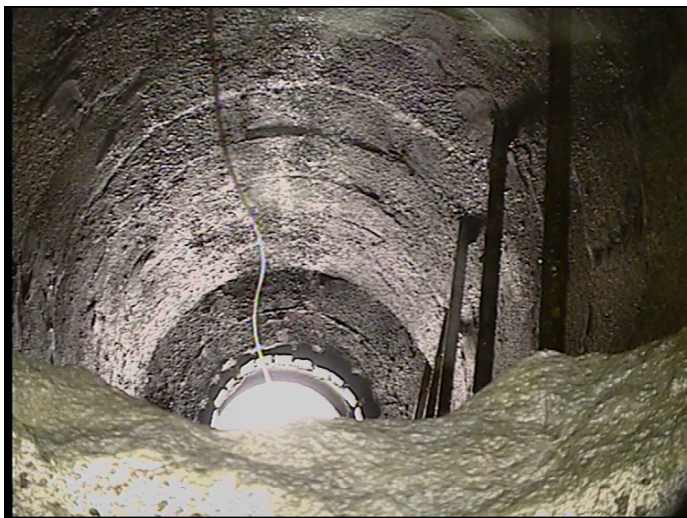
Code: **AMH**  
 Description: **Manhole**

Distance (ft): **.0**  
 Structural Grade: **0**  
 O&M Grade: **0**  
 Clock Start/From:  
 Clock To:  
 1st Value:  
 2nd Value:  
 Value Percent:  
 Continuous Index:  
 Within 8" of Joint: **NO**  
 Remarks: **M-504-020**

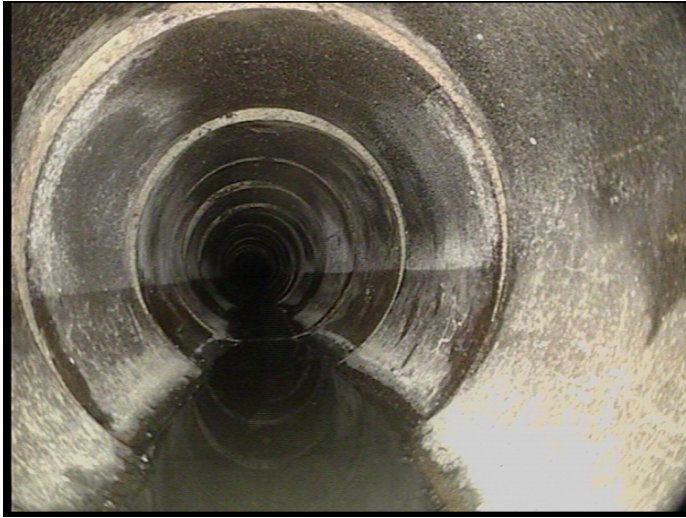
Code: **MWL**  
Description: **Water Level**

Distance (ft): **.0**  
Structural Grade: **0**  
O&M Grade: **0**  
Clock Start/From:  
Clock To:  
1st Value:  
2nd Value:  
Value Percent: **5.000**  
Continuous Index:  
Within 8" of Joint: **NO**  
Remarks:

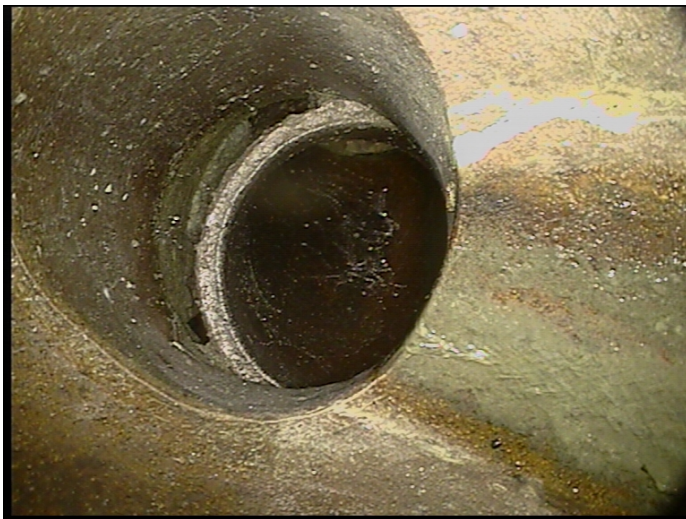
Code: **TFA**  
Description: **Tap Factory Active**

Distance (ft): **27.9**  
Structural Grade: **0**  
O&M Grade: **0**  
Clock Start/From: **2**  
Clock To:  
1st Value: **4.000**  
2nd Value:  
Value Percent:  
Continuous Index:  
Within 8" of Joint: **NO**  
Remarks:

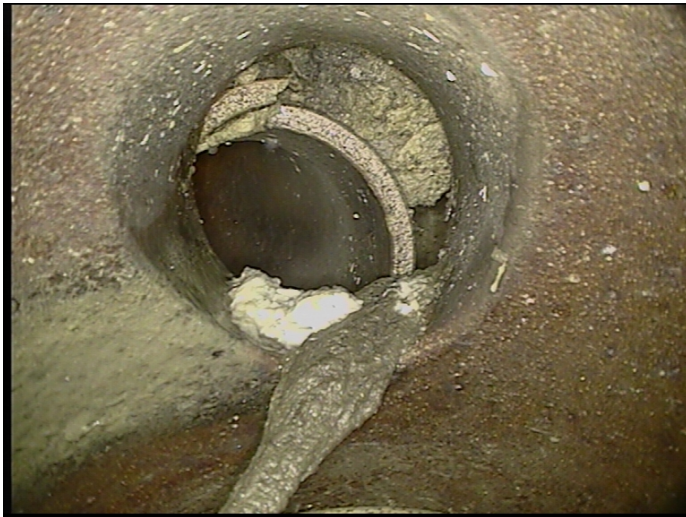
Code:	<b>TF</b>
Description:	<b>Tap Factory</b>
Distance (ft):	<b>29.8</b>
Structural Grade:	<b>0</b>
O&M Grade:	<b>0</b>
Clock Start/From:	<b>10</b>
Clock To:	
1st Value:	<b>4.000</b>
2nd Value:	
Value Percent:	
Continuous Index:	
Within 8" of Joint:	<b>NO</b>
Remarks:

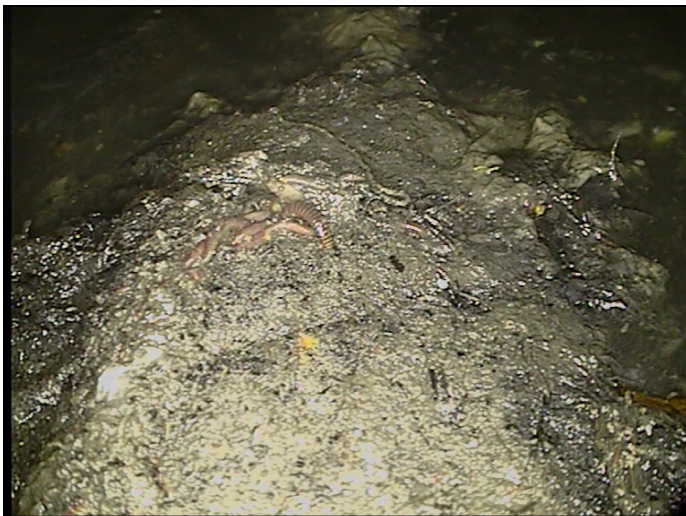
Code:	<b>DSF</b>
Description:	<b>Deposits Settled Fine</b>
Distance (ft):	<b>67.9</b>
Structural Grade:	<b>0</b>
O&M Grade:	<b>3</b>
Clock Start/From:	<b>5</b>
Clock To:	<b>7</b>
1st Value:	
2nd Value:	
Value Percent:	<b>15.000</b>
Continuous Index:	<b>S02</b>
Within 8" of Joint:	<b>YES</b>
Remarks:

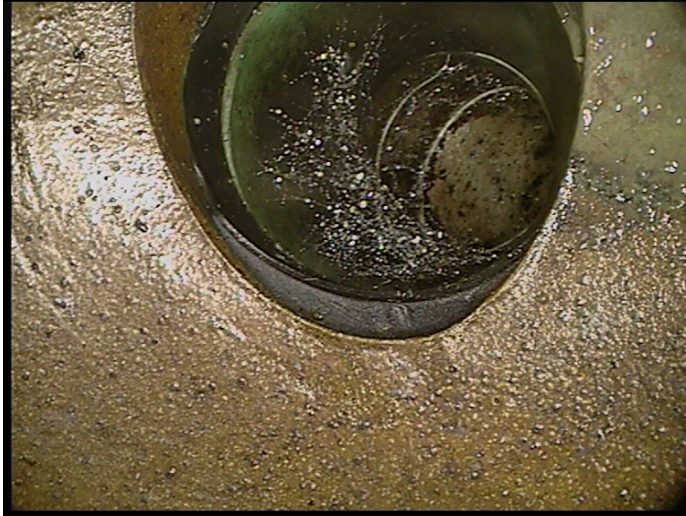
Code: **TF**  
Description: **Tap Factory**

Distance (ft): **70.0**  
Structural Grade: **0**  
O&M Grade: **0**  
Clock Start/From: **2**  
Clock To:  
1st Value: **4.000**  
2nd Value:  
Value Percent:  
Continuous Index:  
Within 8" of Joint: **NO**  
Remarks:

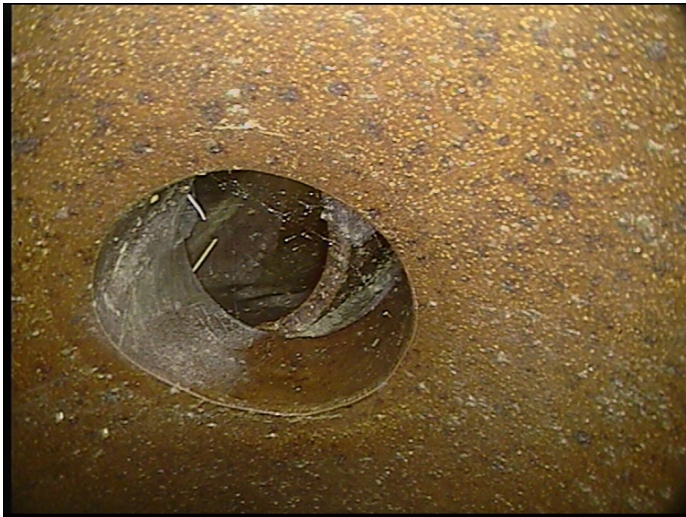
Code: **TF**  
Description: **Tap Factory**

Distance (ft): **70.8**  
Structural Grade: **0**  
O&M Grade: **0**  
Clock Start/From: **10**  
Clock To:  
1st Value: **4.000**  
2nd Value:  
Value Percent:  
Continuous Index:  
Within 8" of Joint: **NO**  
Remarks:

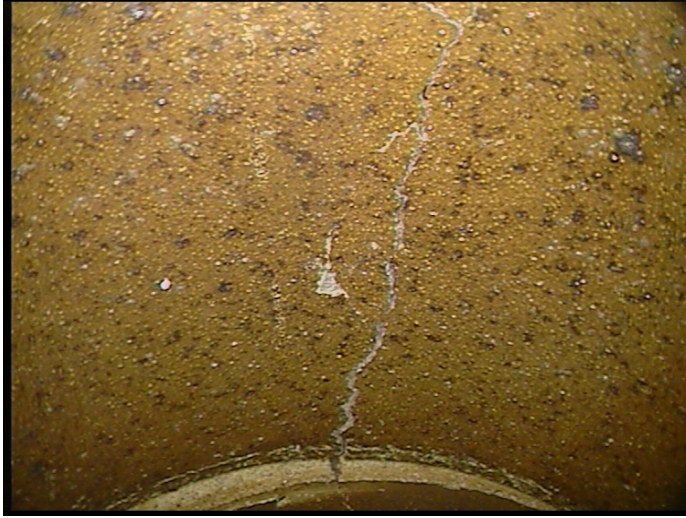
Code: **CL**  
Description: **Crack Longitudinal**

Distance (ft): **79.4**  
Structural Grade: **2**  
O&M Grade: **0**  
Clock Start/From: **12**  
Clock To:  
1st Value:  
2nd Value:  
Value Percent:  
Continuous Index: **S01**  
Within 8" of Joint: **YES**  
Remarks:

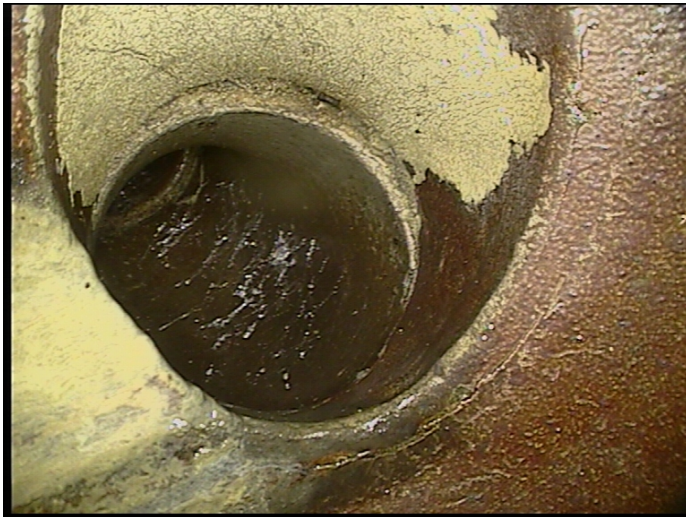
Code: **TF**  
Description: **Tap Factory**

Distance (ft): **110.5**  
Structural Grade: **0**  
O&M Grade: **0**  
Clock Start/From: **10**  
Clock To:  
1st Value: **4.000**  
2nd Value:  
Value Percent:  
Continuous Index:  
Within 8" of Joint: **NO**  
Remarks:

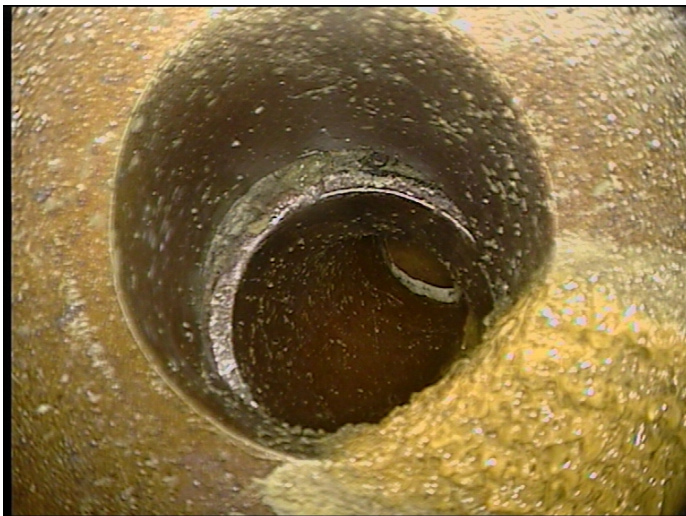
Code: **TF**  
Description: **Tap Factory**

Distance (ft): **146.5**  
Structural Grade: **0**  
O&M Grade: **0**  
Clock Start/From: **2**  
Clock To:  
1st Value: **4.000**  
2nd Value:  
Value Percent:  
Continuous Index:  
Within 8" of Joint: **NO**  
Remarks:

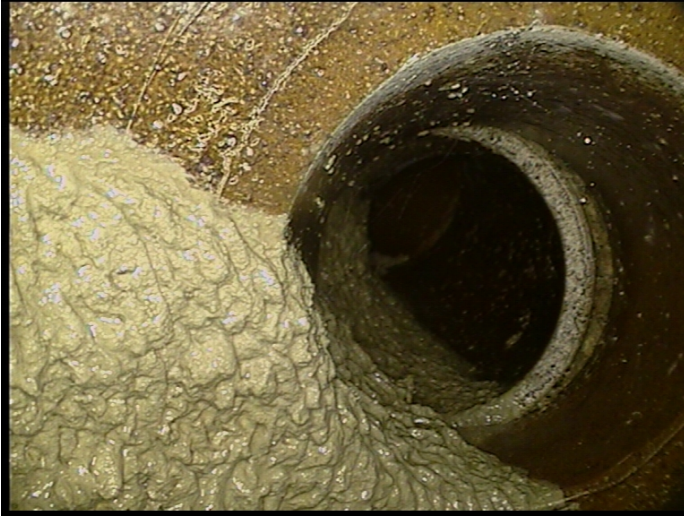
Code: **TF**  
Description: **Tap Factory**

Distance (ft): **148.6**  
Structural Grade: **0**  
O&M Grade: **0**  
Clock Start/From: **10**  
Clock To:  
1st Value: **4.000**  
2nd Value:  
Value Percent:  
Continuous Index:  
Within 8" of Joint: **NO**  
Remarks:

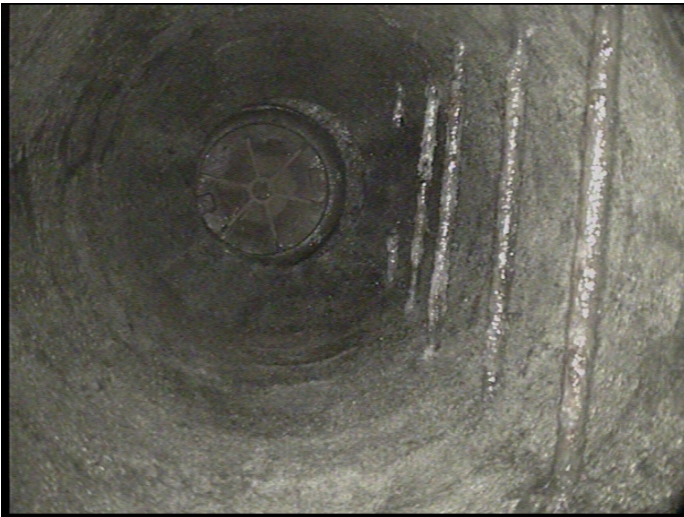
Code: **DSF**  
Description: **Deposits Settled Fine**

Distance (ft): **172.7**  
Structural Grade: **0**  
O&M Grade: **3**  
Clock Start/From: **5**  
Clock To: **7**  
1st Value:  
2nd Value:  
Value Percent: **15.000**  
Continuous Index: **F02**  
Within 8" of Joint: **NO**  
Remarks:

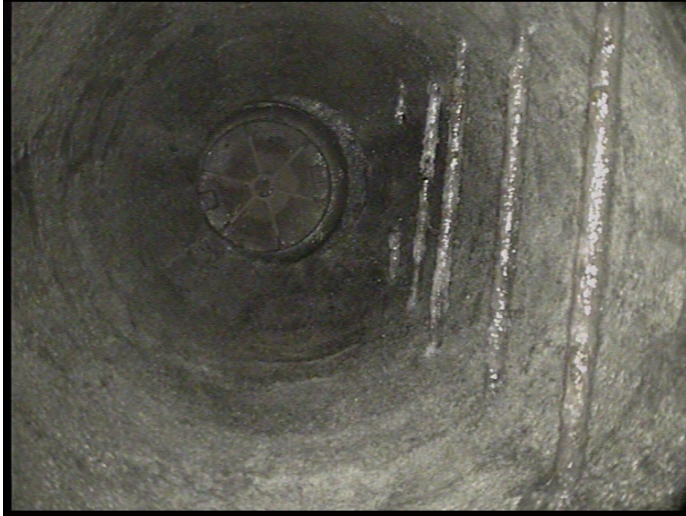
Code:	AMH
Description:	Manhole
Distance (ft):	172.7
Structural Grade:	0
O&M Grade:	0
Clock Start/From:	
Clock To:	
1st Value:	
2nd Value:	
Value Percent:	
Continuous Index:	
Within 8" of Joint:	NO
Remarks:	M-504-019
