## Profile/Photo Observation Report

Date:	<b>04/11/2018</b>	Weather:		Coding:	<b>PACP 6.0</b>
Pipe Length (ft):		Owner:	<b>City of Hobart</b>	Pre Clean:	<b>No Pre-Cleaning</b>
P.O.#:	<b>30-1</b>	Surveyor:	<b>M. Pielacha</b>	PSR:	<b>M-504-020-M-504-019</b>
Customer:	<b>City of Hobart</b>	Clean Date:		Shape:	<b>C</b>

Street:	<b>Wisconsin Street</b>	Flow Control:	<b>Not Controlled</b>
City:	<b>Hobart, IN</b>	Year Renewed:	
Location:	<b>Light Highway</b>	Tape/Media #:	<b>DEP 30</b>
Purpose:	<b>Routine Assessment</b>	Dia/Height:	<b>18"</b>
Use:	<b>Sanitary</b>	Material:	<b>VCP</b>
Drain Area:		Lining:

US MH: **M-504-020** DS MH: **M-504-019** Total Length Surveyed (ft): **172.7**

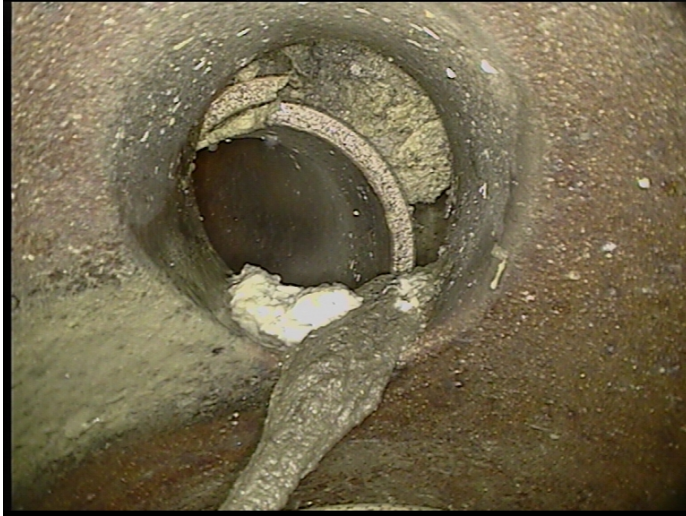
Code: **TF**  
Description: **Tap Factory**

Distance (ft): **29.8**  
Structural Grade: **0**  
O&M Grade: **0**  
Clock Start/From: **10**  
Clock To:  
1st Value: **4.000**  
2nd Value:  
Value Percent:  
Continuous Index:  
Within 8" of Joint: **NO**  
Remarks:

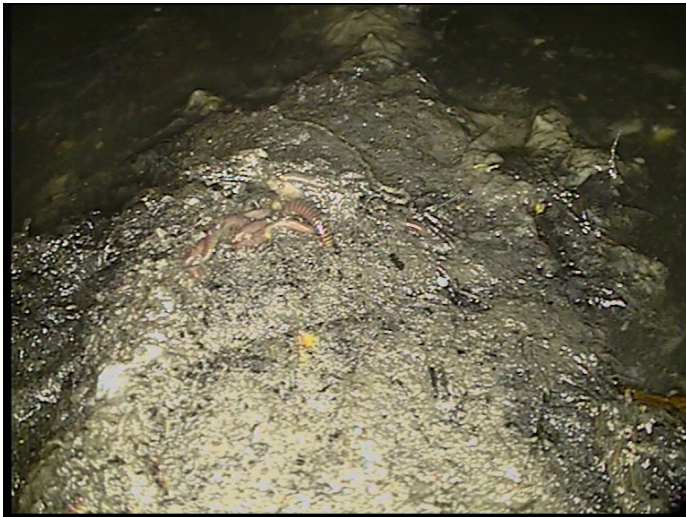
Code: **DSF**  
Description: **Deposits Settled Fine**

Distance (ft): **67.9**  
Structural Grade: **0**  
O&M Grade: **3**  
Clock Start/From: **5**  
Clock To: **7**  
1st Value:  
2nd Value:  
Value Percent: **15.000**  
Continuous Index: **S02**  
Within 8" of Joint: **YES**  
Remarks:

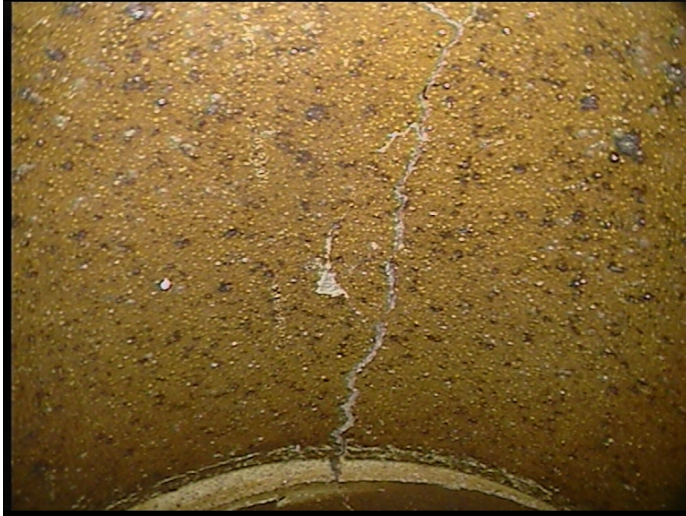
Code: **CL**  
Description: **Crack Longitudinal**

Distance (ft): **79.4**  
Structural Grade: **2**  
O&M Grade: **0**  
Clock Start/From: **12**  
Clock To:  
1st Value:  
2nd Value:  
Value Percent:  
Continuous Index: **S01**  
Within 8" of Joint: **YES**  
Remarks:
