Profile/Photo Observation Report

Date:	04/20/2018	Weather:		Coding:	PACP 6.0
Pipe Length (ft):	282.8	Owner:	NA	Pre Clean:	Not Known
P.O.#:		Surveyor:	Byrd Fitzgerald	PSR:	P-504-021-020
Customer:		Clean Date:	01/01/1900	Shape:	C

Street:	N WISCONSIN ST	Flow Control:	Not Controlled
City:	Hobart, IN	Year Renewed:	
Location:	Light Highway	Tape/Media #:	
Purpose:	Not Known	Dia/Height:	10"
Use:	Sanitary	Material:	VCP
Drain Area:	NA	Lining:	
Category:	NA		
Comment:

Location Details:		Direction of Survey:	Downstream
US MH:	M-504-020	DS MH:	M-504-021
		Total Length Surveyed (ft):	64.5

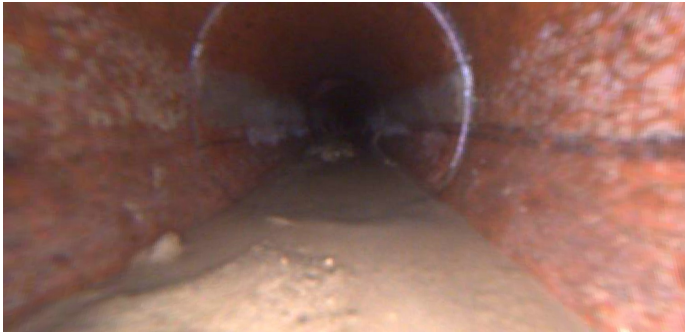
Code:	MWL
Description:	Water Level

Distance (ft):	.0
Structural Grade:	0
O&M Grade:	0
Clock Start/From:	
Clock To:	
1st Value:	
2nd Value:	
Value Percent:	5.000
Continuous Index:	
Within 8" of Joint:	NO
Remarks:

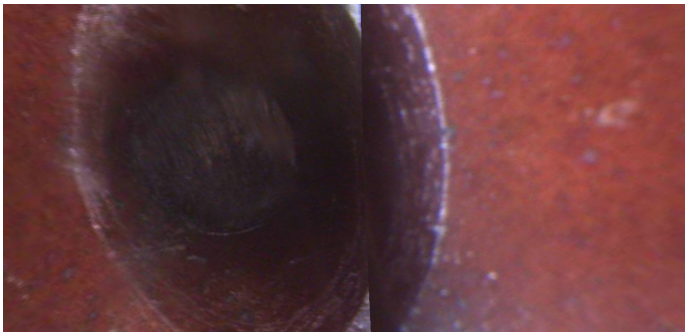
Code:	TFC
Description:	Tap Factory Capped

Distance (ft):	4.9
Structural Grade:	0
O&M Grade:	0
Clock Start/From:	10
Clock To:	
1st Value:	4.000
2nd Value:	
Value Percent:	
Continuous Index:	
Within 8" of Joint:	YES
Remarks:

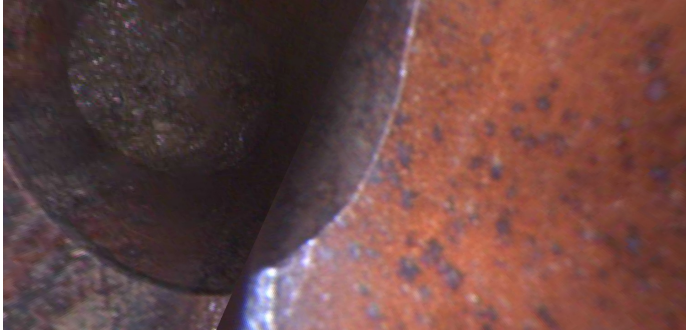
Code: **TFC**
Description: **Tap Factory Capped**

Distance (ft): **29.3**
Structural Grade: **0**
O&M Grade: **0**
Clock Start/From: **10**
Clock To:
1st Value: **4.000**
2nd Value:
Value Percent:
Continuous Index:
Within 8" of Joint: **YES**
Remarks:

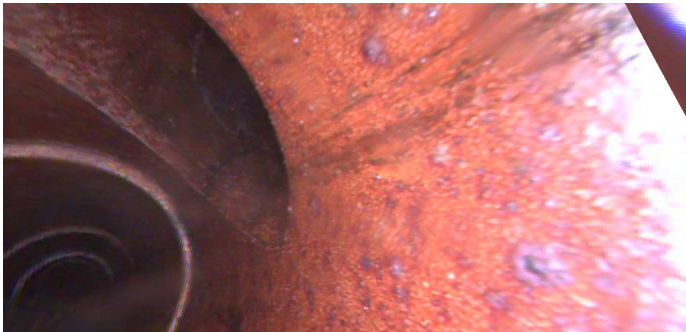
Code: **TF**
Description: **Tap Factory**

Distance (ft): **54.3**
Structural Grade: **0**
O&M Grade: **0**
Clock Start/From: **11**
Clock To:
1st Value: **4.000**
2nd Value:
Value Percent:
Continuous Index:
Within 8" of Joint: **YES**
Remarks:

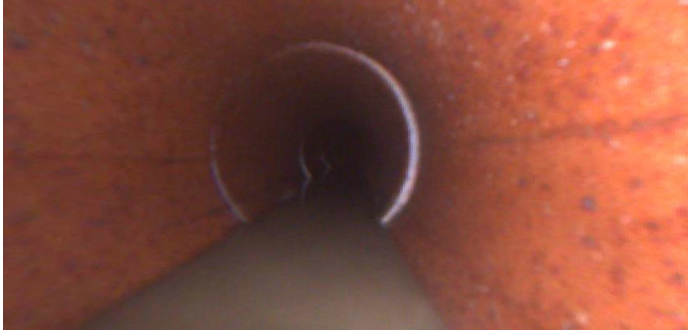
Code:	MSA
Description:	Abandoned Survey
Distance (ft):	64.5
Structural Grade:	0
O&M Grade:	0
Clock Start/From:	
Clock To:	
1st Value:	
2nd Value:	
Value Percent:	
Continuous Index:	
Within 8" of Joint:	NO
Remarks:	no blockage
