Profile/Photo Observation Report

Date:	04/20/2018	Weather:		Coding:	PACP 6.0
Pipe Length (ft):	282.8	Owner:	NA	Pre Clean:	Not Known
P.O.#:		Surveyor:	Byrd Fitzgerald	PSR:	P-504-021-020
Customer:		Clean Date:	01/01/1900	Shape:	C

Location Details:		Direction of Survey:	Downstream
US MH:	M-504-020	DS MH:	M-504-021
		Total Length Surveyed (ft):	64.5

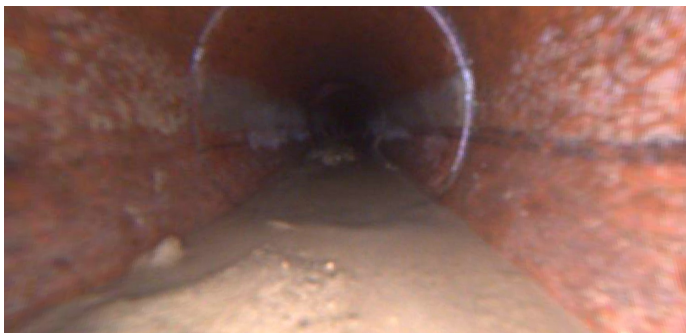
Code: **AMH**
Description: **Manhole**

Distance (ft): **.0**
Structural Grade: **0**
O&M Grade: **0**
Clock Start/From:
Clock To:
1st Value:
2nd Value:
Value Percent:
Continuous Index:
Within 8" of Joint: **NO**
Remarks: **M-504-020**

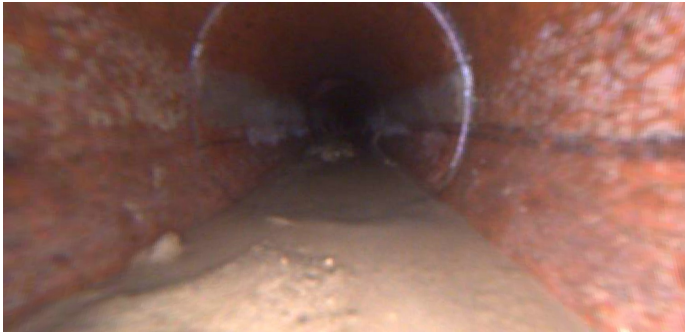
Code:	MWL
Description:	Water Level

Distance (ft):	.0
Structural Grade:	0
O&M Grade:	0
Clock Start/From:	
Clock To:	
1st Value:	
2nd Value:	
Value Percent:	5.000
Continuous Index:	
Within 8" of Joint:	NO
Remarks:

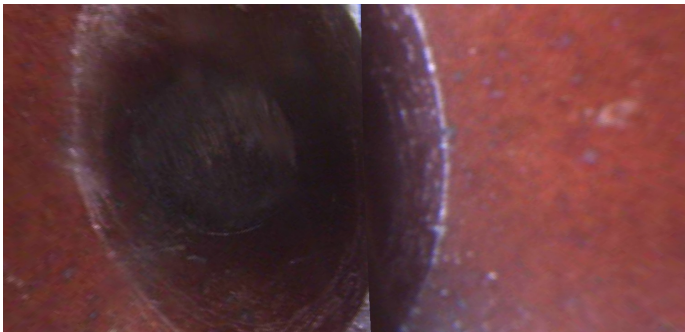
Code:	TFC
Description:	Tap Factory Capped

Distance (ft):	4.9
Structural Grade:	0
O&M Grade:	0
Clock Start/From:	10
Clock To:	
1st Value:	4.000
2nd Value:	
Value Percent:	
Continuous Index:	
Within 8" of Joint:	YES
Remarks:

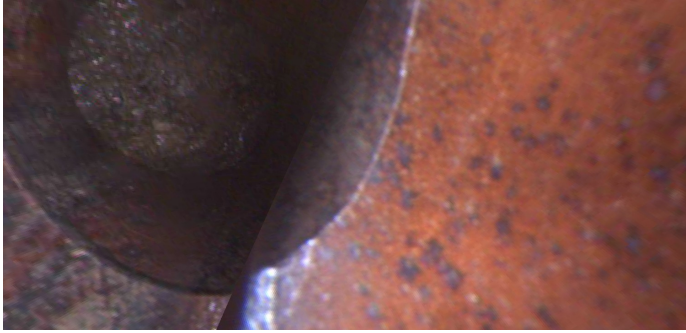
Code: **TFC**
Description: **Tap Factory Capped**

Distance (ft): **29.3**
Structural Grade: **0**
O&M Grade: **0**
Clock Start/From: **10**
Clock To:
1st Value: **4.000**
2nd Value:
Value Percent:
Continuous Index:
Within 8" of Joint: **YES**
Remarks:

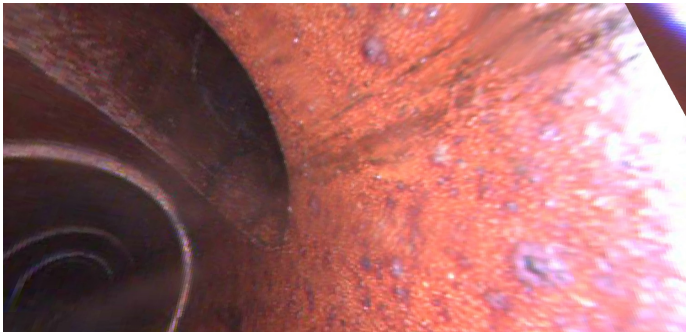
Code: **TF**
Description: **Tap Factory**

Distance (ft): **54.3**
Structural Grade: **0**
O&M Grade: **0**
Clock Start/From: **11**
Clock To:
1st Value: **4.000**
2nd Value:
Value Percent:
Continuous Index:
Within 8" of Joint: **YES**
Remarks:

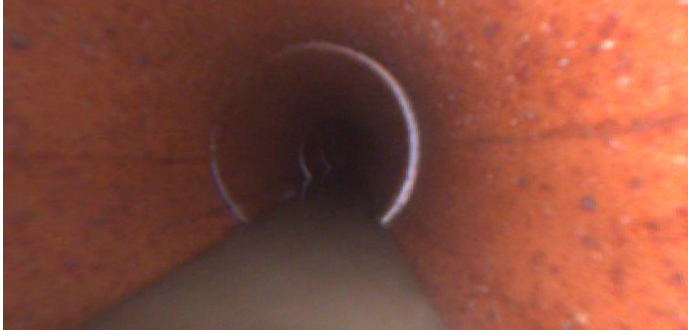
Code:	MSA
Description:	Abandoned Survey
Distance (ft):	64.5
Structural Grade:	0
O&M Grade:	0
Clock Start/From:	
Clock To:	
1st Value:	
2nd Value:	
Value Percent:	
Continuous Index:	
Within 8" of Joint:	NO
Remarks:	no blockage
