Profile/Photo Observation Report

Street:	FOXCROFT STREET	Flow Control:	Not Controlled
City:	Hobart, IN	Year Renewed:	
Location:	Alley	Tape/Media #:	
Purpose:	Routine Assessment	Dia/Height:	12"
Use:	Sanitary	Material:	VCP
Drain Area:	NA	Lining:	
Category:	NA		
Comment:	P_C at 11 ft unknow obstruction . flow direction wrong		
Location Details:		Direction of Survey:	Upstream
US MH:	M-504-023	DS MH:	M-504-030
		Total Length Surveyed (ft):	12.3

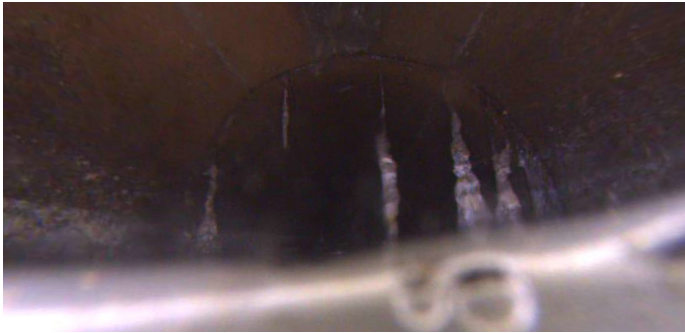
Code:	MWL
Description:	Water Level

Distance (ft):	.0
Structural Grade:	0
O&M Grade:	0
Clock Start/From:	
Clock To:	
1st Value:	
2nd Value:	
Value Percent:	40.000
Continuous Index:	
Within 8" of Joint:	NO
Remarks:

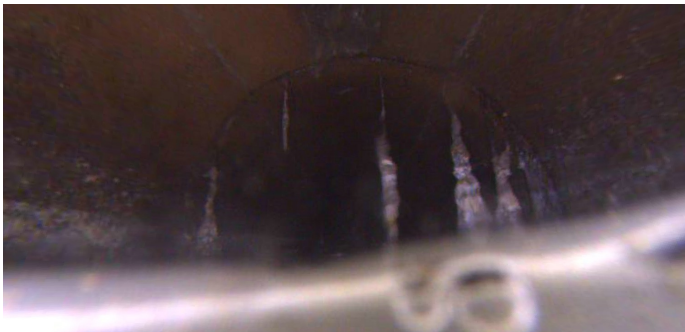
Code:	RMJ
Description:	Roots Medium Joint

Distance (ft):	.0
Structural Grade:	0
O&M Grade:	3
Clock Start/From:	8
Clock To:	4
1st Value:	
2nd Value:	
Value Percent:	5.000
Continuous Index:	
Within 8" of Joint:	YES
Remarks:

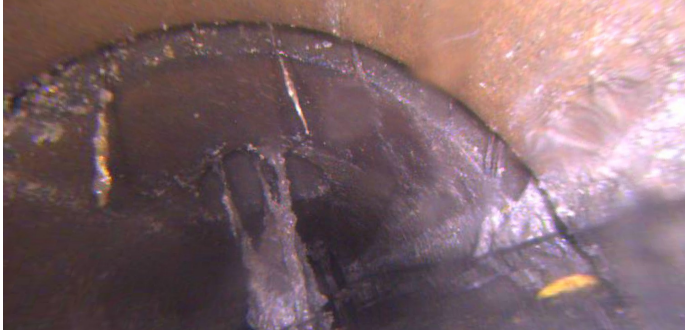
Code: **RFJ**
Description: **Roots Fine Joint**

Distance (ft): **4.1**
Structural Grade: **0**
O&M Grade: **1**
Clock Start/From: **8**
Clock To: **4**
1st Value:
2nd Value:
Value Percent:
Continuous Index:
Within 8" of Joint: **YES**
Remarks:

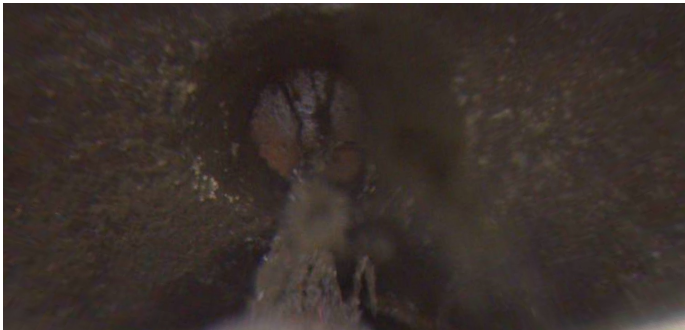
Code: **TFD**
Description: **Tap Factory Defective**

Distance (ft): **5.4**
Structural Grade: **0**
O&M Grade: **2**
Clock Start/From: **12**
Clock To:
1st Value: **4.000**
2nd Value:
Value Percent:
Continuous Index:
Within 8" of Joint:
Remarks: **roots, capped**

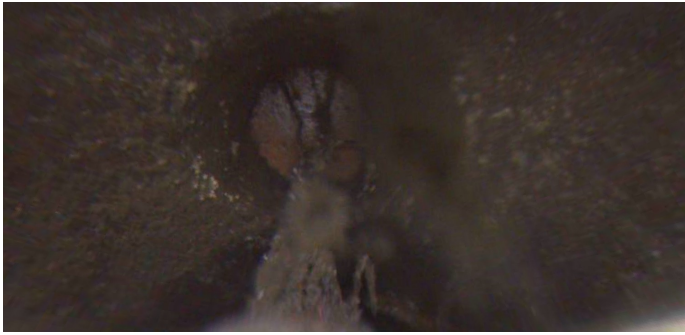
Code: **RML**
Description: **Roots Medium Lateral**

Distance (ft): **5.4**
Structural Grade: **0**
O&M Grade: **3**
Clock Start/From: **12**
Clock To:
1st Value:
2nd Value:
Value Percent: **10.000**
Continuous Index:
Within 8" of Joint: **NO**
Remarks:

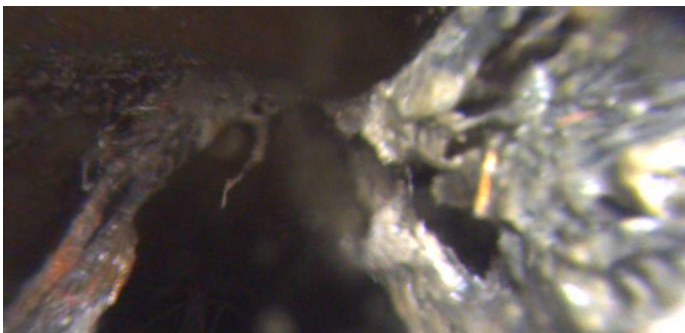
Code: **RMJ**
Description: **Roots Medium Joint**

Distance (ft): **7.3**
Structural Grade: **0**
O&M Grade: **3**
Clock Start/From: **8**
Clock To: **4**
1st Value:
2nd Value:
Value Percent: **20.000**
Continuous Index:
Within 8" of Joint: **YES**
Remarks:

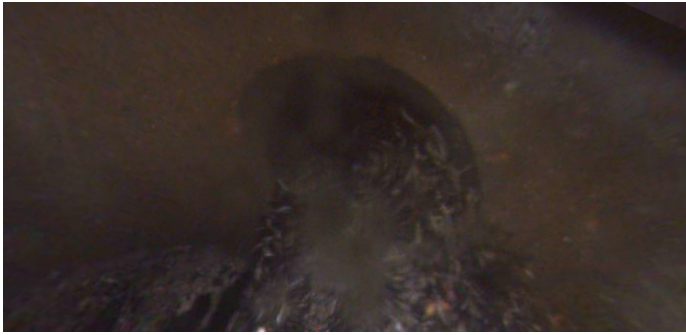
Code: **TFD**
Description: **Tap Factory Defective**

Distance (ft): **8.0**
Structural Grade: **0**
O&M Grade: **2**
Clock Start/From: **11**
Clock To:
1st Value: **4.000**
2nd Value:
Value Percent:
Continuous Index:
Within 8" of Joint:
Remarks: **roots**

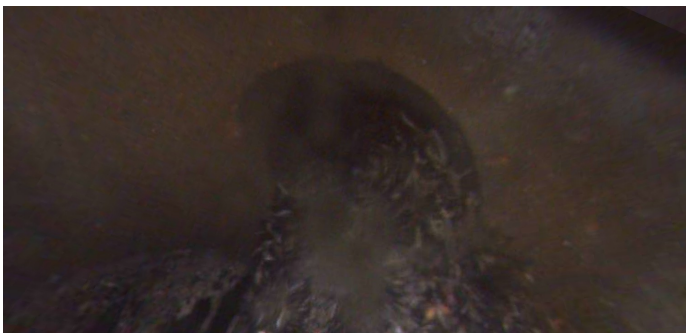
Code: **RML**
Description: **Roots Medium Lateral**

Distance (ft): **8.0**
Structural Grade: **0**
O&M Grade: **3**
Clock Start/From: **10**
Clock To: **11**
1st Value:
2nd Value:
Value Percent: **20.000**
Continuous Index:
Within 8" of Joint: **NO**
Remarks:

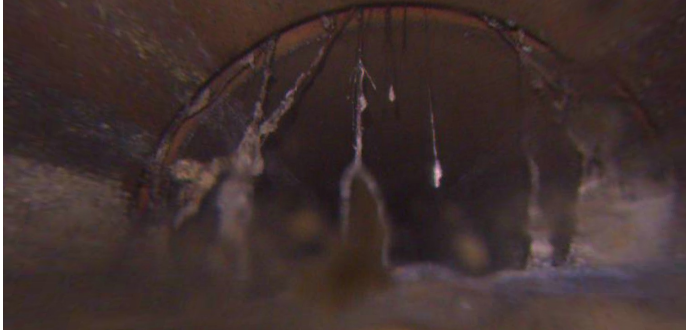
Code: **RMJ**
Description: **Roots Medium Joint**

Distance (ft): **8.9**
Structural Grade: **0**
O&M Grade: **3**
Clock Start/From: **8**
Clock To: **4**
1st Value:
2nd Value:
Value Percent: **5.000**
Continuous Index:
Within 8" of Joint: **YES**
Remarks:

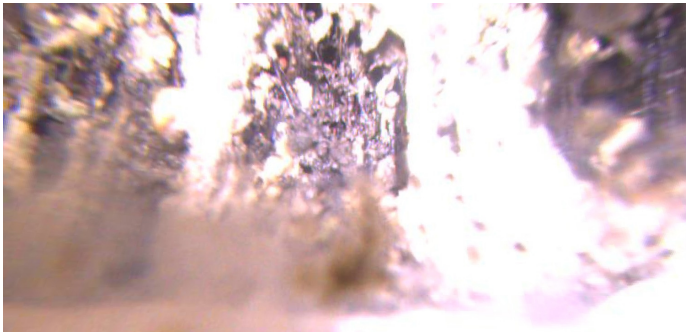
Code: **RBJ**
Description: **Roots Ball Joint**

Distance (ft): **11.8**
Structural Grade: **0**
O&M Grade: **4**
Clock Start/From: **8**
Clock To: **4**
1st Value:
2nd Value:
Value Percent: **60.000**
Continuous Index:
Within 8" of Joint: **YES**
Remarks:
