Profile/Photo Observation Report

Street:	FOXCROFT STREET	Flow Control:	Not Controlled
City:	Hobart, IN	Year Renewed:	
Location:	Light Highway	Tape/Media #:	
Purpose:	Routine Assessment	Dia/Height:	12"
Use:	Sanitary	Material:	VCP
Drain Area:	NA	Lining:	
Category:	NA		
Comment:	P_C at 44 ft roots . Flow direction wrong		
Location Details:		Direction of Survey:	Downstream
US MH:	M-504-024	DS MH:	M-504-023
		Total Length Surveyed (ft):	44.9

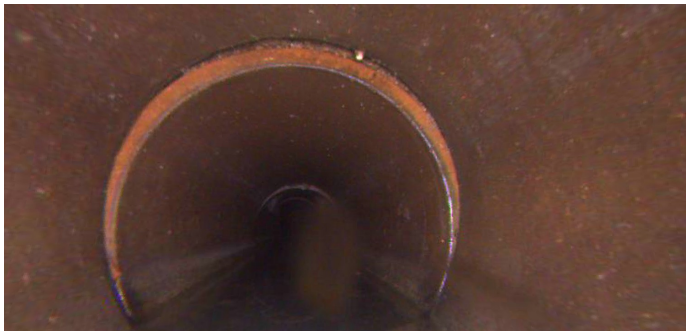
Code: **AMH**
Description: **Manhole**

Distance (ft): **.0**
Structural Grade: **0**
O&M Grade: **0**
Clock Start/From:
Clock To:
1st Value:
2nd Value:
Value Percent:
Continuous Index:
Within 8" of Joint: **NO**
Remarks: **M-504-024**

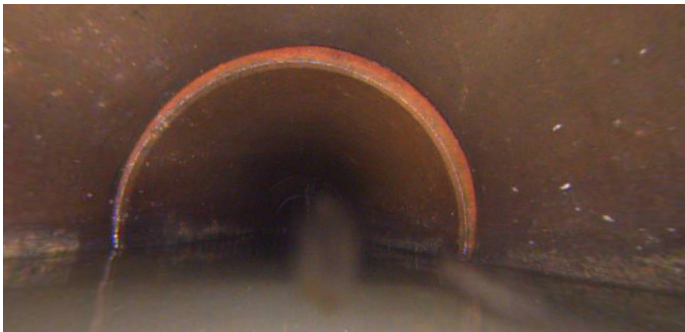
Code:	MWL
Description:	Water Level

Distance (ft):	34.6
Structural Grade:	0
O&M Grade:	0
Clock Start/From:	
Clock To:	
1st Value:	
2nd Value:	
Value Percent:	30.000
Continuous Index:	
Within 8" of Joint:	NO
Remarks:

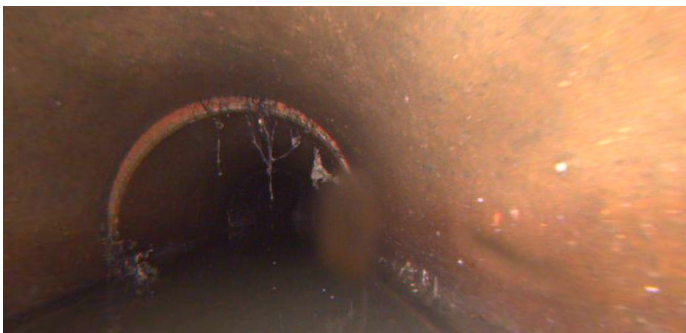
Code: **RFJ**
Description: **Roots Fine Joint**

Distance (ft): **39.2**
Structural Grade: **0**
O&M Grade: **1**
Clock Start/From: **8**
Clock To: **4**
1st Value:
2nd Value:
Value Percent:
Continuous Index:
Within 8" of Joint: **YES**
Remarks:
