## Profile/Photo Observation Report

Date:	<b>04/14/2018</b>	Weather:		Coding:	<b>PACP 6.0</b>
Pipe Length (ft):		Owner:	<b>City of Hobart</b>	Pre Clean:	<b>No Pre-Cleaning</b>
P.O.#:	<b>49-2</b>	Surveyor:	<b>M. Pielacha</b>	PSR:	<b>M-504-025-M-504-024</b>
Customer:	<b>City of Hobart</b>	Clean Date:		Shape:	<b>C</b>

Street:	<b>Cleveland Street</b>	Flow Control:	<b>Not Controlled</b>
City:	<b>Hobart, IN</b>	Year Renewed:	
Location:	<b>Light Highway</b>	Tape/Media #:	<b>DEP 49</b>
Purpose:	<b>Routine Assessment</b>	Dia/Height:	<b>18"</b>
Use:	<b>Sanitary</b>	Material:	<b>VCP</b>
Drain Area:		Lining:

US MH: **M-504-025** DS MH: **M-504-024** Total Length Surveyed (ft): **237.3**

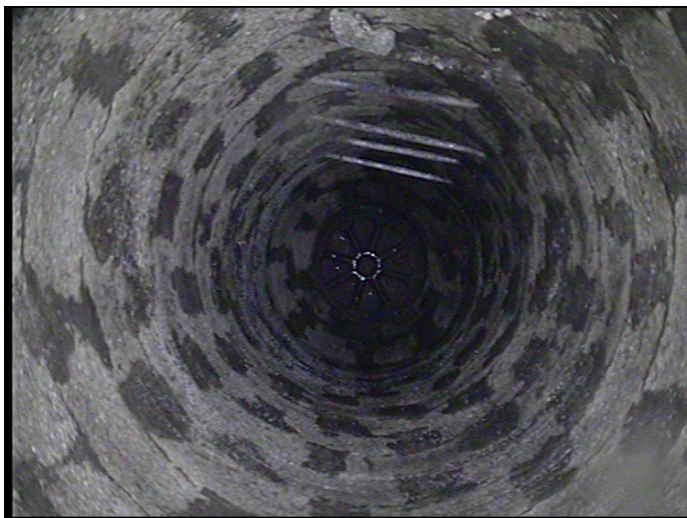
Code: **AMH**  
 Description: **Manhole**

Distance (ft): **.0**  
 Structural Grade: **0**  
 O&M Grade: **0**  
 Clock Start/From:  
 Clock To:  
 1st Value:  
 2nd Value:  
 Value Percent:  
 Continuous Index:  
 Within 8" of Joint: **NO**  
 Remarks: **M-504-025**

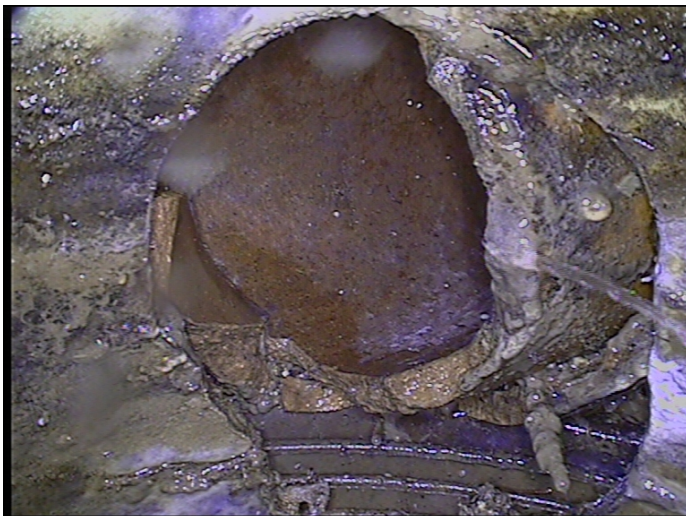
Code: **TBA**  
Description: **Tap Break-in Active**

Distance (ft): **49.6**  
Structural Grade: **0**  
O&M Grade: **0**  
Clock Start/From: **12**  
Clock To:  
1st Value: **4.000**  
2nd Value:  
Value Percent:  
Continuous Index:  
Within 8" of Joint: **NO**  
Remarks:
