Profile/Photo Observation Report

Date:	04/14/2018	Weather:		Coding:	PACP 6.0
Pipe Length (ft):		Owner:	City of Hobart	Pre Clean:	No Pre-Cleaning
P.O.#:	49-2	Surveyor:	M. Pielacha	PSR:	M-504-025-M-504-024
Customer:	City of Hobart	Clean Date:		Shape:	C

Street:	Cleveland Street	Flow Control:	Not Controlled
City:	Hobart, IN	Year Renewed:	
Location:	Light Highway	Tape/Media #:	DEP 49
Purpose:	Routine Assessment	Dia/Height:	18"
Use:	Sanitary	Material:	VCP
Drain Area:		Lining:

US MH: **M-504-025** DS MH: **M-504-024** Total Length Surveyed (ft): **237.3**

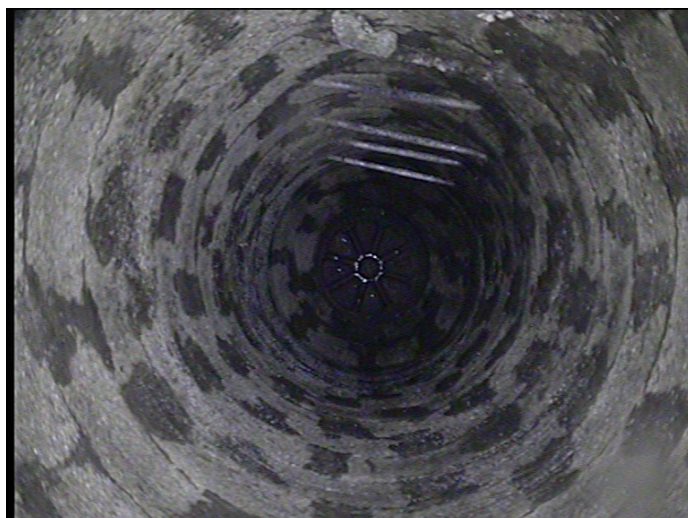
Code: **AMH**
 Description: **Manhole**

Distance (ft): **.0**
 Structural Grade: **0**
 O&M Grade: **0**
 Clock Start/From:
 Clock To:
 1st Value:
 2nd Value:
 Value Percent:
 Continuous Index:
 Within 8" of Joint: **NO**
 Remarks: **M-504-025**

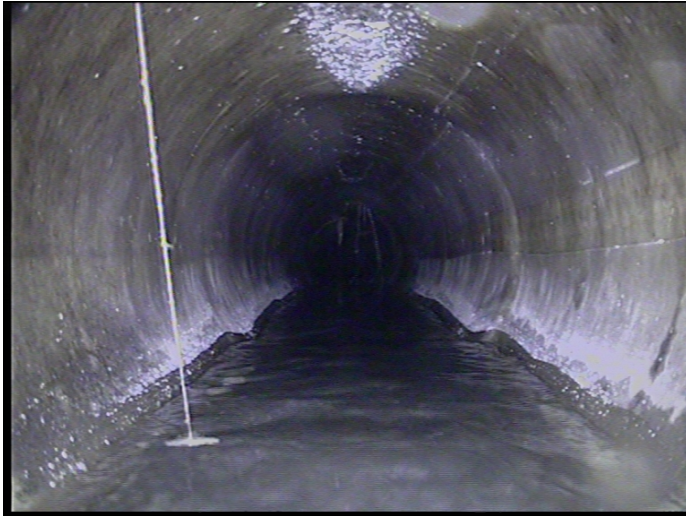
Code: **MWL**
Description: **Water Level**

Distance (ft): **.0**
Structural Grade: **0**
O&M Grade: **0**
Clock Start/From:
Clock To:
1st Value:
2nd Value:
Value Percent: **10.000**
Continuous Index:
Within 8" of Joint: **NO**
Remarks:

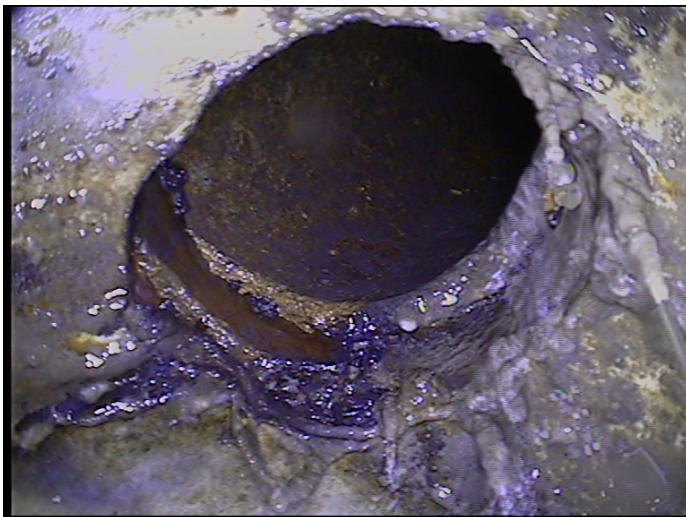
Code: **TBA**
Description: **Tap Break-in Active**

Distance (ft): **11.6**
Structural Grade: **0**
O&M Grade: **0**
Clock Start/From: **12**
Clock To:
1st Value: **4.000**
2nd Value:
Value Percent:
Continuous Index:
Within 8" of Joint: **NO**
Remarks:

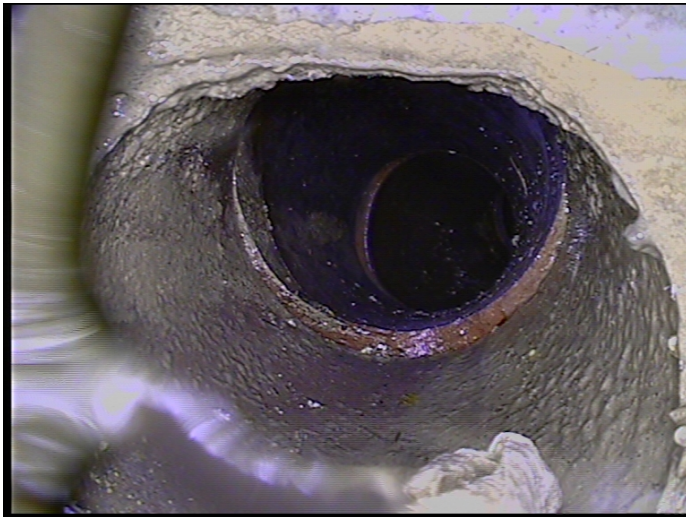
Code: **TBA**
Description: **Tap Break-in Active**

Distance (ft): **15.1**
Structural Grade: **0**
O&M Grade: **0**
Clock Start/From: **10**
Clock To:
1st Value: **4.000**
2nd Value:
Value Percent:
Continuous Index:
Within 8" of Joint: **NO**
Remarks:

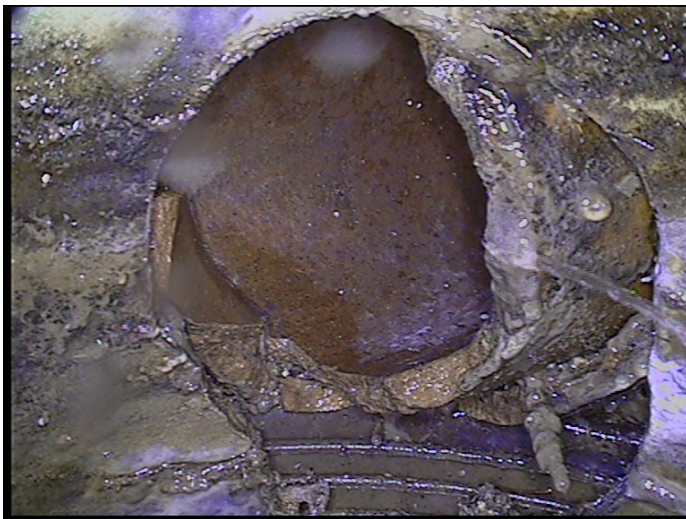
Code: **TBA**
Description: **Tap Break-in Active**

Distance (ft): **49.6**
Structural Grade: **0**
O&M Grade: **0**
Clock Start/From: **12**
Clock To:
1st Value: **4.000**
2nd Value:
Value Percent:
Continuous Index:
Within 8" of Joint: **NO**
Remarks:

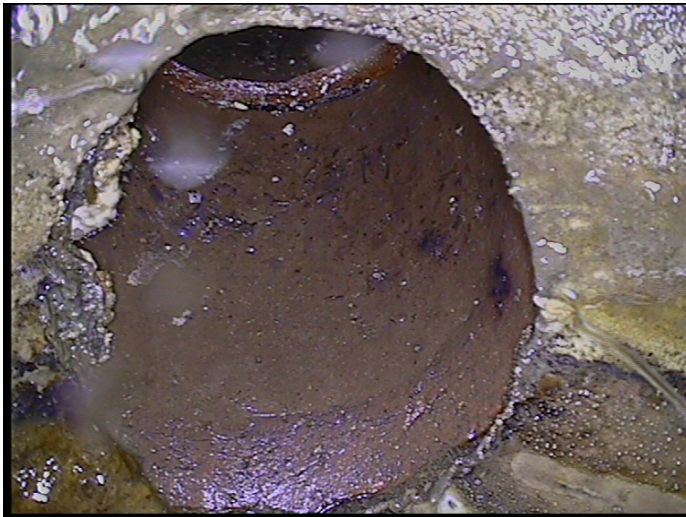
Code: **TBA**
Description: **Tap Break-in Active**

Distance (ft): **53.5**
Structural Grade: **0**
O&M Grade: **0**
Clock Start/From: **12**
Clock To:
1st Value: **4.000**
2nd Value:
Value Percent:
Continuous Index:
Within 8" of Joint: **NO**
Remarks:

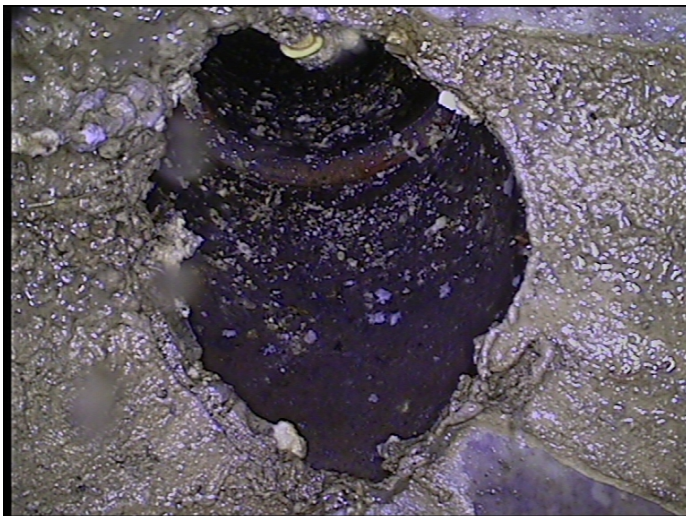
Code: **TB**
Description: **Tap Break-in**

Distance (ft): **95.4**
Structural Grade: **0**
O&M Grade: **0**
Clock Start/From: **10**
Clock To:
1st Value: **4.000**
2nd Value:
Value Percent:
Continuous Index:
Within 8" of Joint: **NO**
Remarks:

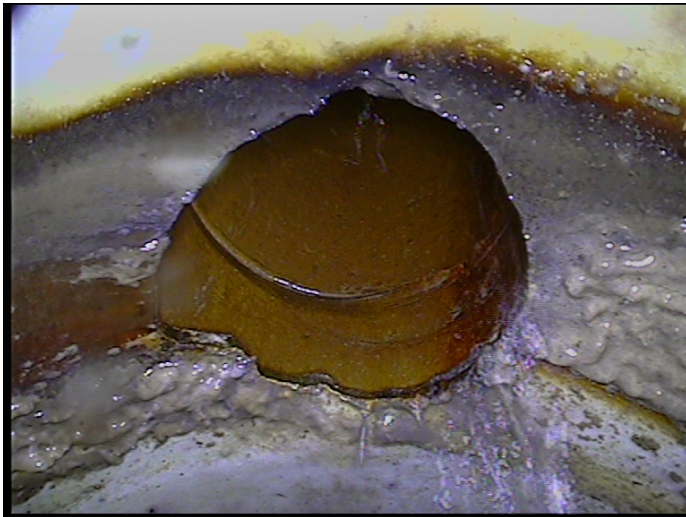
Code: **TBA**
 Description: **Tap Break-in Active**

Distance (ft): **99.9**
 Structural Grade: **0**
 O&M Grade: **0**
 Clock Start/From: **12**
 Clock To:
 1st Value: **4.000**
 2nd Value:
 Value Percent:
 Continuous Index:
 Within 8" of Joint: **NO**
 Remarks:

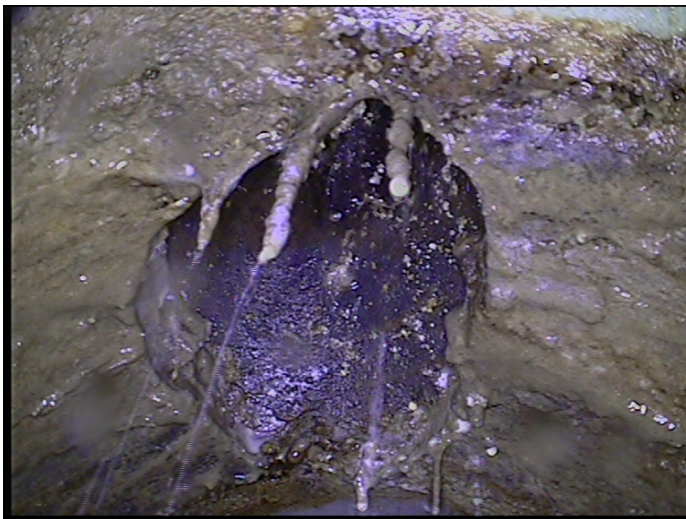
Code: **TBA**
 Description: **Tap Break-in Active**

Distance (ft): **131.3**
 Structural Grade: **0**
 O&M Grade: **0**
 Clock Start/From: **12**
 Clock To:
 1st Value: **4.000**
 2nd Value:
 Value Percent:
 Continuous Index:
 Within 8" of Joint: **NO**
 Remarks:

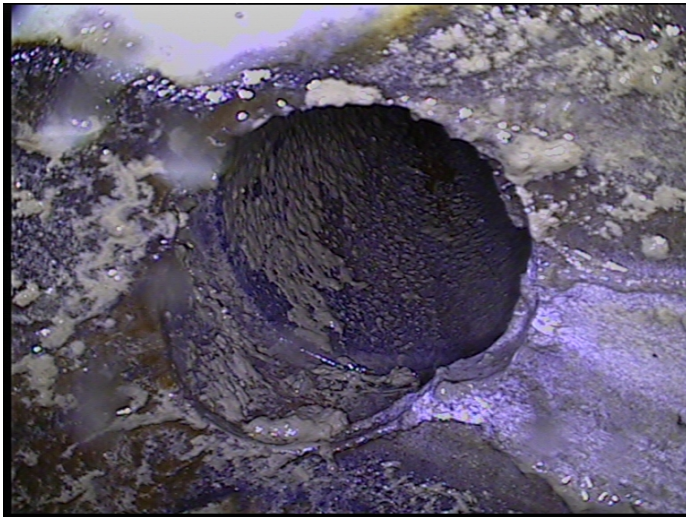
Code: **TBA**
Description: **Tap Break-in Active**

Distance (ft): **145.2**
Structural Grade: **0**
O&M Grade: **0**
Clock Start/From: **1**
Clock To:
1st Value: **4.000**
2nd Value:
Value Percent:
Continuous Index:
Within 8" of Joint: **NO**
Remarks:

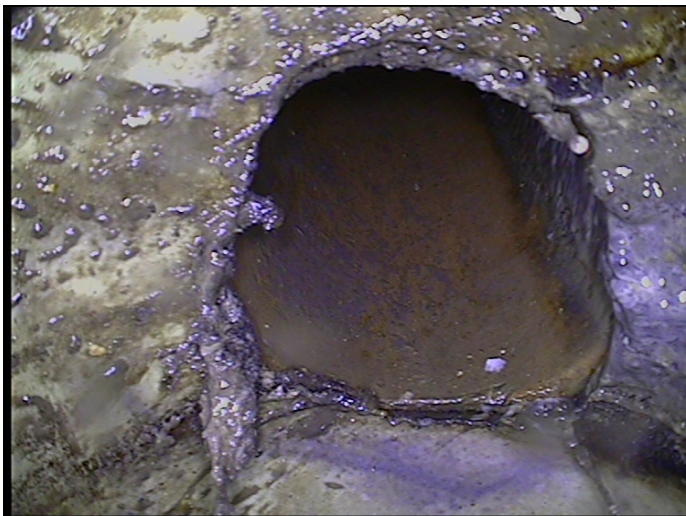
Code: **TBA**
Description: **Tap Break-in Active**

Distance (ft): **164.8**
Structural Grade: **0**
O&M Grade: **0**
Clock Start/From: **12**
Clock To:
1st Value: **4.000**
2nd Value:
Value Percent:
Continuous Index:
Within 8" of Joint: **NO**
Remarks:

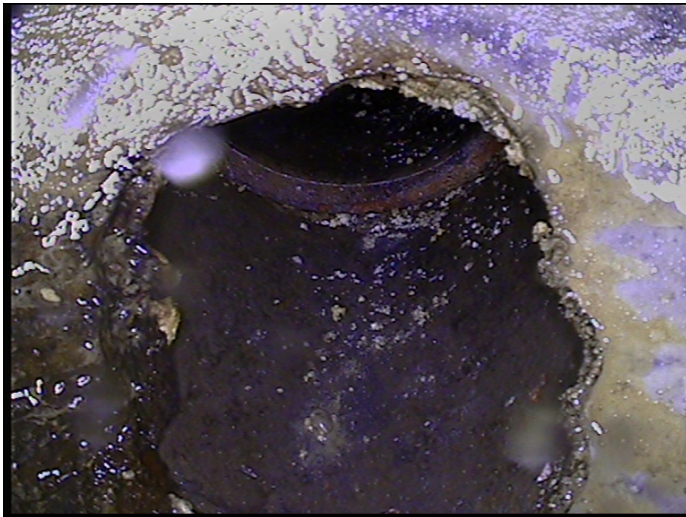
Code: **TBA**
 Description: **Tap Break-in Active**

Distance (ft): **175.9**
 Structural Grade: **0**
 O&M Grade: **0**
 Clock Start/From: **11**
 Clock To:
 1st Value: **4.000**
 2nd Value:
 Value Percent:
 Continuous Index:
 Within 8" of Joint: **NO**
 Remarks:

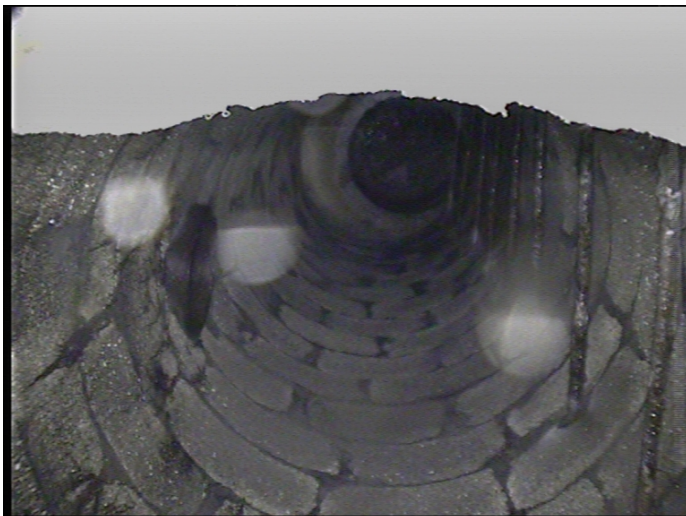
Code: **AMH**
 Description: **Manhole**

Distance (ft): **237.3**
 Structural Grade: **0**
 O&M Grade: **0**
 Clock Start/From:
 Clock To:
 1st Value:
 2nd Value:
 Value Percent:
 Continuous Index:
 Within 8" of Joint: **NO**
 Remarks: **M-504-024**
