Profile/Photo Observation Report

Date:	04/14/2018	Weather:		Coding:	PACP 6.0
Pipe Length (ft):		Owner:	City of Hobart	Pre Clean:	No Pre-Cleaning
P.O.#:	49-1	Surveyor:	M. Pielacha	PSR:	M-504-026-M-504-025
Customer:	City of Hobart	Clean Date:		Shape:	C

Street:	Cleveland Street	Flow Control:	Not Controlled
City:	Hobart, IN	Year Renewed:	
Location:	Light Highway	Tape/Media #:	DEP 49
Purpose:	Routine Assessment	Dia/Height:	18"
Use:	Sanitary	Material:	VCP
Drain Area:		Lining:

US MH: **M-504-026** DS MH: **M-504-025** Total Length Surveyed (ft): **236.6**

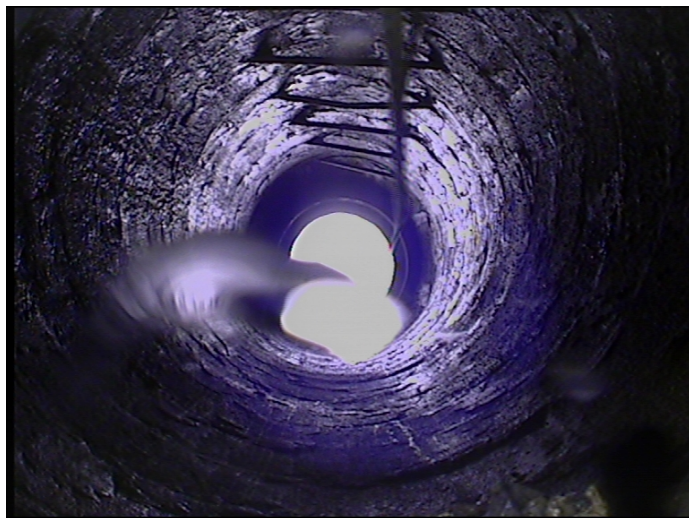
Code: **AMH**
 Description: **Manhole**

Distance (ft): **.0**
 Structural Grade: **0**
 O&M Grade: **0**
 Clock Start/From:
 Clock To:
 1st Value:
 2nd Value:
 Value Percent:
 Continuous Index:
 Within 8" of Joint: **NO**
 Remarks: **M-504-026**

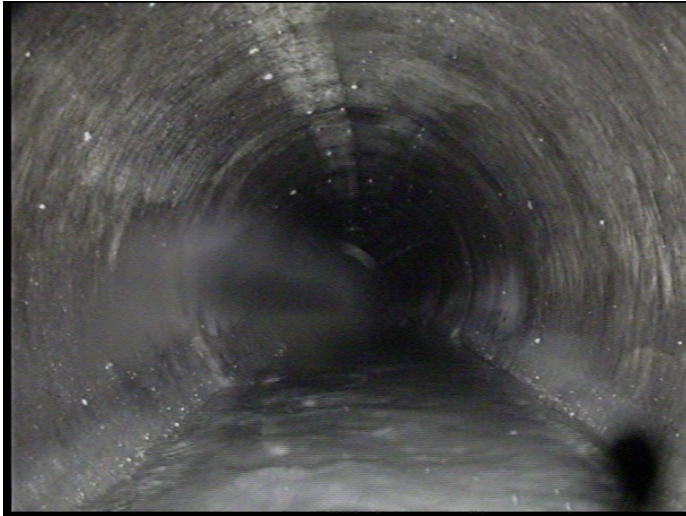
Code: **MWL**
Description: **Water Level**

Distance (ft): **.0**
Structural Grade: **0**
O&M Grade: **0**
Clock Start/From:
Clock To:
1st Value:
2nd Value:
Value Percent: **10.000**
Continuous Index:
Within 8" of Joint: **NO**
Remarks:

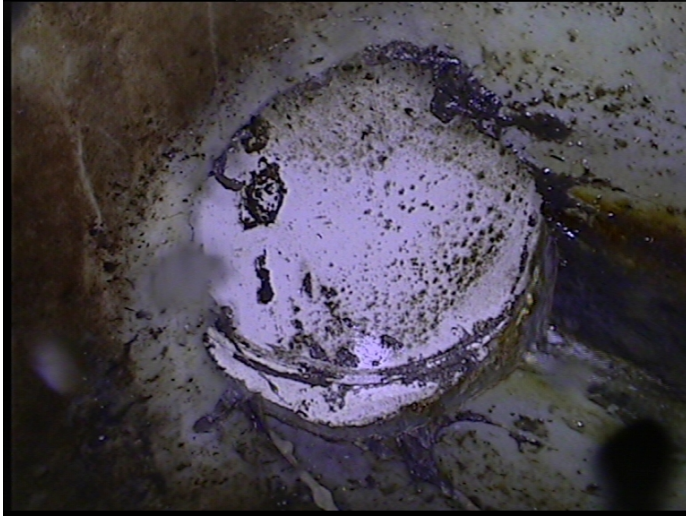
Code: **TBC**
Description: **Tap Break-in Capped**

Distance (ft): **67.8**
Structural Grade: **0**
O&M Grade: **2**
Clock Start/From: **2**
Clock To:
1st Value: **4.000**
2nd Value:
Value Percent:
Continuous Index:
Within 8" of Joint: **NO**
Remarks:

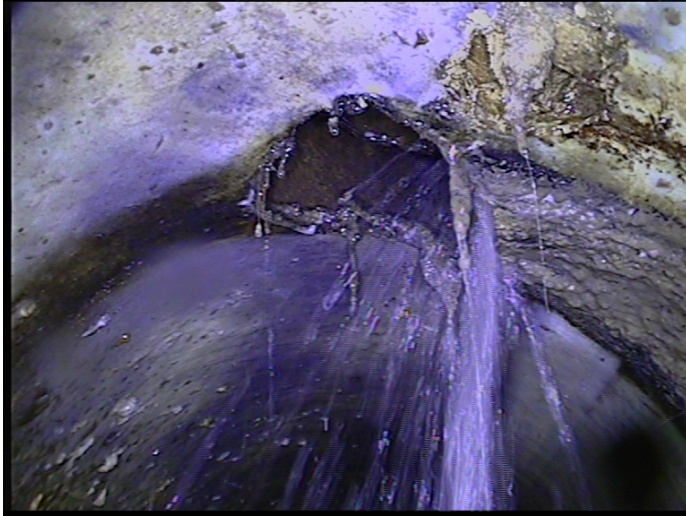
Code: **TBA**
Description: **Tap Break-in Active**

Distance (ft): **112.2**
Structural Grade: **0**
O&M Grade: **0**
Clock Start/From: **1**
Clock To:
1st Value: **4.000**
2nd Value:
Value Percent:
Continuous Index:
Within 8" of Joint: **NO**
Remarks:

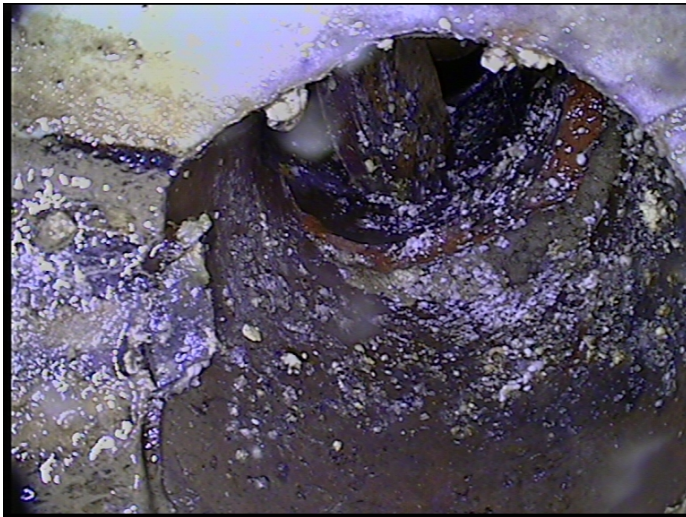
Code: **TB**
Description: **Tap Break-in**

Distance (ft): **131.9**
Structural Grade: **0**
O&M Grade: **0**
Clock Start/From: **11**
Clock To:
1st Value: **4.000**
2nd Value:
Value Percent:
Continuous Index:
Within 8" of Joint: **NO**
Remarks:

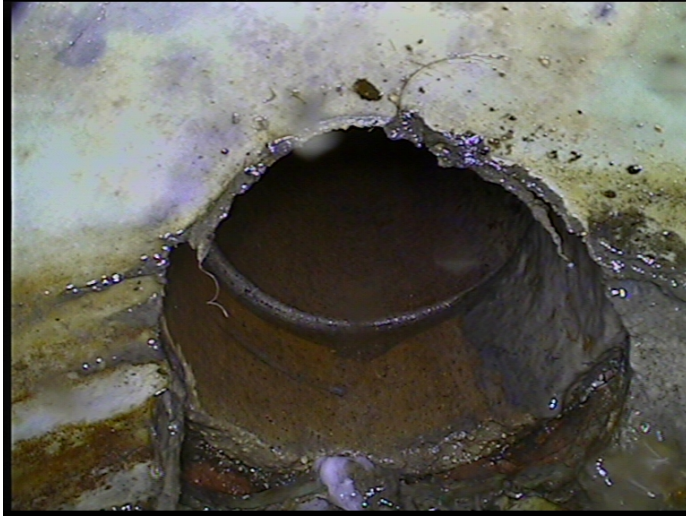
Code: **TB**
Description: **Tap Break-in**

Distance (ft): **157.8**
Structural Grade: **0**
O&M Grade: **0**
Clock Start/From: **12**
Clock To:
1st Value: **4.000**
2nd Value:
Value Percent:
Continuous Index:
Within 8" of Joint: **NO**
Remarks:

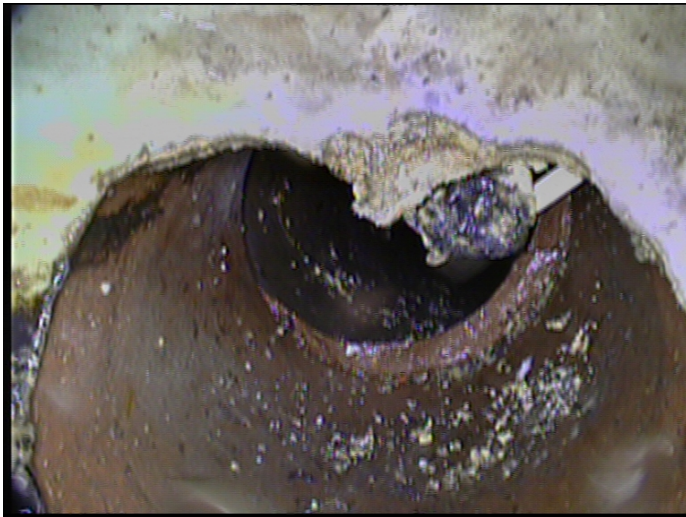
Code: **TBA**
Description: **Tap Break-in Active**

Distance (ft): **173.3**
Structural Grade: **0**
O&M Grade: **0**
Clock Start/From: **10**
Clock To:
1st Value: **4.000**
2nd Value:
Value Percent:
Continuous Index:
Within 8" of Joint: **NO**
Remarks:

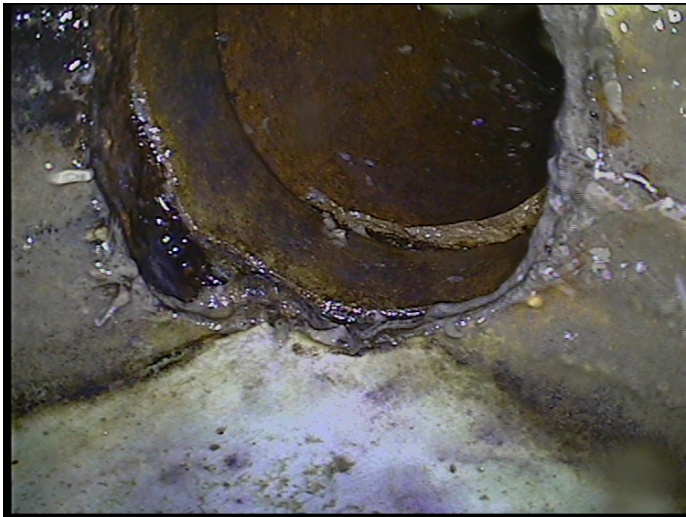
Code: **TBA**
Description: **Tap Break-in Active**

Distance (ft): **178.7**
Structural Grade: **0**
O&M Grade: **0**
Clock Start/From: **12**
Clock To:
1st Value: **4.000**
2nd Value:
Value Percent:
Continuous Index:
Within 8" of Joint: **NO**
Remarks:

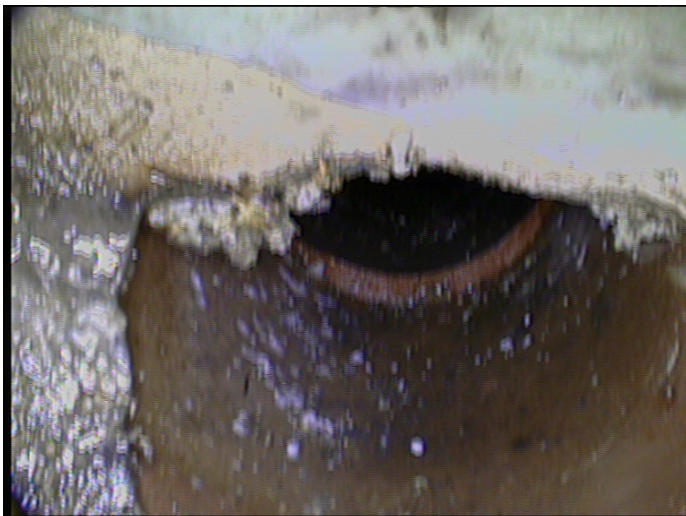
Code: **TB**
Description: **Tap Break-in**

Distance (ft): **212.6**
Structural Grade: **0**
O&M Grade: **0**
Clock Start/From: **10**
Clock To:
1st Value: **4.000**
2nd Value:
Value Percent:
Continuous Index:
Within 8" of Joint: **NO**
Remarks:

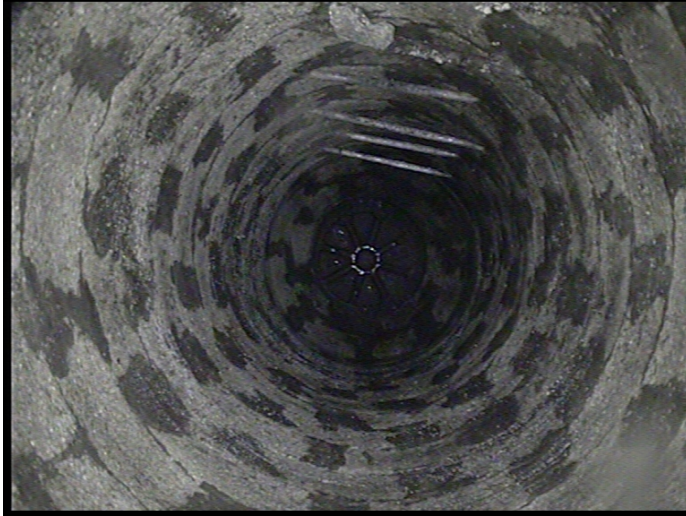
Code:	AMH
Description:	Manhole
Distance (ft):	236.6
Structural Grade:	0
O&M Grade:	0
Clock Start/From:	
Clock To:	
1st Value:	
2nd Value:	
Value Percent:	
Continuous Index:	
Within 8" of Joint:	NO
Remarks:	M-504-025
