Profile/Photo Observation Report

Date:	04/14/2018	Weather:		Coding:	PACP 6.0
Pipe Length (ft):		Owner:	City of Hobart	Pre Clean:	No Pre-Cleaning
P.O.#:	48-2	Surveyor:	M. Pielacha	PSR:	M-504-027-M-504-026
Customer:	City of Hobart	Clean Date:		Shape:	C

Street:	Cleveland Avenue	Flow Control:	Not Controlled
City:	Hobart, IN	Year Renewed:	
Location:	Light Highway	Tape/Media #:	DEP 48
Purpose:	Routine Assessment	Dia/Height:	18"
Use:	Sanitary	Material:	VCP
Drain Area:		Lining:	
Category:	NA		
Comment:			
Location Details:		Direction of Survey:	Downstream
US MH:	M-504-027	DS MH:	M-504-026
		Total Length Surveyed (ft):	160.5

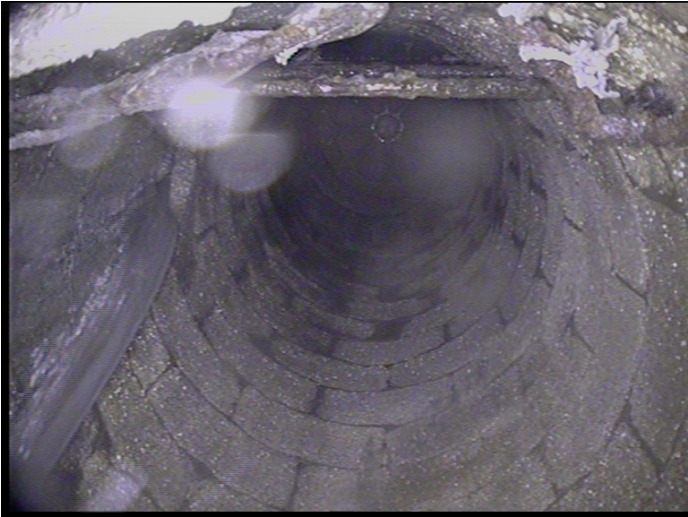
Code:	AMH
Description:	Manhole
Distance (ft):	.0
Structural Grade:	0
O&M Grade:	0
Clock Start/From:	
Clock To:	
1st Value:	
2nd Value:	
Value Percent:	
Continuous Index:	
Within 8" of Joint:	NO
Remarks:	M-504-027

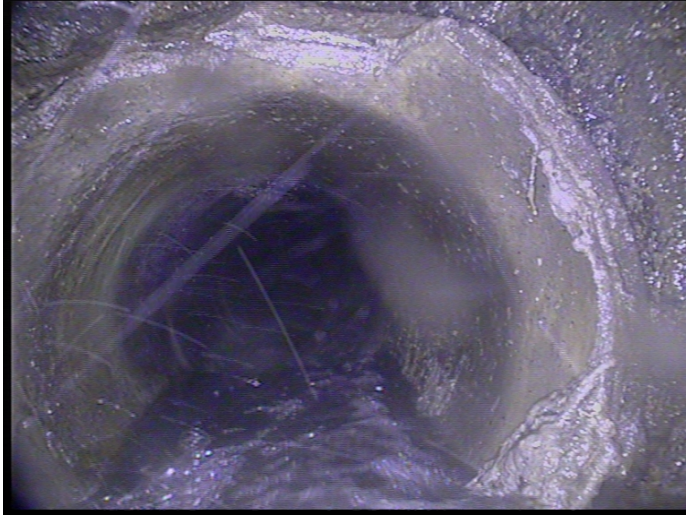
Code: **MWL**
Description: **Water Level**

Distance (ft): **.0**
Structural Grade: **0**
O&M Grade: **0**
Clock Start/From:
Clock To:
1st Value:
2nd Value:
Value Percent: **5.000**
Continuous Index:
Within 8" of Joint: **NO**
Remarks:

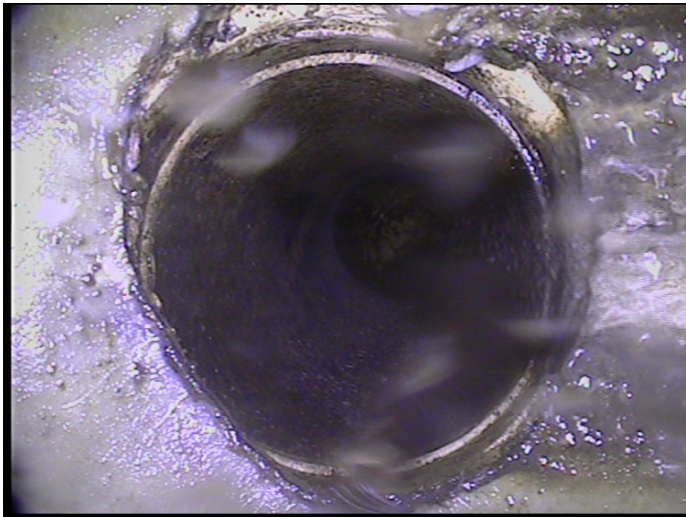
Code: **TBA**
Description: **Tap Break-in Active**

Distance (ft): **107.1**
Structural Grade: **0**
O&M Grade: **0**
Clock Start/From: **2**
Clock To:
1st Value: **4.000**
2nd Value:
Value Percent:
Continuous Index:
Within 8" of Joint: **NO**
Remarks:

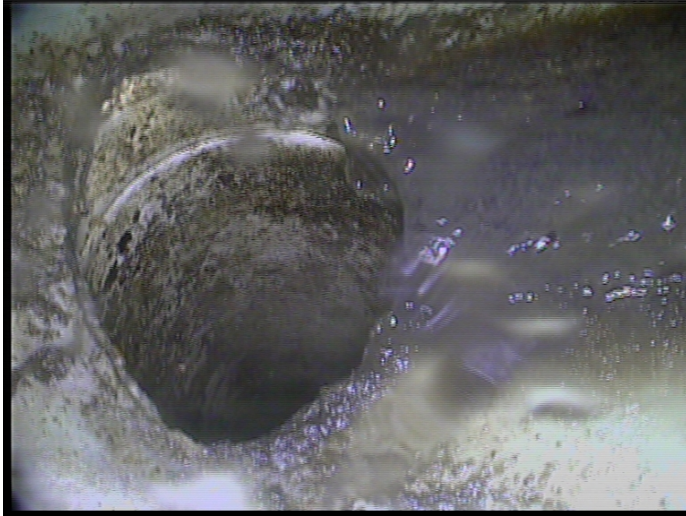
Code: **TBA**
Description: **Tap Break-in Active**

Distance (ft): **134.4**
Structural Grade: **0**
O&M Grade: **0**
Clock Start/From: **2**
Clock To:
1st Value: **4.000**
2nd Value:
Value Percent:
Continuous Index:
Within 8" of Joint: **NO**
Remarks:

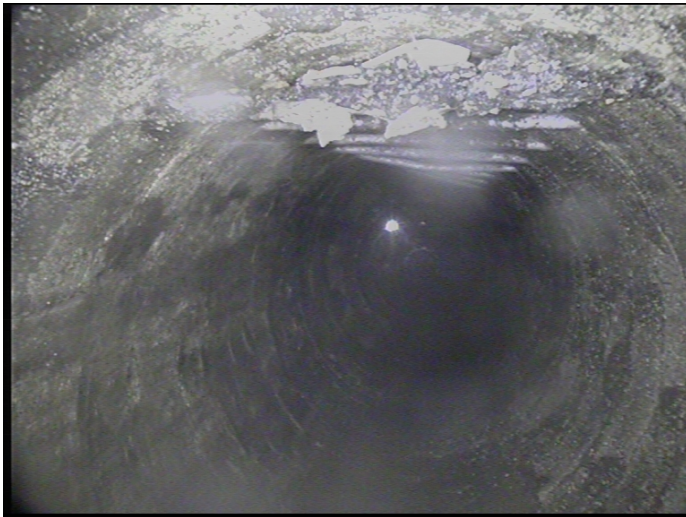
Code: **AMH**
Description: **Manhole**

Distance (ft): **160.5**
Structural Grade: **0**
O&M Grade: **0**
Clock Start/From:
Clock To:
1st Value:
2nd Value:
Value Percent:
Continuous Index:
Within 8" of Joint: **NO**
Remarks: **M-504-026**
