Profile/Photo Observation Report

Date:	04/14/2018	Weather:		Coding:	PACP 6.0
Pipe Length (ft):		Owner:	City of Hobart	Pre Clean:	No Pre-Cleaning
P.O.#:	48-2	Surveyor:	M. Pielacha	PSR:	M-504-027-M-504-026
Customer:	City of Hobart	Clean Date:		Shape:	C

Street:	Cleveland Avenue	Flow Control:	Not Controlled
City:	Hobart, IN	Year Renewed:	
Location:	Light Highway	Tape/Media #:	DEP 48
Purpose:	Routine Assessment	Dia/Height:	18"
Use:	Sanitary	Material:	VCP
Drain Area:		Lining:

US MH: **M-504-027** DS MH: **M-504-026** Total Length Surveyed (ft): **160.5**

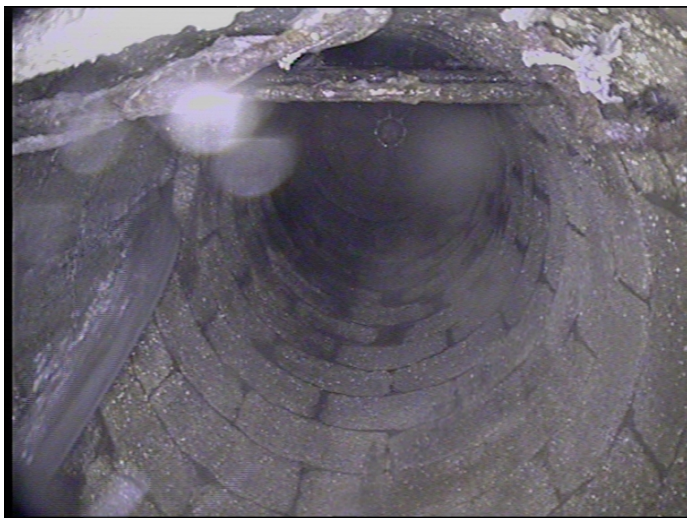
Code: **AMH**
Description: **Manhole**

Distance (ft): **.0**
Structural Grade: **0**
O&M Grade: **0**
Clock Start/From:
Clock To:
1st Value:
2nd Value:
Value Percent:
Continuous Index:
Within 8" of Joint: **NO**
Remarks: **M-504-027**
