Profile/Photo Observation Report

Street:	ALLEY BETWEEN N COLORADO ST &	Flow Control:	Not Controlled
City:	Hobart, IN	Year Renewed:	
Location:	Alley	Tape/Media #:	
Purpose:	Routine Assessment	Dia/Height:	12"
Use:	Sanitary	Material:	VCP
Drain Area:	NA	Lining:	
Category:	NA		
Comment:	P_C at 6 ft roots . Flow direction wrong		
Location Details:		Direction of Survey:	Downstream
US MH:	M-504-031	DS MH:	M-504-032
		Total Length Surveyed (ft):	7.9

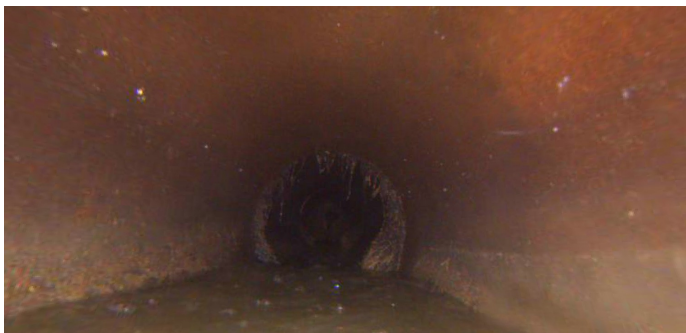
Code: **AMH**
Description: **Manhole**

Distance (ft): **.0**
Structural Grade: **0**
O&M Grade: **0**
Clock Start/From:
Clock To:
1st Value:
2nd Value:
Value Percent:
Continuous Index:
Within 8" of Joint: **NO**
Remarks: **M-504-031**

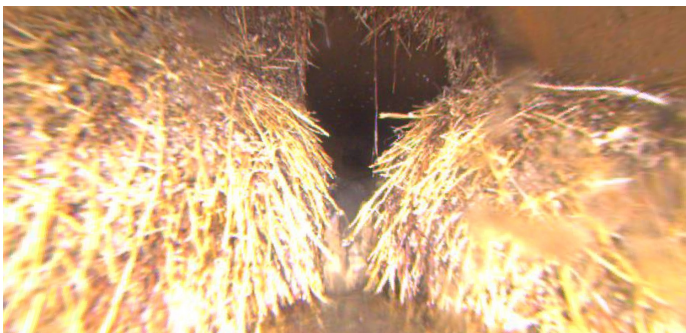
Code: **RBJ**
Description: **Roots Ball Joint**

Distance (ft): **7.3**
Structural Grade: **0**
O&M Grade: **4**
Clock Start/From: **12**
Clock To: **12**
1st Value:
2nd Value:
Value Percent: **80.000**
Continuous Index:
Within 8" of Joint: **YES**
Remarks:

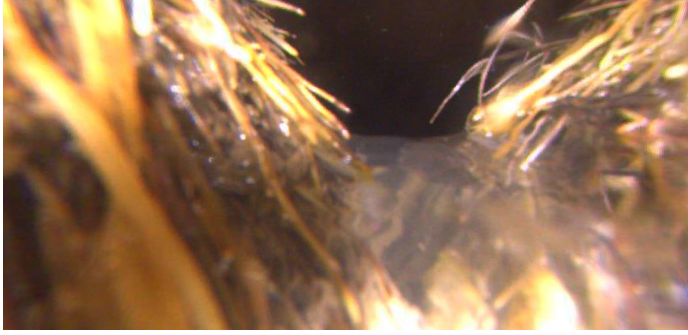
Code:	MSA
Description:	Abandoned Survey
Distance (ft):	7.9
Structural Grade:	0
O&M Grade:	0
Clock Start/From:	
Clock To:	
1st Value:	
2nd Value:	
Value Percent:	
Continuous Index:	
Within 8" of Joint:	NO
Remarks:	roots
