## Profile/Photo Observation Report

Street:	<b>FOXCROFT STREET</b>	Flow Control:	<b>Not Controlled</b>
City:	<b>Hobart, IN</b>	Year Renewed:	
Location:	<b>Alley</b>	Tape/Media #:	
Purpose:	<b>Routine Assessment</b>	Dia/Height:	<b>12"</b>
Use:	<b>Sanitary</b>	Material:	<b>VCP</b>
Drain Area:	<b>NA</b>	Lining:	
Category:	<b>NA</b>		
Comment:	<b>P_C at 6 ft roots . Flow direction wrong</b>		
Location Details:		Direction of Survey:	<b>Downstream</b>
US MH:	<b>M-504-031</b>	DS MH:	<b>M-504-032</b>
		Total Length Surveyed (ft):	<b>7.9</b>

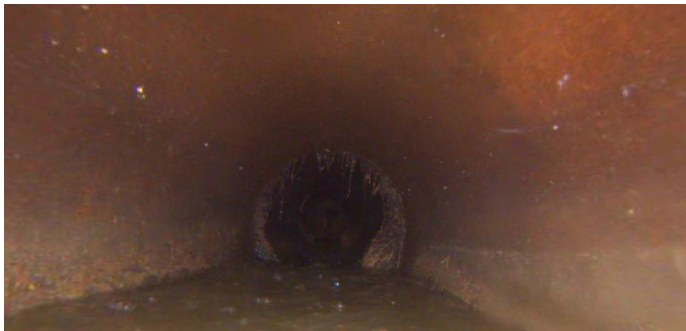
Code: **AMH**  
Description: **Manhole**

Distance (ft): **.0**  
Structural Grade: **0**  
O&M Grade: **0**  
Clock Start/From:  
Clock To:  
1st Value:  
2nd Value:  
Value Percent:  
Continuous Index:  
Within 8" of Joint: **NO**  
Remarks: **M-504-031**

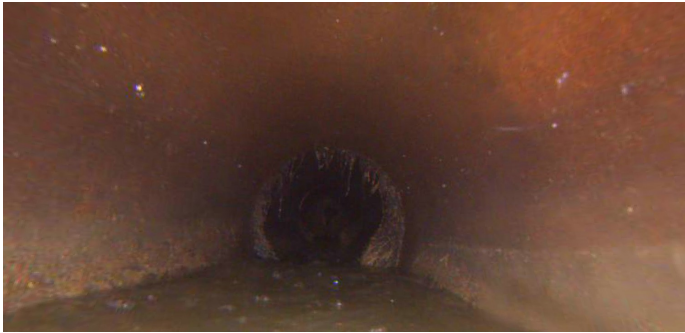
Code:	<b>MWL</b>
Description:	<b>Water Level</b>

Distance (ft):	<b>.0</b>
Structural Grade:	<b>0</b>
O&M Grade:	<b>0</b>
Clock Start/From:	
Clock To:	
1st Value:	
2nd Value:	
Value Percent:	<b>30.000</b>
Continuous Index:	
Within 8" of Joint:	<b>NO</b>
Remarks:

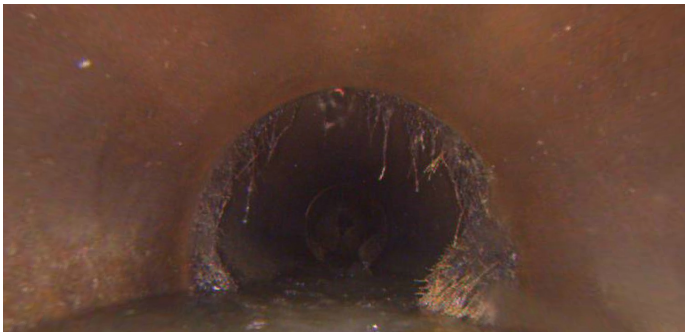
Code:	<b>RMJ</b>
Description:	<b>Roots Medium Joint</b>

Distance (ft):	<b>2.2</b>
Structural Grade:	<b>0</b>
O&M Grade:	<b>3</b>
Clock Start/From:	<b>8</b>
Clock To:	<b>4</b>
1st Value:	
2nd Value:	
Value Percent:	<b>10.000</b>
Continuous Index:	
Within 8" of Joint:	<b>YES</b>
Remarks:

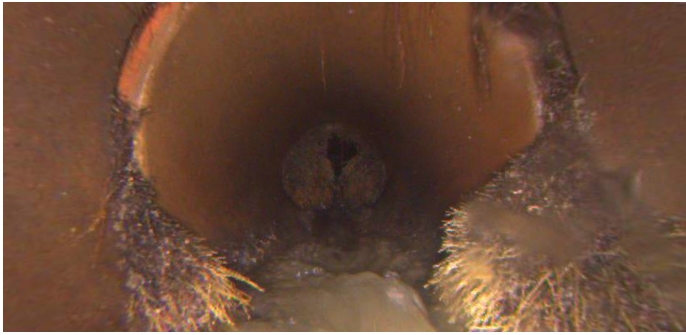
Code: **RMJ**  
Description: **Roots Medium Joint**

Distance (ft): **4.9**  
Structural Grade: **0**  
O&M Grade: **3**  
Clock Start/From: **8**  
Clock To: **4**  
1st Value:  
2nd Value:  
Value Percent: **10.000**  
Continuous Index:  
Within 8" of Joint: **YES**  
Remarks:

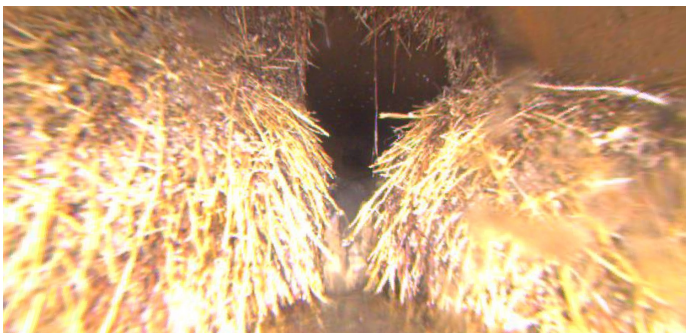
Code: **RBJ**  
Description: **Roots Ball Joint**

Distance (ft): **7.3**  
Structural Grade: **0**  
O&M Grade: **4**  
Clock Start/From: **12**  
Clock To: **12**  
1st Value:  
2nd Value:  
Value Percent: **80.000**  
Continuous Index:  
Within 8" of Joint: **YES**  
Remarks:

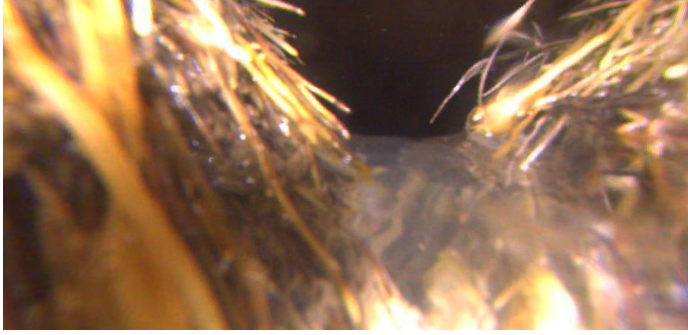
Code:	<b>MSA</b>
Description:	<b>Abandoned Survey</b>
Distance (ft):	<b>7.9</b>
Structural Grade:	<b>0</b>
O&M Grade:	<b>0</b>
Clock Start/From:	
Clock To:	
1st Value:	
2nd Value:	
Value Percent:	
Continuous Index:	
Within 8" of Joint:	<b>NO</b>
Remarks:	<b>roots</b>
