## Profile/Photo Observation Report

Date:	<b>04/24/2018</b>	Weather:		Coding:	<b>PACP 6.0</b>
Pipe Length (ft):	<b>156.1</b>	Owner:	<b>NA</b>	Pre Clean:	<b>No Pre-Cleaning</b>
P.O.#:		Surveyor:	<b>Jen Costello</b>	PSR:	<b>P-504-033-032</b>
Customer:		Clean Date:	<b>01/01/1900</b>	Shape:	<b>C</b>

Street:	<b>W HOME AVE</b>	Flow Control:	<b>Not Controlled</b>
City:	<b>Hobart, IN</b>	Year Renewed:	
Location:	<b>Light Highway</b>	Tape/Media #:	
Purpose:	<b>Routine Assessment</b>	Dia/Height:	<b>12"</b>
Use:	<b>Sanitary</b>	Material:	<b>VCP</b>
Drain Area:	<b>NA</b>	Lining:	
Category:	<b>NA</b>		
Comment:	<b>Flow direction wrong</b>		
Location Details:		Direction of Survey:	<b>Upstream</b>
US MH:	<b>M-504-032</b>	DS MH:	<b>M-504-033</b>
		Total Length Surveyed (ft):	<b>162.9</b>

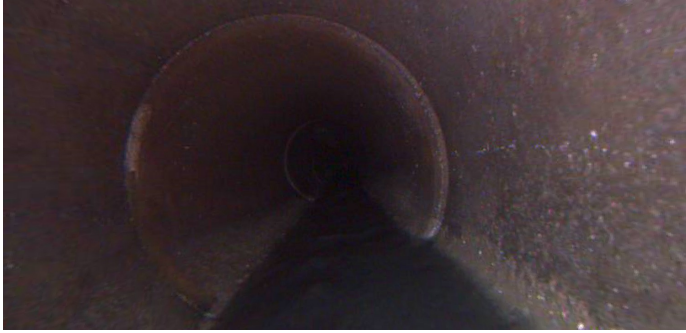
Code: **AMH**  
Description: **Manhole**

Distance (ft): **.0**  
Structural Grade: **0**  
O&M Grade: **0**  
Clock Start/From:  
Clock To:  
1st Value:  
2nd Value:  
Value Percent:  
Continuous Index:  
Within 8" of Joint: **NO**  
Remarks: **M-504-033**

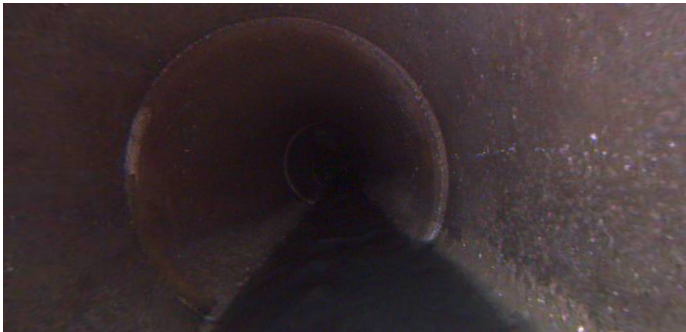
Code: **MWL**  
Description: **Water Level**

Distance (ft): **.0**  
Structural Grade: **0**  
O&M Grade: **0**  
Clock Start/From:  
Clock To:  
1st Value:  
2nd Value:  
Value Percent: **10.000**  
Continuous Index:  
Within 8" of Joint: **NO**  
Remarks:

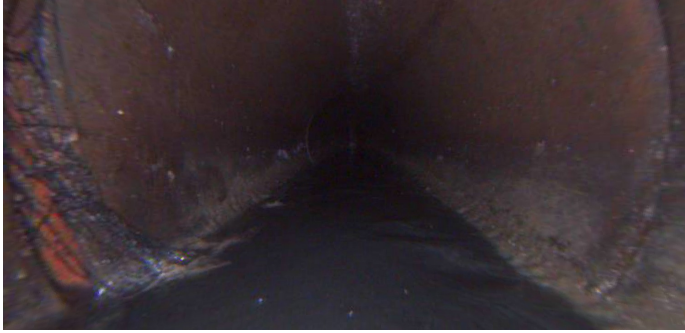
Code: **RFJ**  
Description: **Roots Fine Joint**

Distance (ft): **6.5**  
Structural Grade: **0**  
O&M Grade: **1**  
Clock Start/From: **8**  
Clock To: **4**  
1st Value:  
2nd Value:  
Value Percent:  
Continuous Index:  
Within 8" of Joint: **YES**  
Remarks:

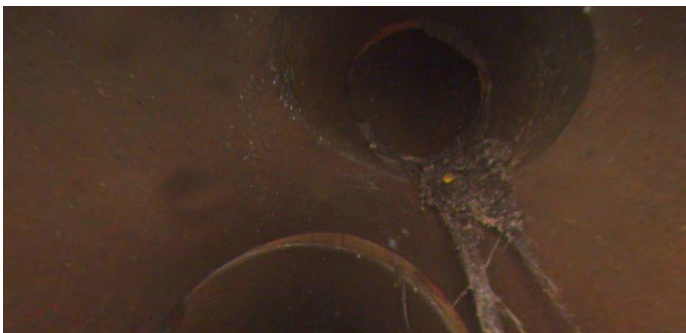
Code: **RFL**  
Description: **Roots Fine Lateral**

Distance (ft): **52.3**  
Structural Grade: **0**  
O&M Grade: **1**  
Clock Start/From: **12**  
Clock To:  
1st Value:  
2nd Value:  
Value Percent:  
Continuous Index:  
Within 8" of Joint: **NO**  
Remarks:

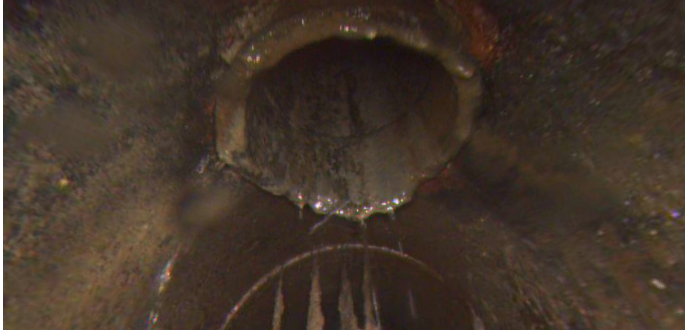
Code: **TBI**  
Description: **Tap Break-in Intruding**

Distance (ft): **57.0**  
Structural Grade: **0**  
O&M Grade: **2**  
Clock Start/From: **12**  
Clock To:  
1st Value: **4.000**  
2nd Value: **1.000**  
Value Percent:  
Continuous Index:  
Within 8" of Joint:  
Remarks:

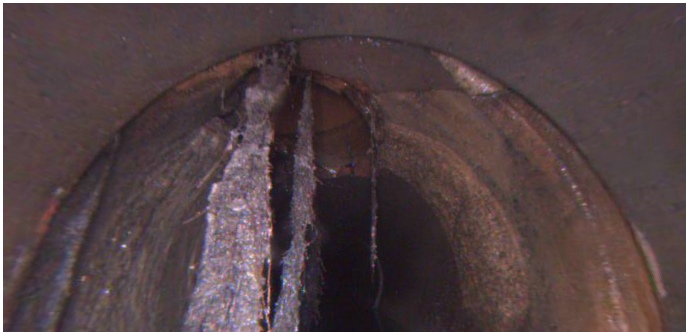
Code: **RMJ**  
Description: **Roots Medium Joint**

Distance (ft): **78.7**  
Structural Grade: **0**  
O&M Grade: **3**  
Clock Start/From: **12**  
Clock To:  
1st Value:  
2nd Value:  
Value Percent: **10.000**  
Continuous Index:  
Within 8" of Joint: **YES**  
Remarks:

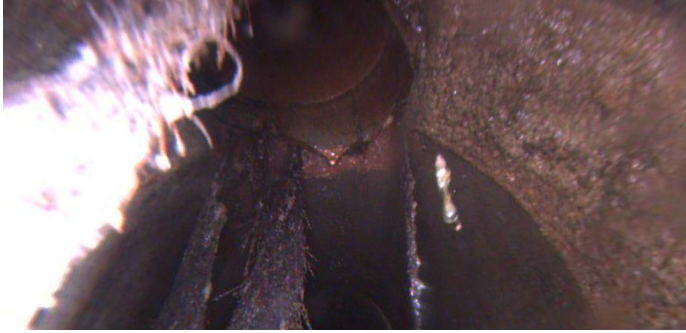
Code: **TBD**  
Description: **Tap Break-in Defective**

Distance (ft): **79.2**  
Structural Grade: **0**  
O&M Grade: **3**  
Clock Start/From: **12**  
Clock To:  
1st Value: **4.000**  
2nd Value:  
Value Percent:  
Continuous Index:  
Within 8" of Joint:  
Remarks: **roots**

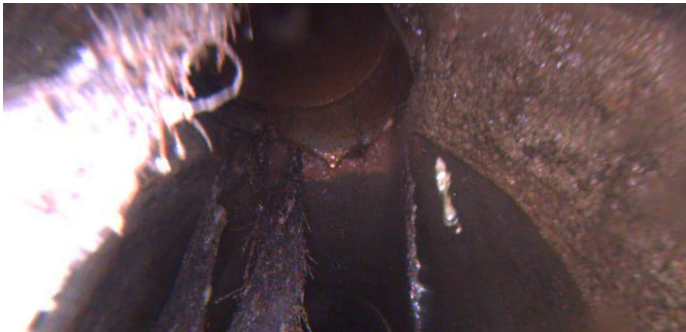
Code: **RML**  
Description: **Roots Medium Lateral**

Distance (ft): **79.2**  
Structural Grade: **0**  
O&M Grade: **3**  
Clock Start/From: **12**  
Clock To:  
1st Value:  
2nd Value:  
Value Percent: **20.000**  
Continuous Index:  
Within 8" of Joint: **NO**  
Remarks:

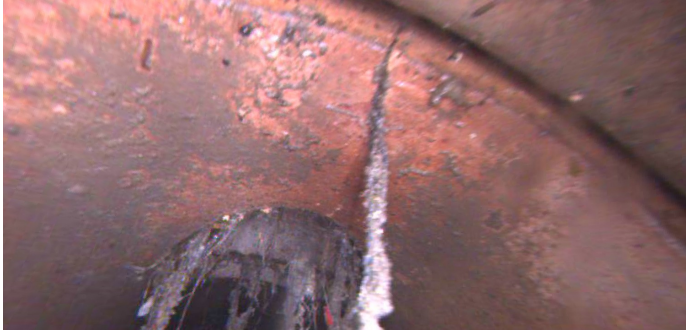
Code: **RFJ**  
Description: **Roots Fine Joint**

Distance (ft): **89.5**  
Structural Grade: **0**  
O&M Grade: **1**  
Clock Start/From: **12**  
Clock To:  
1st Value:  
2nd Value:  
Value Percent:  
Continuous Index:  
Within 8" of Joint: **YES**  
Remarks:

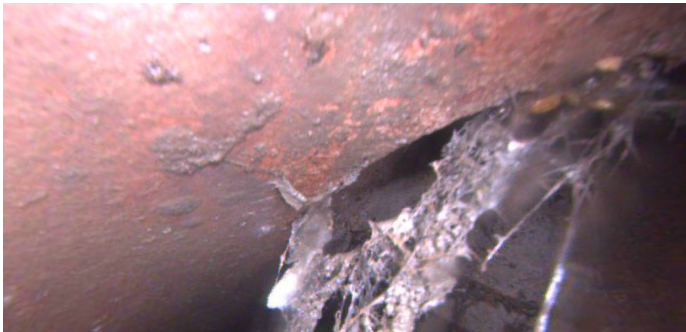
Code: **TFD**  
Description: **Tap Factory Defective**

Distance (ft): **90.1**  
Structural Grade: **0**  
O&M Grade: **2**  
Clock Start/From: **12**  
Clock To:  
1st Value: **4.000**  
2nd Value:  
Value Percent:  
Continuous Index:  
Within 8" of Joint:  
Remarks: **roots**

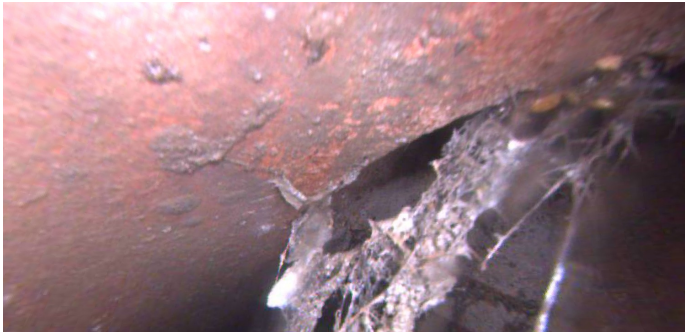
Code: **RML**  
Description: **Roots Medium Lateral**

Distance (ft): **90.1**  
Structural Grade: **0**  
O&M Grade: **3**  
Clock Start/From: **11**  
Clock To: **1**  
1st Value:  
2nd Value:  
Value Percent: **10.000**  
Continuous Index:  
Within 8" of Joint: **NO**  
Remarks:

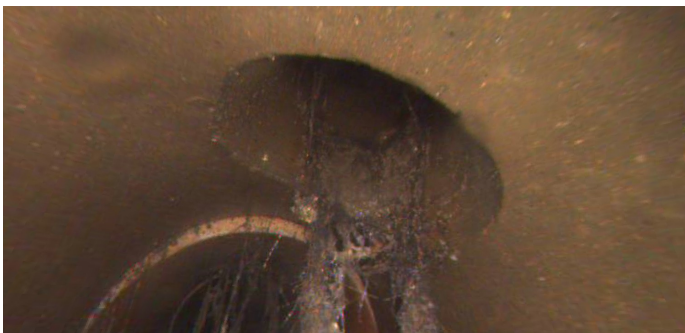
Code: **TFD**  
Description: **Tap Factory Defective**

Distance (ft): **93.0**  
Structural Grade: **0**  
O&M Grade: **2**  
Clock Start/From: **12**  
Clock To:  
1st Value: **4.000**  
2nd Value:  
Value Percent:  
Continuous Index:  
Within 8" of Joint:  
Remarks: **roots**

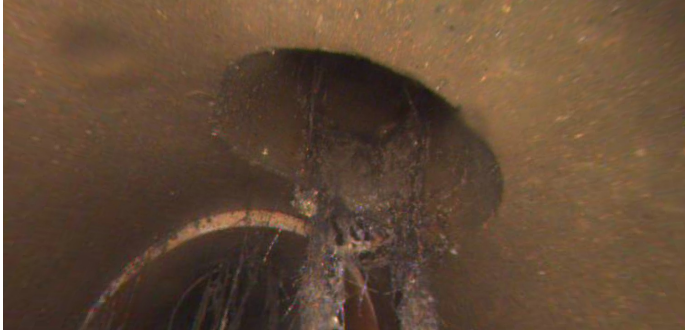
Code: **RML**  
Description: **Roots Medium Lateral**

Distance (ft): **93.0**  
Structural Grade: **0**  
O&M Grade: **3**  
Clock Start/From: **11**  
Clock To: **1**  
1st Value:  
2nd Value:  
Value Percent: **10.000**  
Continuous Index:  
Within 8" of Joint: **NO**  
Remarks:

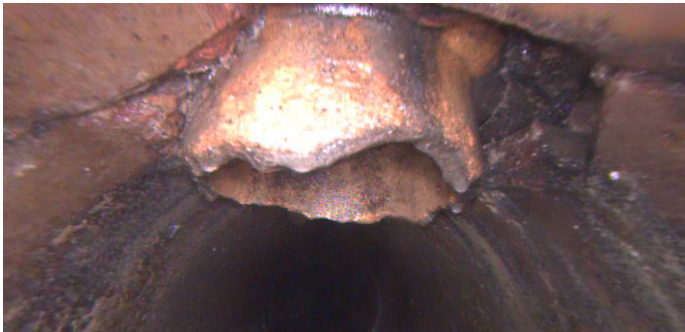
Code: **TBI**  
Description: **Tap Break-in Intruding**

Distance (ft): **99.0**  
Structural Grade: **0**  
O&M Grade: **2**  
Clock Start/From: **12**  
Clock To:  
1st Value: **4.000**  
2nd Value: **1.000**  
Value Percent:  
Continuous Index:  
Within 8" of Joint:  
Remarks:

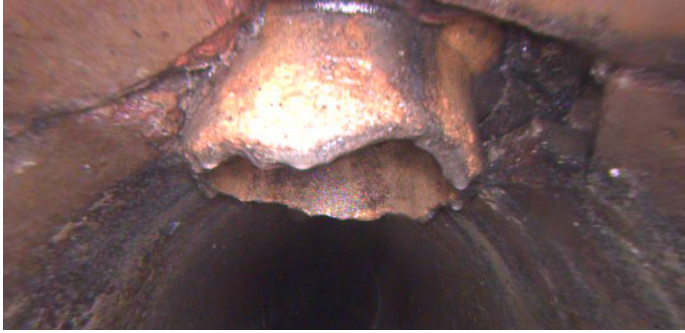
Code: HSV  
Description: Hole Soil Visible

Distance (ft): 99.0  
Structural Grade: 5  
O&M Grade: 0  
Clock Start/From: 12  
Clock To: 1  
1st Value:  
2nd Value:  
Value Percent:  
Continuous Index:  
Within 8" of Joint: YES  
Remarks:

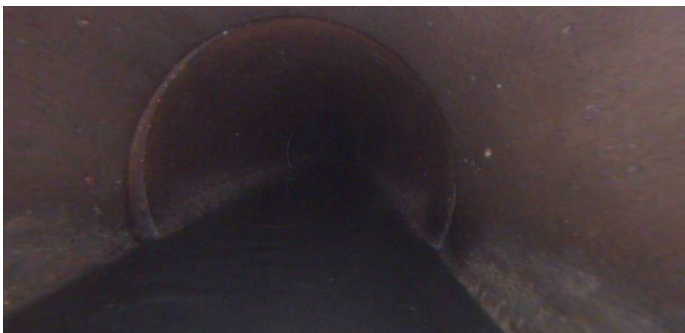
Code: RFJ  
Description: Roots Fine Joint

Distance (ft): 108.6  
Structural Grade: 0  
O&M Grade: 1  
Clock Start/From: 8  
Clock To: 4  
1st Value:  
2nd Value:  
Value Percent:  
Continuous Index: F02  
Within 8" of Joint: YES  
Remarks:

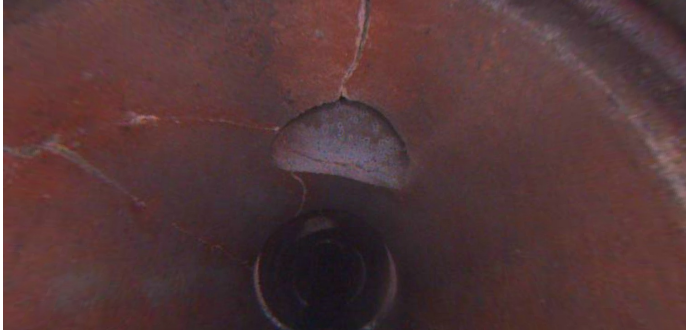
Code: **FM**  
Description: **Fracture Multiple**

Distance (ft): **127.5**  
Structural Grade: **4**  
O&M Grade: **0**  
Clock Start/From: **8**  
Clock To: **4**  
1st Value:  
2nd Value:  
Value Percent:  
Continuous Index: **S03**  
Within 8" of Joint: **YES**  
Remarks:

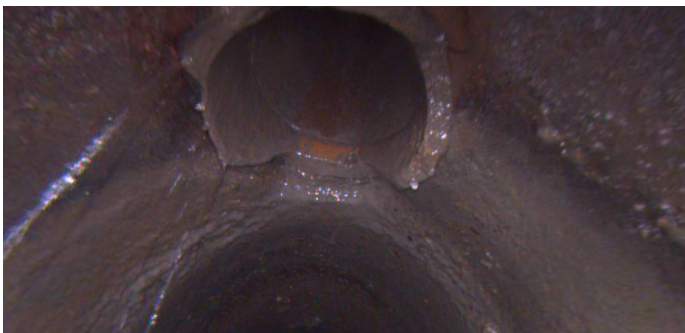
Code: **TBI**  
Description: **Tap Break-in Intruding**

Distance (ft): **132.3**  
Structural Grade: **0**  
O&M Grade: **2**  
Clock Start/From: **12**  
Clock To:  
1st Value: **4.000**  
2nd Value: **1.000**  
Value Percent:  
Continuous Index:  
Within 8" of Joint:  
Remarks:

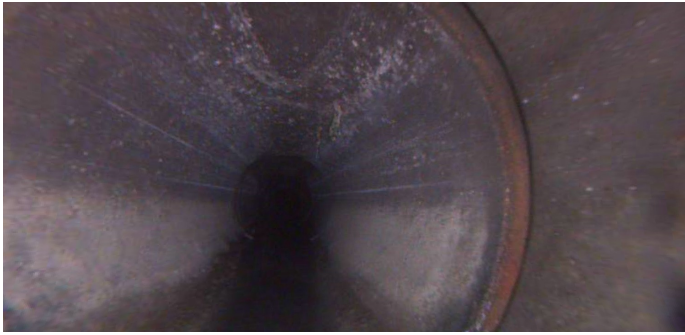
Code: **FM**  
Description: **Fracture Multiple**

Distance (ft): **149.9**  
Structural Grade: **4**  
O&M Grade: **0**  
Clock Start/From: **8**  
Clock To: **4**  
1st Value:  
2nd Value:  
Value Percent:  
Continuous Index: **F03**  
Within 8" of Joint: **YES**  
Remarks:

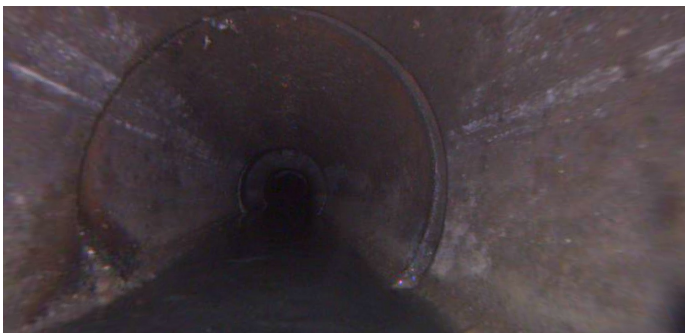
Code: **IW**  
Description: **Infil Weeper**

Distance (ft): **154.8**  
Structural Grade: **0**  
O&M Grade: **2**  
Clock Start/From: **8**  
Clock To: **9**  
1st Value:  
2nd Value:  
Value Percent:  
Continuous Index:  
Within 8" of Joint: **YES**  
Remarks:

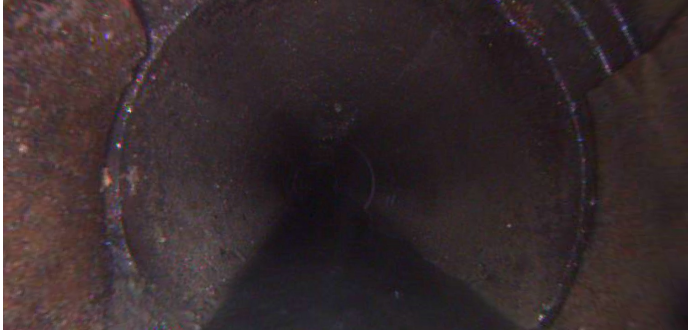
Code:	<b>AMH</b>
Description:	<b>Manhole</b>
Distance (ft):	<b>162.9</b>
Structural Grade:	<b>0</b>
O&M Grade:	<b>0</b>
Clock Start/From:	
Clock To:	
1st Value:	
2nd Value:	
Value Percent:	
Continuous Index:	
Within 8" of Joint:	<b>NO</b>
Remarks:	<b>M-504-032</b>
