Profile/Photo Observation Report

Street:	FOXCROFT STREET	Flow Control:	Not Controlled
City:	Hobart, IN	Year Renewed:	
Location:	Light Highway	Tape/Media #:	
Purpose:	Routine Assessment	Dia/Height:	12"
Use:	Sanitary	Material:	VCP
Drain Area:	NA	Lining:	
Category:	NA		
Comment:	P_C at 21 ft debris Flow direction wrong		
Location Details:		Direction of Survey:	Downstream
US MH:	M-504-033	DS MH:	M-504-045
		Total Length Surveyed (ft):	22.4

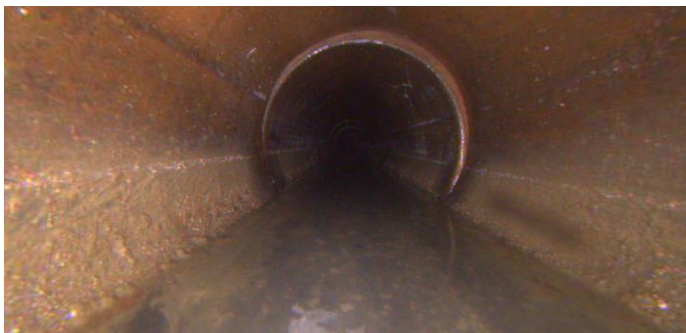
Code: **AMH**
Description: **Manhole**

Distance (ft): **.0**
Structural Grade: **0**
O&M Grade: **0**
Clock Start/From:
Clock To:
1st Value:
2nd Value:
Value Percent:
Continuous Index:
Within 8" of Joint: **NO**
Remarks: **M-504-033**

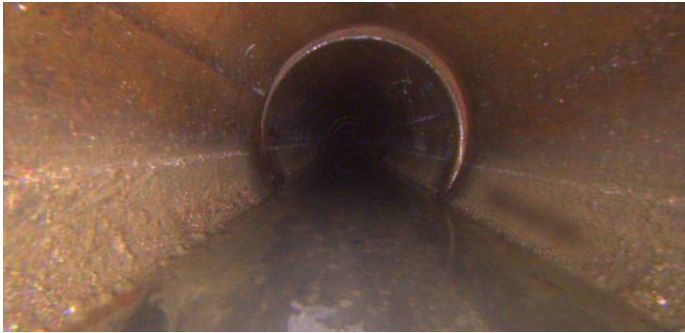
Code:	MWL
Description:	Water Level

Distance (ft):	.0
Structural Grade:	0
O&M Grade:	0
Clock Start/From:	
Clock To:	
1st Value:	
2nd Value:	
Value Percent:	10.000
Continuous Index:	
Within 8" of Joint:	NO
Remarks:

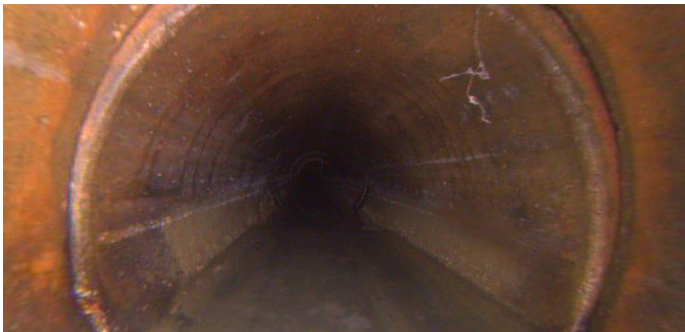
Code:	RFJ
Description:	Roots Fine Joint

Distance (ft):	2.0
Structural Grade:	0
O&M Grade:	1
Clock Start/From:	8
Clock To:	4
1st Value:	
2nd Value:	
Value Percent:	
Continuous Index:	S01
Within 8" of Joint:	YES
Remarks:

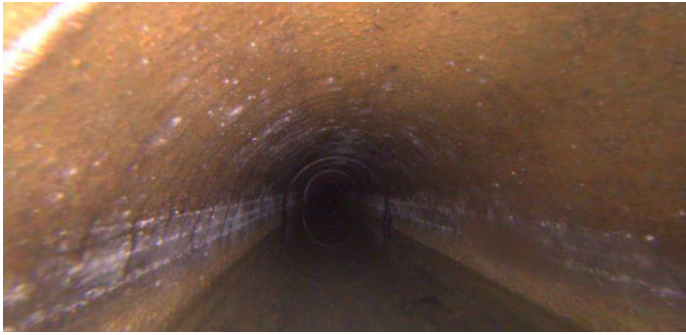
Code: **RFJ**
Description: **Roots Fine Joint**

Distance (ft): **17.2**
Structural Grade: **0**
O&M Grade: **1**
Clock Start/From: **8**
Clock To: **4**
1st Value:
2nd Value:
Value Percent:
Continuous Index: **F01**
Within 8" of Joint: **YES**
Remarks:

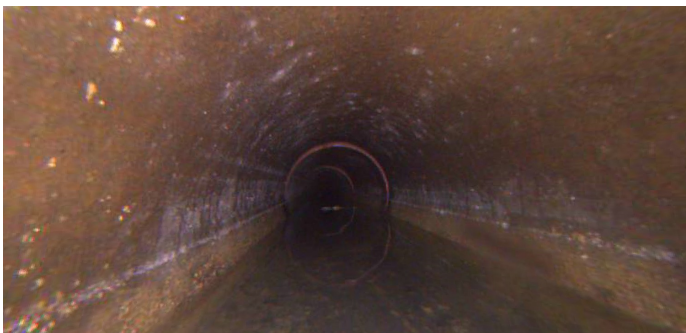
Code: **MSA**
Description: **Abandoned Survey**

Distance (ft): **22.4**
Structural Grade: **0**
O&M Grade: **0**
Clock Start/From:
Clock To:
1st Value:
2nd Value:
Value Percent:
Continuous Index:
Within 8" of Joint: **NO**
Remarks: **unknown**
