## Profile/Photo Observation Report

Street:	<b>W CLEVELAND AVE &amp; N CAVENDER S</b>	Flow Control:	<b>Not Controlled</b>
City:	<b>Hobart, IN</b>	Year Renewed:	
Location:	<b>Light Highway</b>	Tape/Media #:	
Purpose:	<b>Routine Assessment</b>	Dia/Height:	<b>10"</b>
Use:	<b>Sanitary</b>	Material:	<b>VCP</b>
Drain Area:	<b>NA</b>	Lining:	
Category:	<b>NA</b>		
Comment:	<b>R_M at 7 ft debris and roots</b>		
Location Details:		Direction of Survey:	<b>Upstream</b>
US MH:	<b>M-504-034</b>	DS MH:	<b>M-504-041</b>
		Total Length Surveyed (ft):	<b>8.1</b>

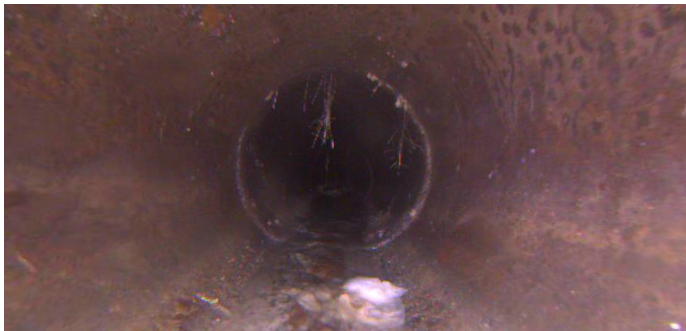
Code: **AMH**  
Description: **Manhole**

Distance (ft): **.0**  
Structural Grade: **0**  
O&M Grade: **0**  
Clock Start/From:  
Clock To:  
1st Value:  
2nd Value:  
Value Percent:  
Continuous Index:  
Within 8" of Joint: **NO**  
Remarks: **M-504-041**

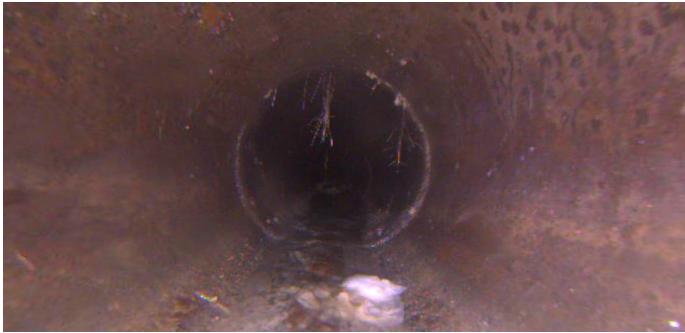
Code:	<b>MWL</b>
Description:	<b>Water Level</b>

Distance (ft):	<b>.0</b>
Structural Grade:	<b>0</b>
O&M Grade:	<b>0</b>
Clock Start/From:	
Clock To:	
1st Value:	
2nd Value:	
Value Percent:	<b>5.000</b>
Continuous Index:	
Within 8" of Joint:	<b>NO</b>
Remarks:

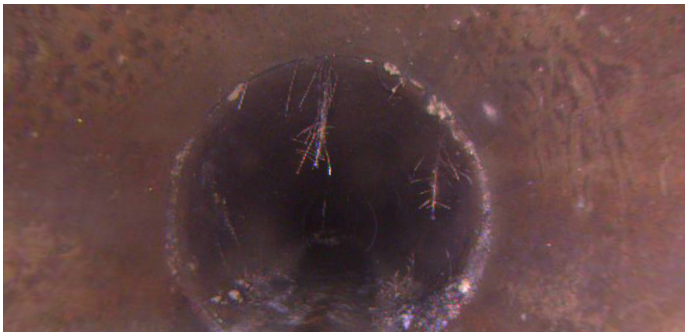
Code:	<b>RFJ</b>
Description:	<b>Roots Fine Joint</b>

Distance (ft):	<b>.8</b>
Structural Grade:	<b>0</b>
O&M Grade:	<b>1</b>
Clock Start/From:	<b>8</b>
Clock To:	<b>4</b>
1st Value:	
2nd Value:	
Value Percent:	
Continuous Index:	<b>S01</b>
Within 8" of Joint:	<b>YES</b>
Remarks:

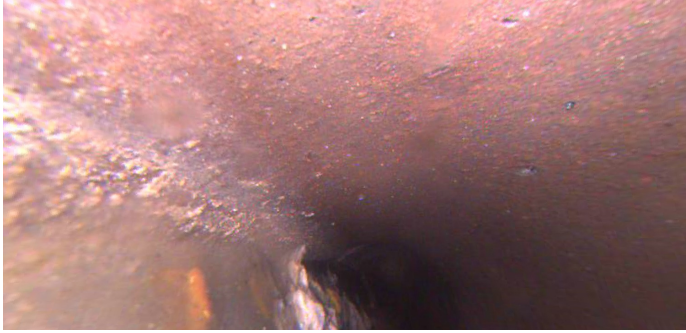
Code: **MSA**  
Description: **Abandoned Survey**

Distance (ft): **8.1**  
Structural Grade: **0**  
O&M Grade: **0**  
Clock Start/From:  
Clock To:  
1st Value:  
2nd Value:  
Value Percent:  
Continuous Index:  
Within 8" of Joint: **NO**  
Remarks: **OVERTURNED**

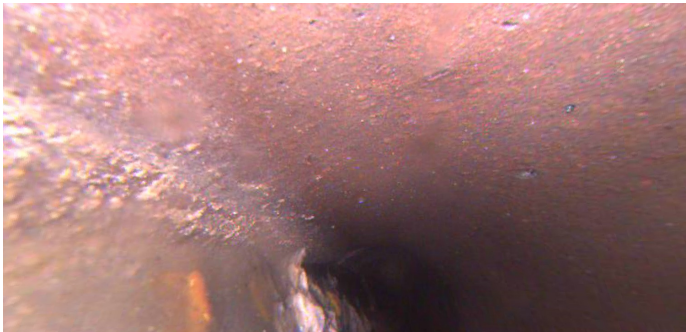
Code: **RFJ**  
Description: **Roots Fine Joint**

Distance (ft): **8.1**  
Structural Grade: **0**  
O&M Grade: **1**  
Clock Start/From: **8**  
Clock To: **4**  
1st Value:  
2nd Value:  
Value Percent:  
Continuous Index: **F01**  
Within 8" of Joint: **YES**  
Remarks:
