Profile/Photo Observation Report

Street:	FOXCROFT STREET	Flow Control:	Not Controlled
City:	Hobart, IN	Year Renewed:	
Location:	Light Highway	Tape/Media #:	
Purpose:	Routine Assessment	Dia/Height:	10"
Use:	Sanitary	Material:	VCP
Drain Area:	NA	Lining:	
Category:	NA		
Comment:	P_C at 16 ft depris . Flow direction wrong		
Location Details:		Direction of Survey:	Upstream
US MH:	M-504-036	DS MH:	M-504-037
		Total Length Surveyed (ft):	17.2

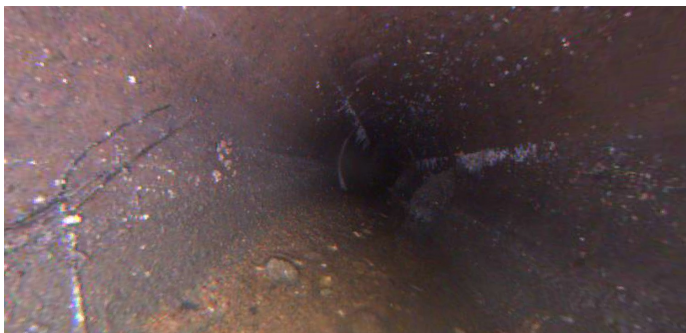
Code: **AMH**
Description: **Manhole**

Distance (ft): **.0**
Structural Grade: **0**
O&M Grade: **0**
Clock Start/From:
Clock To:
1st Value:
2nd Value:
Value Percent:
Continuous Index:
Within 8" of Joint: **NO**
Remarks: **M-504-037**

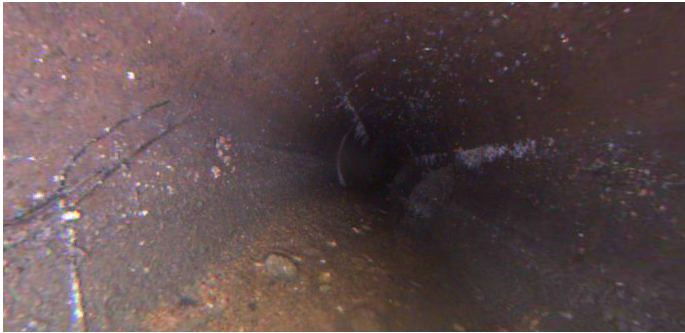
Code:	MWL
Description:	Water Level

Distance (ft):	.0
Structural Grade:	0
O&M Grade:	0
Clock Start/From:	
Clock To:	
1st Value:	
2nd Value:	
Value Percent:	0.000
Continuous Index:	
Within 8" of Joint:	NO
Remarks:

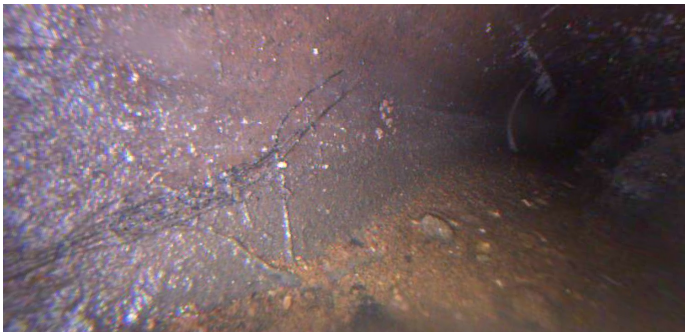
Code:	RFJ
Description:	Roots Fine Joint

Distance (ft):	.0
Structural Grade:	0
O&M Grade:	1
Clock Start/From:	8
Clock To:	9
1st Value:	
2nd Value:	
Value Percent:	
Continuous Index:	
Within 8" of Joint:	YES
Remarks:

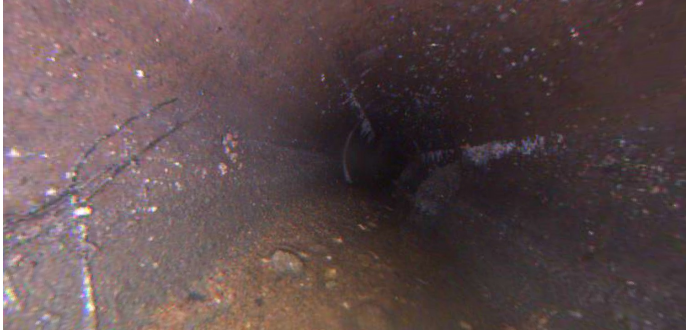
Code: **DSF**
Description: **Deposits Settled Fine**

Distance (ft): **.0**
Structural Grade: **0**
O&M Grade: **2**
Clock Start/From: **5**
Clock To: **7**
1st Value:
2nd Value:
Value Percent: **10.000**
Continuous Index:
Within 8" of Joint: **NO**
Remarks:

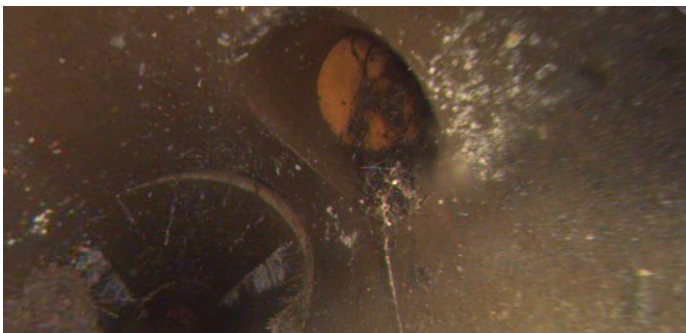
Code: **TFC**
Description: **Tap Factory Capped**

Distance (ft): **6.9**
Structural Grade: **0**
O&M Grade: **0**
Clock Start/From: **10**
Clock To:
1st Value: **4.000**
2nd Value:
Value Percent:
Continuous Index:
Within 8" of Joint:
Remarks: **ROOTS**

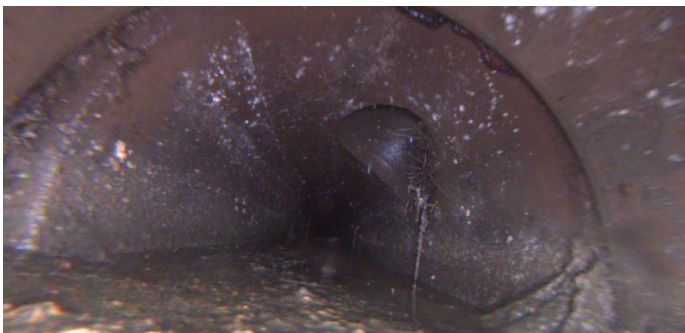
Code: **RFJ**
Description: **Roots Fine Joint**

Distance (ft): **7.8**
Structural Grade: **0**
O&M Grade: **1**
Clock Start/From: **8**
Clock To: **4**
1st Value:
2nd Value:
Value Percent:
Continuous Index:
Within 8" of Joint: **YES**
Remarks:

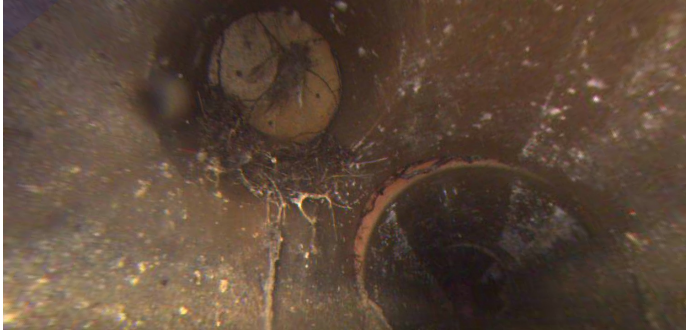
Code: **TFC**
Description: **Tap Factory Capped**

Distance (ft): **9.2**
Structural Grade: **0**
O&M Grade: **0**
Clock Start/From: **2**
Clock To:
1st Value: **4.000**
2nd Value:
Value Percent:
Continuous Index:
Within 8" of Joint:
Remarks:

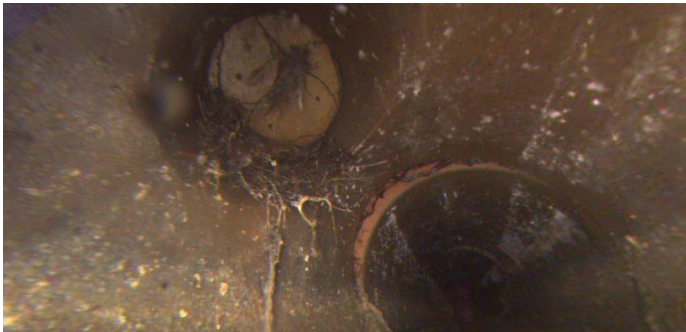
Code: **RFL**
Description: **Roots Fine Lateral**

Distance (ft): **9.2**
Structural Grade: **0**
O&M Grade: **1**
Clock Start/From: **2**
Clock To:
1st Value:
2nd Value:
Value Percent:
Continuous Index:
Within 8" of Joint: **NO**
Remarks:

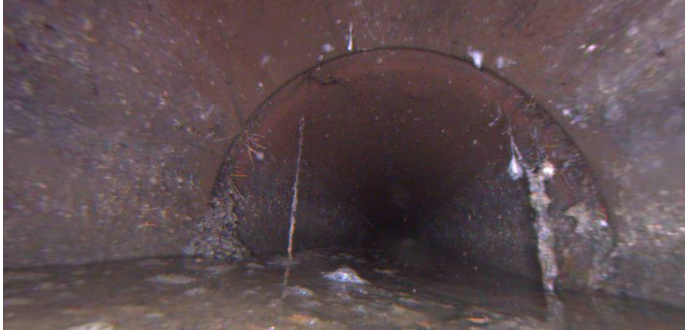
Code: **RFJ**
Description: **Roots Fine Joint**

Distance (ft): **10.2**
Structural Grade: **0**
O&M Grade: **1**
Clock Start/From: **8**
Clock To: **4**
1st Value:
2nd Value:
Value Percent:
Continuous Index:
Within 8" of Joint: **YES**
Remarks:

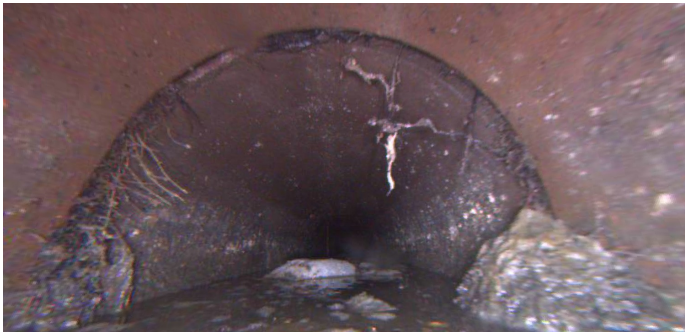
Code: **RMJ**
Description: **Roots Medium Joint**

Distance (ft): **12.8**
Structural Grade: **0**
O&M Grade: **3**
Clock Start/From: **8**
Clock To: **4**
1st Value:
2nd Value:
Value Percent: **10.000**
Continuous Index:
Within 8" of Joint: **YES**
Remarks:

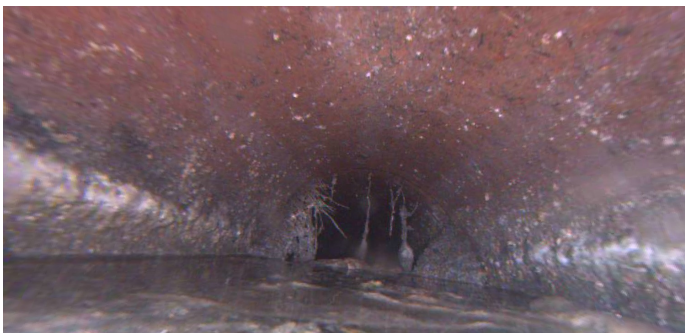
Code: **MSA**
Description: **Abandoned Survey**

Distance (ft): **17.2**
Structural Grade: **0**
O&M Grade: **0**
Clock Start/From:
Clock To:
1st Value:
2nd Value:
Value Percent:
Continuous Index:
Within 8" of Joint: **NO**
Remarks: **DEBRIS UNDER WATER**
