## Profile/Photo Observation Report

Street:	<b>ALLEY BETWEEN W 43RD PL &amp; W HO</b>	Flow Control:	<b>Not Controlled</b>
City:	<b>Hobart, IN</b>	Year Renewed:	
Location:	<b>Light Highway</b>	Tape/Media #:	
Purpose:	<b>Not Known</b>	Dia/Height:	<b>10"</b>
Use:	<b>Sanitary</b>	Material:	<b>PVC</b>
Drain Area:	<b>NA</b>	Lining:	
Category:	<b>NA</b>		
Comment:

Location Details:		Direction of Survey:	<b>Downstream</b>
US MH:	<b>M-504-042</b>	DS MH:	<b>M-504-043</b>
		Total Length Surveyed (ft):	<b>401.5</b>

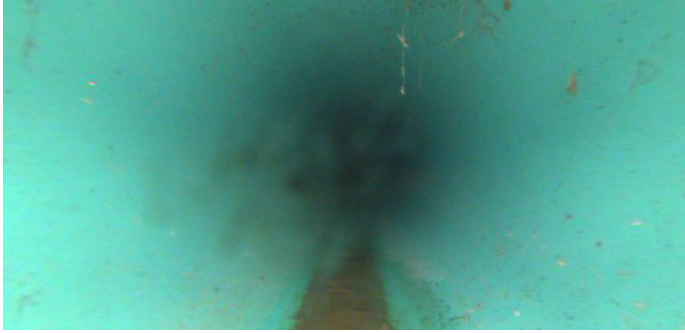
Code: **AMH**  
Description: **Manhole**

Distance (ft): **.0**  
Structural Grade: **0**  
O&M Grade: **0**  
Clock Start/From:  
Clock To:  
1st Value:  
2nd Value:  
Value Percent:  
Continuous Index:  
Within 8" of Joint: **NO**  
Remarks: **M-504-042**

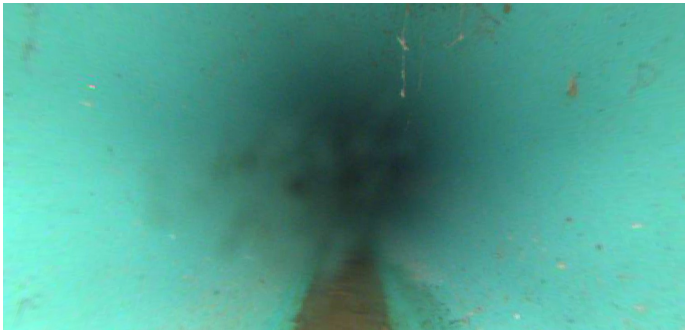
Code: **MWL**  
Description: **Water Level**

Distance (ft): **.0**  
Structural Grade: **0**  
O&M Grade: **0**  
Clock Start/From:  
Clock To:  
1st Value:  
2nd Value:  
Value Percent: **5.000**  
Continuous Index:  
Within 8" of Joint: **NO**  
Remarks:

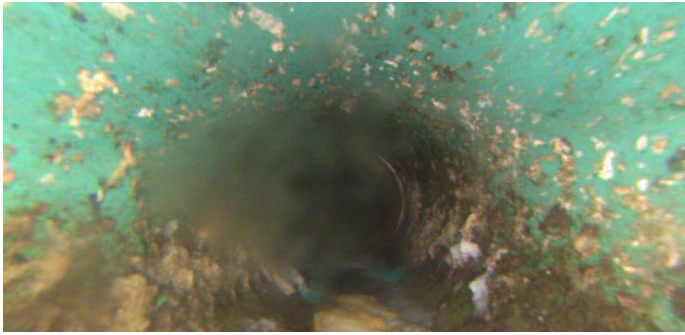
Code: **DAGS**  
Description: **Deposits Attached Grease**

Distance (ft): **13.4**  
Structural Grade: **0**  
O&M Grade: **2**  
Clock Start/From: **8**  
Clock To: **4**  
1st Value:  
2nd Value:  
Value Percent: **5.000**  
Continuous Index:  
Within 8" of Joint: **NO**  
Remarks:

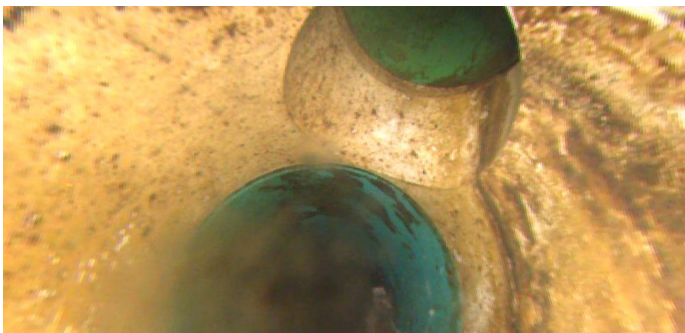
Code: **TF**  
Description: **Tap Factory**

Distance (ft): **15.3**  
Structural Grade: **0**  
O&M Grade: **0**  
Clock Start/From: **1**  
Clock To:  
1st Value: **4.000**  
2nd Value:  
Value Percent:  
Continuous Index:  
Within 8" of Joint:  
Remarks:

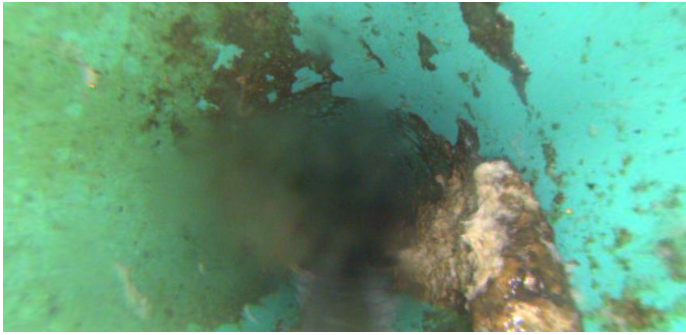
Code: **DAGS**  
Description: **Deposits Attached Grease**

Distance (ft): **16.3**  
Structural Grade: **0**  
O&M Grade: **2**  
Clock Start/From: **8**  
Clock To: **4**  
1st Value:  
2nd Value:  
Value Percent: **10.000**  
Continuous Index:  
Within 8" of Joint: **NO**  
Remarks:

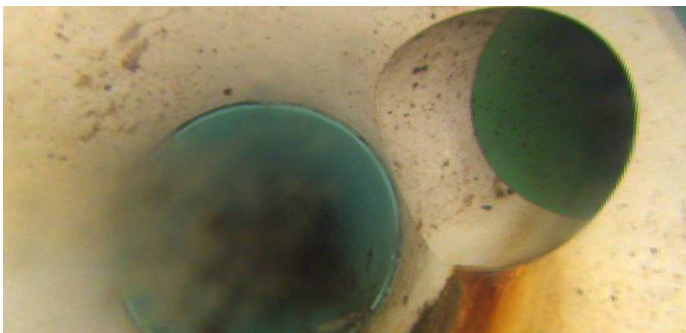
Code: **TF**  
Description: **Tap Factory**

Distance (ft): **40.4**  
Structural Grade: **0**  
O&M Grade: **0**  
Clock Start/From: **3**  
Clock To:  
1st Value: **4.000**  
2nd Value:  
Value Percent:  
Continuous Index:  
Within 8" of Joint:  
Remarks:

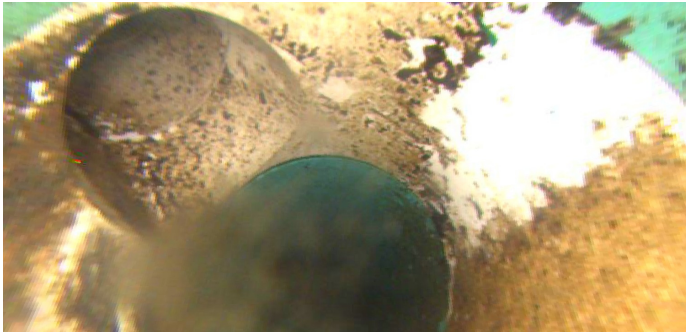
Code: **TF**  
Description: **Tap Factory**

Distance (ft): **43.7**  
Structural Grade: **0**  
O&M Grade: **0**  
Clock Start/From: **10**  
Clock To:  
1st Value: **4.000**  
2nd Value:  
Value Percent:  
Continuous Index:  
Within 8" of Joint:  
Remarks:

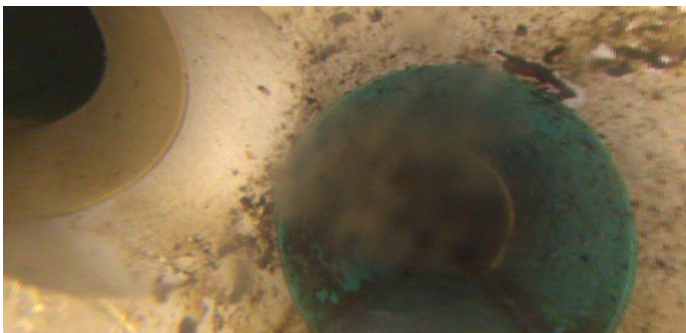
Code: **TF**  
Description: **Tap Factory**

Distance (ft): **84.8**  
Structural Grade: **0**  
O&M Grade: **0**  
Clock Start/From: **9**  
Clock To:  
1st Value: **4.000**  
2nd Value:  
Value Percent:  
Continuous Index:  
Within 8" of Joint:  
Remarks:

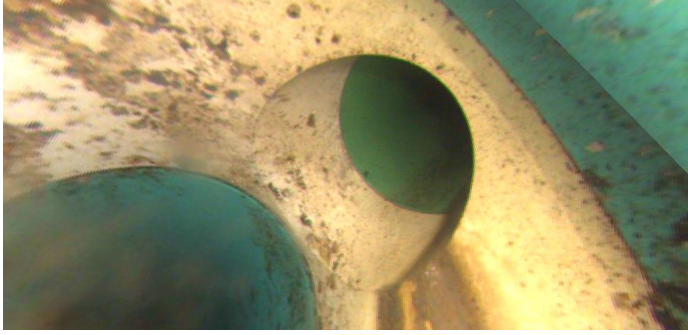
Code: **TF**  
Description: **Tap Factory**

Distance (ft): **86.4**  
Structural Grade: **0**  
O&M Grade: **0**  
Clock Start/From: **2**  
Clock To:  
1st Value: **4.000**  
2nd Value:  
Value Percent:  
Continuous Index:  
Within 8" of Joint:  
Remarks:

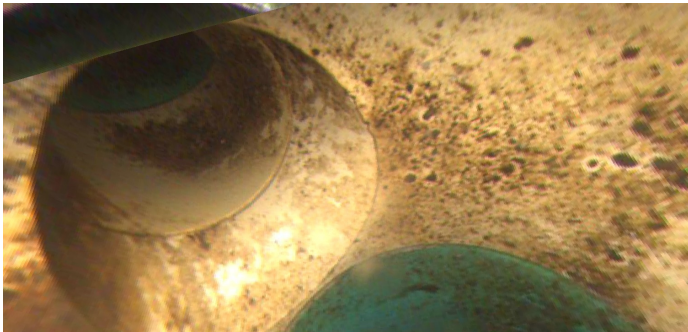
Code: **TF**  
Description: **Tap Factory**

Distance (ft): **122.0**  
Structural Grade: **0**  
O&M Grade: **0**  
Clock Start/From: **10**  
Clock To:  
1st Value: **4.000**  
2nd Value:  
Value Percent:  
Continuous Index:  
Within 8" of Joint:  
Remarks:

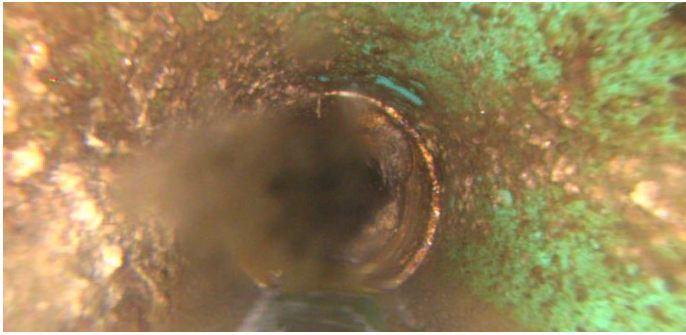
Code: **DAGS**  
Description: **Deposits Attached Grease**

Distance (ft): **129.3**  
Structural Grade: **0**  
O&M Grade: **2**  
Clock Start/From: **8**  
Clock To: **4**  
1st Value:  
2nd Value:  
Value Percent: **5.000**  
Continuous Index:  
Within 8" of Joint: **NO**  
Remarks:

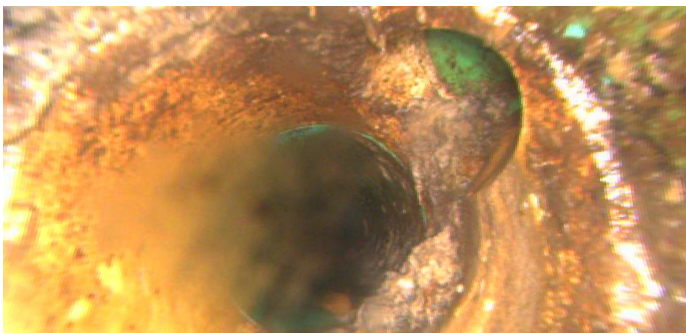
Code: **TF**  
Description: **Tap Factory**

Distance (ft): **130.0**  
Structural Grade: **0**  
O&M Grade: **0**  
Clock Start/From: **2**  
Clock To:  
1st Value: **4.000**  
2nd Value:  
Value Percent:  
Continuous Index:  
Within 8" of Joint:  
Remarks:

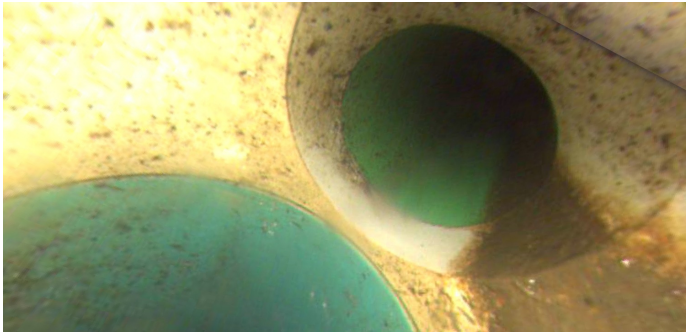
Code: **TF**  
Description: **Tap Factory**

Distance (ft): **159.7**  
Structural Grade: **0**  
O&M Grade: **0**  
Clock Start/From: **11**  
Clock To:  
1st Value: **4.000**  
2nd Value:  
Value Percent:  
Continuous Index:  
Within 8" of Joint:  
Remarks:

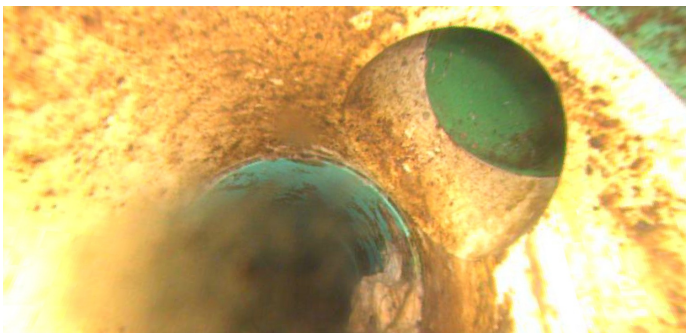
Code: **TF**  
Description: **Tap Factory**

Distance (ft): **167.8**  
Structural Grade: **0**  
O&M Grade: **0**  
Clock Start/From: **2**  
Clock To:  
1st Value: **4.000**  
2nd Value:  
Value Percent:  
Continuous Index:  
Within 8" of Joint:  
Remarks:

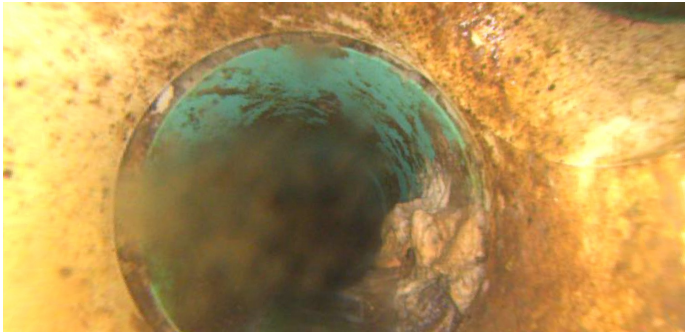
Code: **DAGS**  
Description: **Deposits Attached Grease**

Distance (ft): **168.1**  
Structural Grade: **0**  
O&M Grade: **2**  
Clock Start/From: **3**  
Clock To: **5**  
1st Value:  
2nd Value:  
Value Percent: **10.000**  
Continuous Index:  
Within 8" of Joint: **YES**  
Remarks:

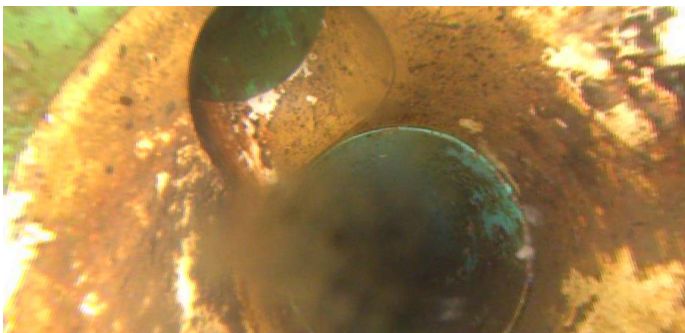
Code: **TF**  
Description: **Tap Factory**

Distance (ft): **199.4**  
Structural Grade: **0**  
O&M Grade: **0**  
Clock Start/From: **10**  
Clock To:  
1st Value: **4.000**  
2nd Value:  
Value Percent:  
Continuous Index:  
Within 8" of Joint:  
Remarks:

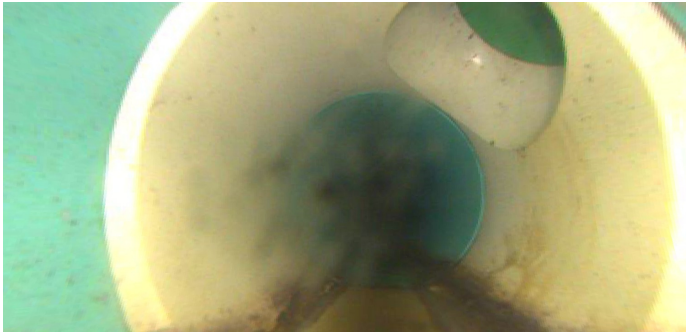
Code: **TF**  
Description: **Tap Factory**

Distance (ft): **209.9**  
Structural Grade: **0**  
O&M Grade: **0**  
Clock Start/From: **2**  
Clock To:  
1st Value: **4.000**  
2nd Value:  
Value Percent:  
Continuous Index:  
Within 8" of Joint:  
Remarks:

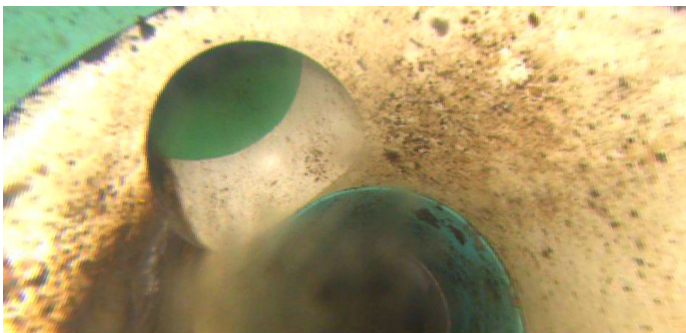
Code: **TF**  
Description: **Tap Factory**

Distance (ft): **240.8**  
Structural Grade: **0**  
O&M Grade: **0**  
Clock Start/From: **10**  
Clock To:  
1st Value: **4.000**  
2nd Value:  
Value Percent:  
Continuous Index:  
Within 8" of Joint:  
Remarks:

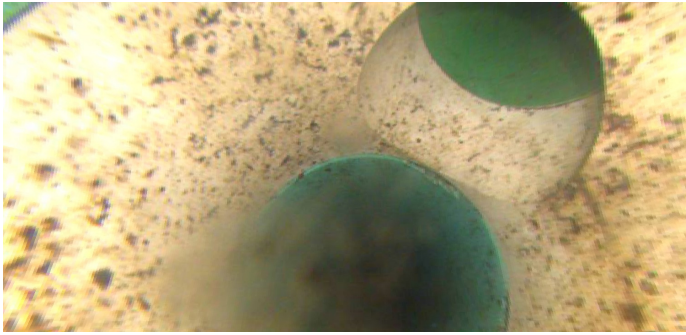
Code: **TF**  
Description: **Tap Factory**

Distance (ft): **242.4**  
Structural Grade: **0**  
O&M Grade: **0**  
Clock Start/From: **2**  
Clock To:  
1st Value: **4.000**  
2nd Value:  
Value Percent:  
Continuous Index:  
Within 8" of Joint:  
Remarks:

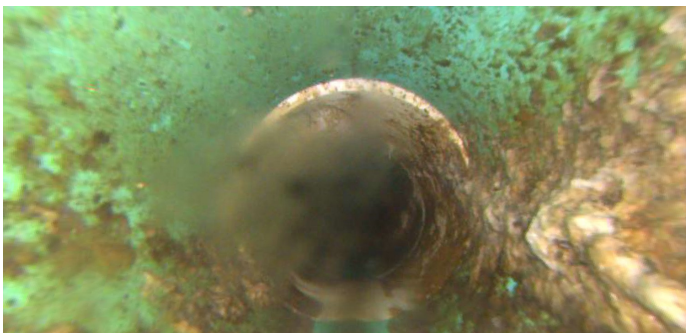
Code: **DAGS**  
Description: **Deposits Attached Grease**

Distance (ft): **271.8**  
Structural Grade: **0**  
O&M Grade: **2**  
Clock Start/From: **8**  
Clock To: **4**  
1st Value:  
2nd Value:  
Value Percent: **5.000**  
Continuous Index:  
Within 8" of Joint: **NO**  
Remarks:

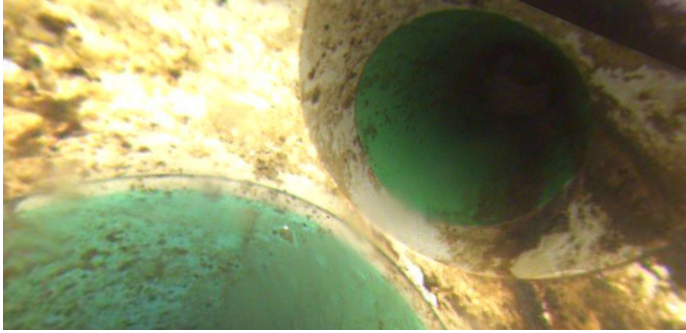
Code: **TF**  
Description: **Tap Factory**

Distance (ft): **273.3**  
Structural Grade: **0**  
O&M Grade: **0**  
Clock Start/From: **11**  
Clock To:  
1st Value: **4.000**  
2nd Value:  
Value Percent:  
Continuous Index:  
Within 8" of Joint:  
Remarks:

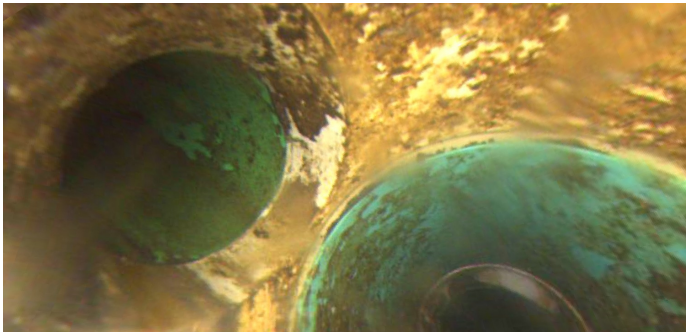
Code: **TF**  
Description: **Tap Factory**

Distance (ft): **275.5**  
Structural Grade: **0**  
O&M Grade: **0**  
Clock Start/From: **2**  
Clock To:  
1st Value: **4.000**  
2nd Value:  
Value Percent:  
Continuous Index:  
Within 8" of Joint:  
Remarks:

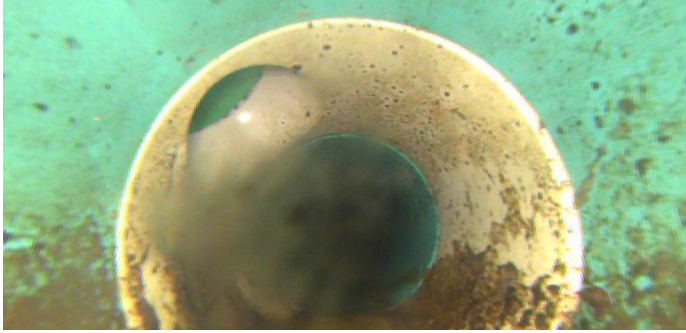
Code: **TF**  
Description: **Tap Factory**

Distance (ft): **312.6**  
Structural Grade: **0**  
O&M Grade: **0**  
Clock Start/From: **10**  
Clock To:  
1st Value: **4.000**  
2nd Value:  
Value Percent:  
Continuous Index:  
Within 8" of Joint:  
Remarks:

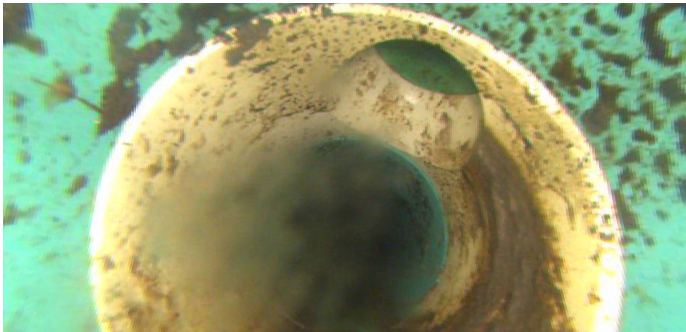
Code: **TF**  
Description: **Tap Factory**

Distance (ft): **315.1**  
Structural Grade: **0**  
O&M Grade: **0**  
Clock Start/From: **2**  
Clock To:  
1st Value: **4.000**  
2nd Value:  
Value Percent:  
Continuous Index:  
Within 8" of Joint:  
Remarks:

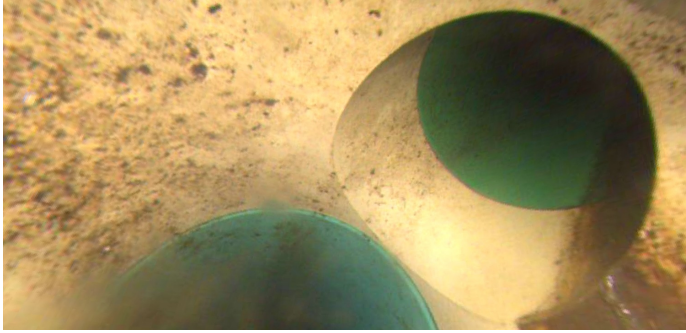
Code: **TFA**  
Description: **Tap Factory Active**

Distance (ft): **353.9**  
Structural Grade: **0**  
O&M Grade: **0**  
Clock Start/From: **2**  
Clock To:  
1st Value: **4.000**  
2nd Value:  
Value Percent:  
Continuous Index:  
Within 8" of Joint:  
Remarks:

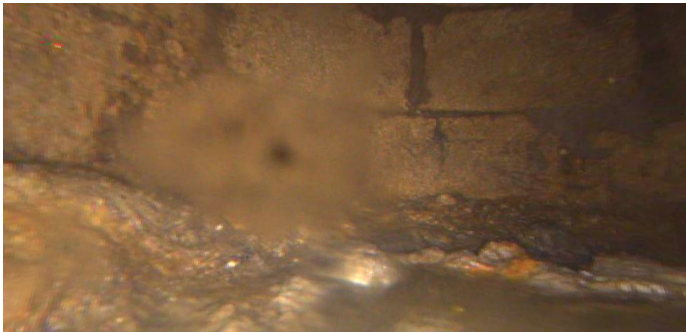
Code: **AMH**  
Description: **Manhole**

Distance (ft): **401.5**  
Structural Grade: **0**  
O&M Grade: **0**  
Clock Start/From:  
Clock To:  
1st Value:  
2nd Value:  
Value Percent:  
Continuous Index:  
Within 8" of Joint: **NO**  
Remarks: **M-504-043**
