Profile/Photo Observation Report

Street:	Summerlin	Flow Control:	Not Controlled
City:	Hobart, IN	Year Renewed:	
Location:	Light Highway	Tape/Media #:	
Purpose:	Not Known	Dia/Height:	10"
Use:	Sanitary	Material:	PVC
Drain Area:	NA	Lining:	
Category:	NA		
Comment:

Location Details:		Direction of Survey:	Downstream
US MH:	M-504-042	DS MH:	M-504-043
		Total Length Surveyed (ft):	401.5

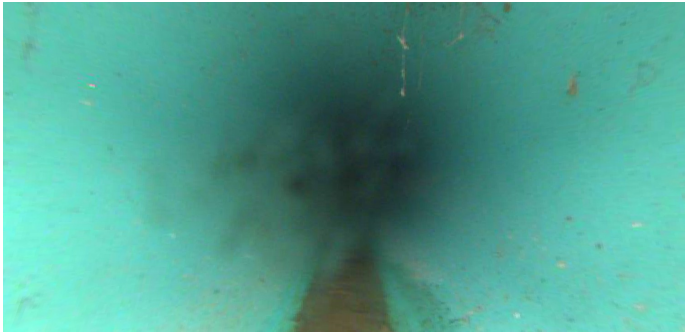
Code: **AMH**
Description: **Manhole**

Distance (ft): **.0**
Structural Grade: **0**
O&M Grade: **0**
Clock Start/From:
Clock To:
1st Value:
2nd Value:
Value Percent:
Continuous Index:
Within 8" of Joint: **NO**
Remarks: **M-504-042**

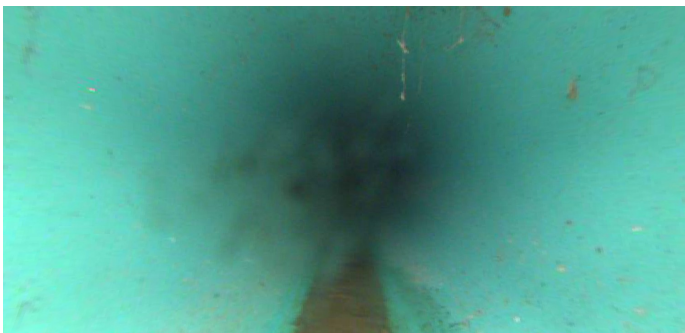
Code: **MWL**
Description: **Water Level**

Distance (ft): **.0**
Structural Grade: **0**
O&M Grade: **0**
Clock Start/From:
Clock To:
1st Value:
2nd Value:
Value Percent: **5.000**
Continuous Index:
Within 8" of Joint: **NO**
Remarks:

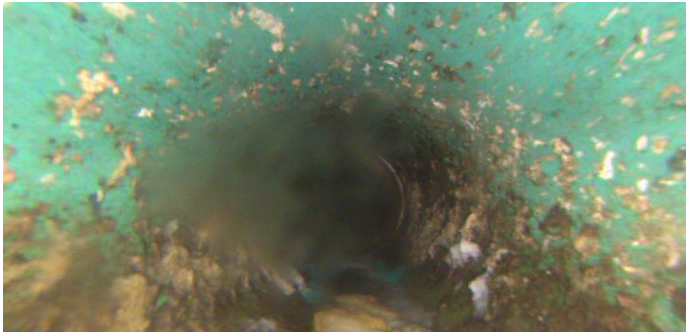
Code: **DAGS**
Description: **Deposits Attached Grease**

Distance (ft): **13.4**
Structural Grade: **0**
O&M Grade: **2**
Clock Start/From: **8**
Clock To: **4**
1st Value:
2nd Value:
Value Percent: **5.000**
Continuous Index:
Within 8" of Joint: **NO**
Remarks:

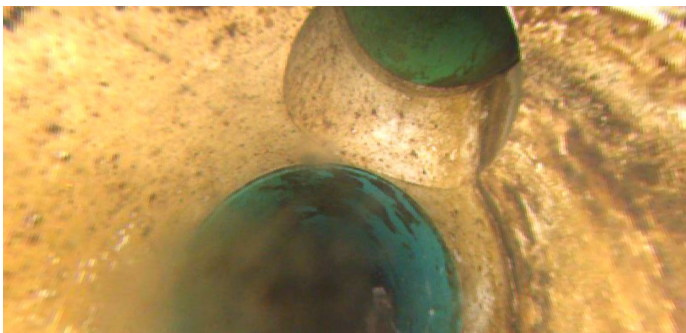
Code: **TF**
Description: **Tap Factory**

Distance (ft): **15.3**
Structural Grade: **0**
O&M Grade: **0**
Clock Start/From: **1**
Clock To:
1st Value: **4.000**
2nd Value:
Value Percent:
Continuous Index:
Within 8" of Joint:
Remarks:

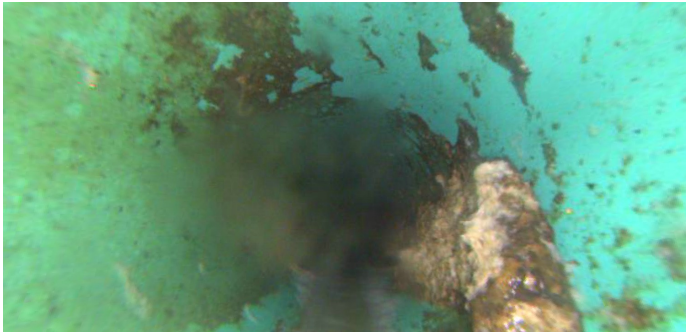
Code: **DAGS**
Description: **Deposits Attached Grease**

Distance (ft): **16.3**
Structural Grade: **0**
O&M Grade: **2**
Clock Start/From: **8**
Clock To: **4**
1st Value:
2nd Value:
Value Percent: **10.000**
Continuous Index:
Within 8" of Joint: **NO**
Remarks:

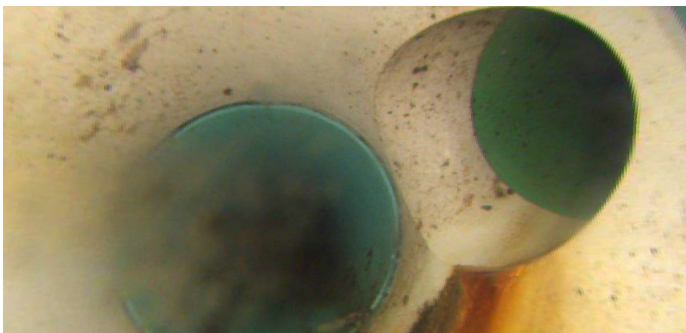
Code: **TF**
Description: **Tap Factory**

Distance (ft): **40.4**
Structural Grade: **0**
O&M Grade: **0**
Clock Start/From: **3**
Clock To:
1st Value: **4.000**
2nd Value:
Value Percent:
Continuous Index:
Within 8" of Joint:
Remarks:

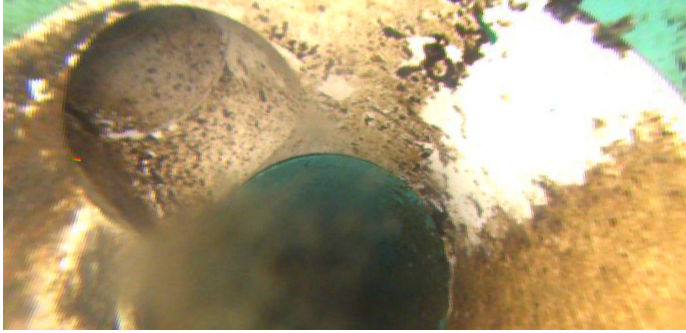
Code: **TF**
Description: **Tap Factory**

Distance (ft): **43.7**
Structural Grade: **0**
O&M Grade: **0**
Clock Start/From: **10**
Clock To:
1st Value: **4.000**
2nd Value:
Value Percent:
Continuous Index:
Within 8" of Joint:
Remarks:

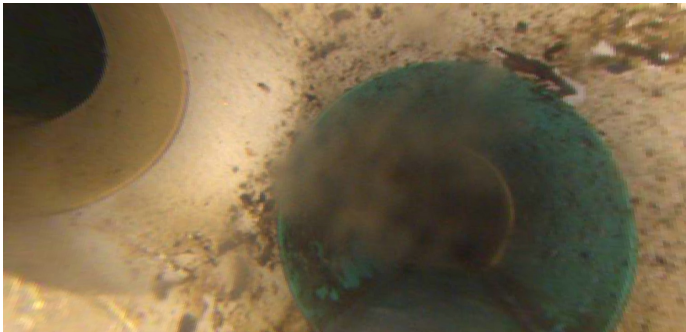
Code: **TF**
Description: **Tap Factory**

Distance (ft): **84.8**
Structural Grade: **0**
O&M Grade: **0**
Clock Start/From: **9**
Clock To:
1st Value: **4.000**
2nd Value:
Value Percent:
Continuous Index:
Within 8" of Joint:
Remarks:

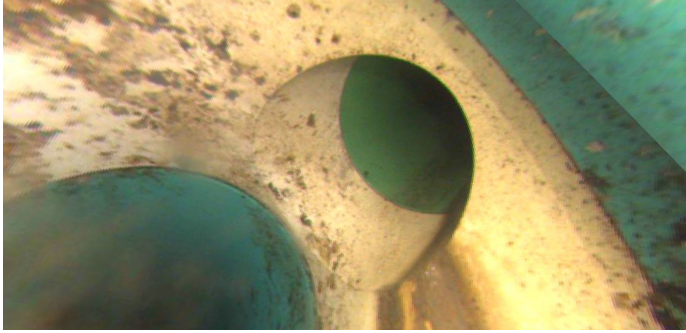
Code: **TF**
Description: **Tap Factory**

Distance (ft): **86.4**
Structural Grade: **0**
O&M Grade: **0**
Clock Start/From: **2**
Clock To:
1st Value: **4.000**
2nd Value:
Value Percent:
Continuous Index:
Within 8" of Joint:
Remarks:

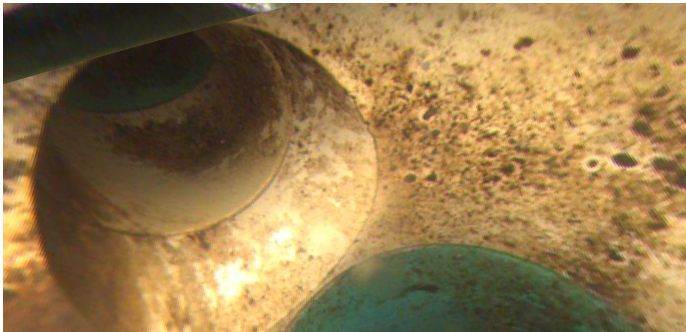
Code: **TF**
Description: **Tap Factory**

Distance (ft): **122.0**
Structural Grade: **0**
O&M Grade: **0**
Clock Start/From: **10**
Clock To:
1st Value: **4.000**
2nd Value:
Value Percent:
Continuous Index:
Within 8" of Joint:
Remarks:

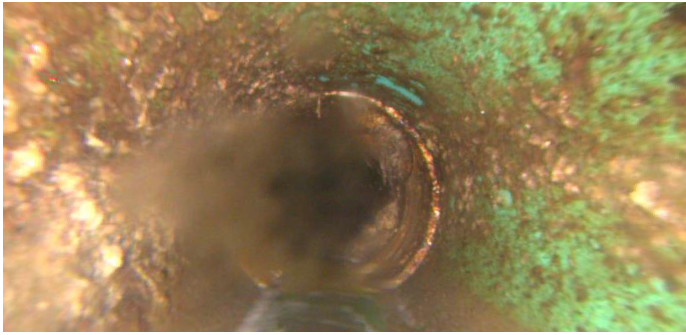
Code: **DAGS**
Description: **Deposits Attached Grease**

Distance (ft): **129.3**
Structural Grade: **0**
O&M Grade: **2**
Clock Start/From: **8**
Clock To: **4**
1st Value:
2nd Value:
Value Percent: **5.000**
Continuous Index:
Within 8" of Joint: **NO**
Remarks:

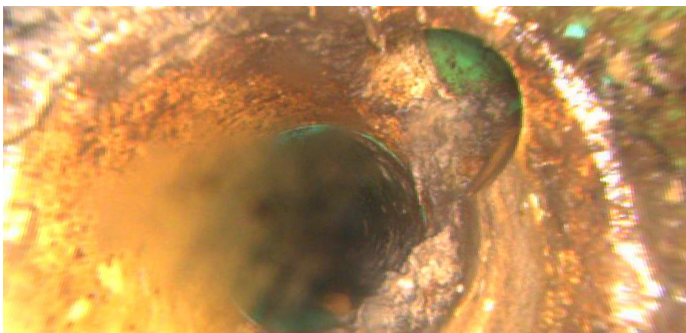
Code: **TF**
Description: **Tap Factory**

Distance (ft): **130.0**
Structural Grade: **0**
O&M Grade: **0**
Clock Start/From: **2**
Clock To:
1st Value: **4.000**
2nd Value:
Value Percent:
Continuous Index:
Within 8" of Joint:
Remarks:

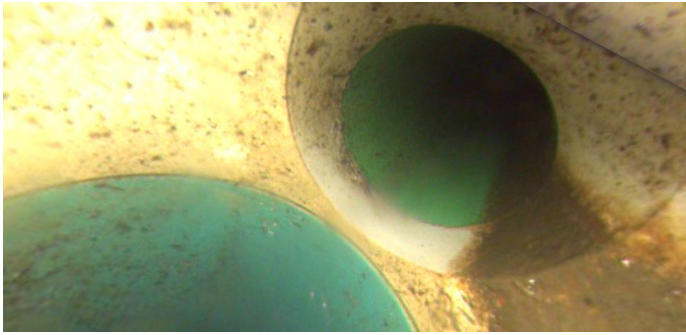
Code: **TF**
Description: **Tap Factory**

Distance (ft): **159.7**
Structural Grade: **0**
O&M Grade: **0**
Clock Start/From: **11**
Clock To:
1st Value: **4.000**
2nd Value:
Value Percent:
Continuous Index:
Within 8" of Joint:
Remarks:

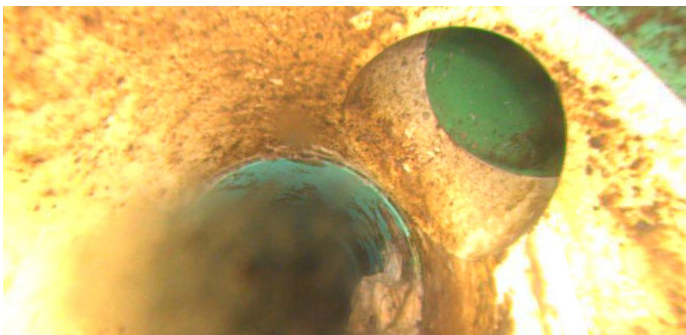
Code: **TF**
Description: **Tap Factory**

Distance (ft): **167.8**
Structural Grade: **0**
O&M Grade: **0**
Clock Start/From: **2**
Clock To:
1st Value: **4.000**
2nd Value:
Value Percent:
Continuous Index:
Within 8" of Joint:
Remarks:

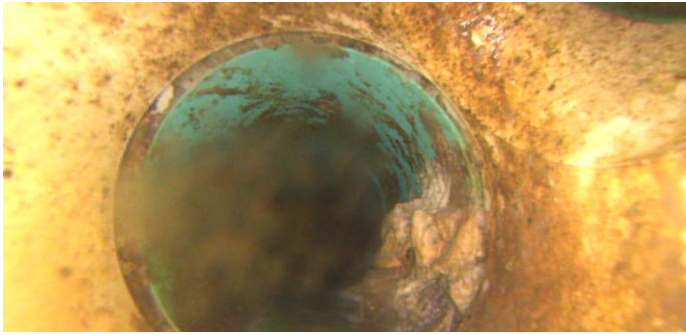
Code: **DAGS**
Description: **Deposits Attached Grease**

Distance (ft): **168.1**
Structural Grade: **0**
O&M Grade: **2**
Clock Start/From: **3**
Clock To: **5**
1st Value:
2nd Value:
Value Percent: **10.000**
Continuous Index:
Within 8" of Joint: **YES**
Remarks:

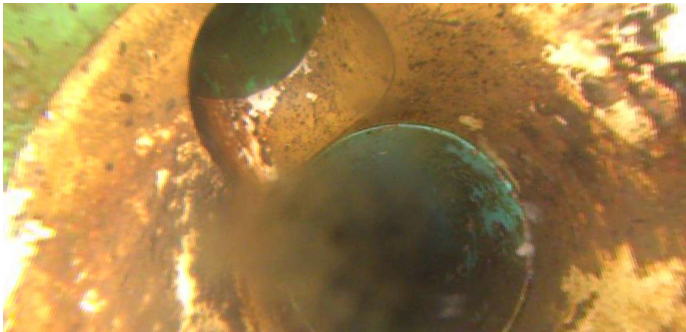
Code: **TF**
Description: **Tap Factory**

Distance (ft): **199.4**
Structural Grade: **0**
O&M Grade: **0**
Clock Start/From: **10**
Clock To:
1st Value: **4.000**
2nd Value:
Value Percent:
Continuous Index:
Within 8" of Joint:
Remarks:

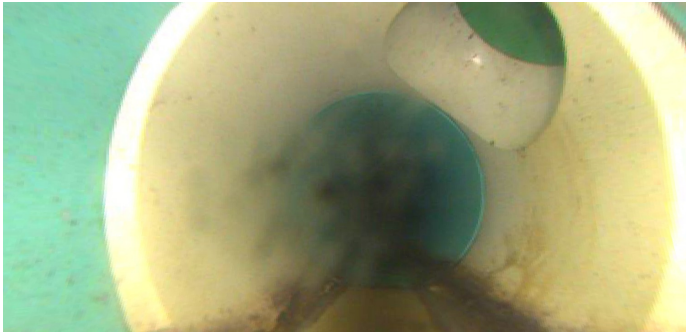
Code: **TF**
Description: **Tap Factory**

Distance (ft): **209.9**
Structural Grade: **0**
O&M Grade: **0**
Clock Start/From: **2**
Clock To:
1st Value: **4.000**
2nd Value:
Value Percent:
Continuous Index:
Within 8" of Joint:
Remarks:

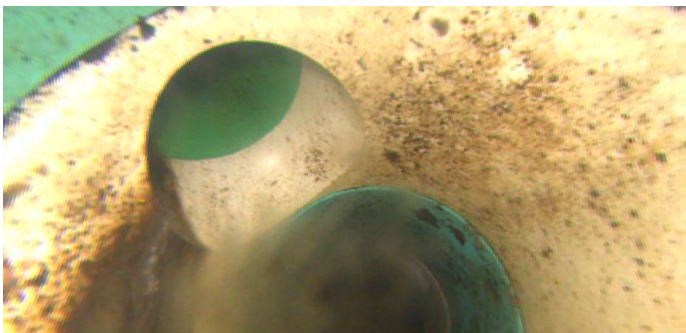
Code: **TF**
Description: **Tap Factory**

Distance (ft): **240.8**
Structural Grade: **0**
O&M Grade: **0**
Clock Start/From: **10**
Clock To:
1st Value: **4.000**
2nd Value:
Value Percent:
Continuous Index:
Within 8" of Joint:
Remarks:

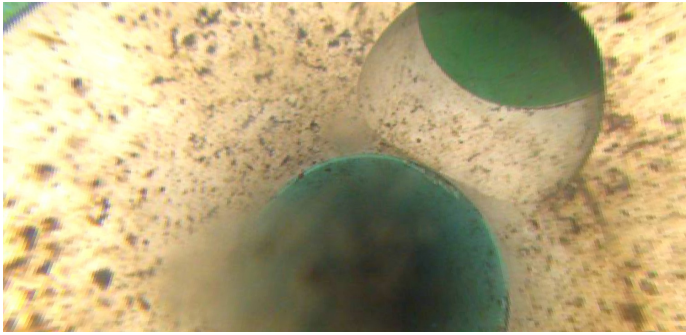
Code: **TF**
Description: **Tap Factory**

Distance (ft): **242.4**
Structural Grade: **0**
O&M Grade: **0**
Clock Start/From: **2**
Clock To:
1st Value: **4.000**
2nd Value:
Value Percent:
Continuous Index:
Within 8" of Joint:
Remarks:

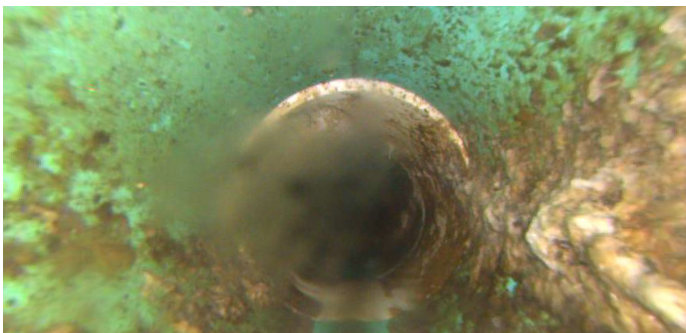
Code: **DAGS**
Description: **Deposits Attached Grease**

Distance (ft): **271.8**
Structural Grade: **0**
O&M Grade: **2**
Clock Start/From: **8**
Clock To: **4**
1st Value:
2nd Value:
Value Percent: **5.000**
Continuous Index:
Within 8" of Joint: **NO**
Remarks:

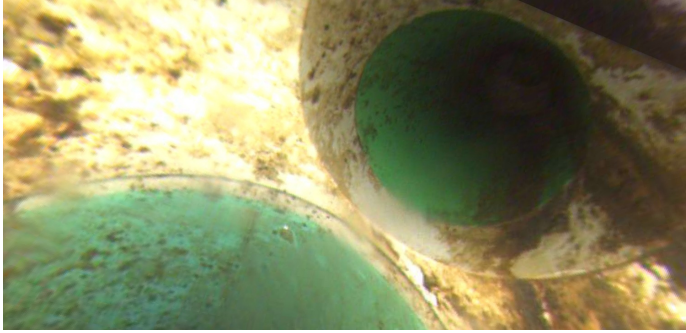
Code: **TF**
Description: **Tap Factory**

Distance (ft): **273.3**
Structural Grade: **0**
O&M Grade: **0**
Clock Start/From: **11**
Clock To:
1st Value: **4.000**
2nd Value:
Value Percent:
Continuous Index:
Within 8" of Joint:
Remarks:

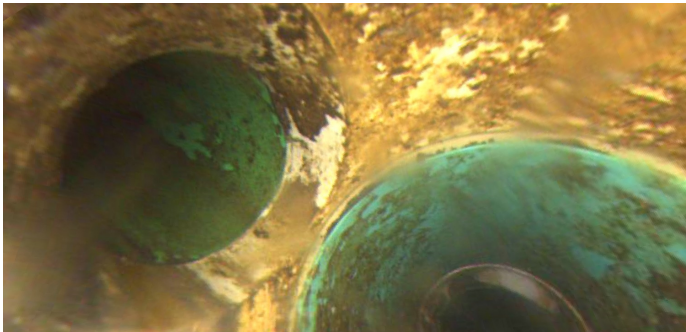
Code: **TF**
Description: **Tap Factory**

Distance (ft): **275.5**
Structural Grade: **0**
O&M Grade: **0**
Clock Start/From: **2**
Clock To:
1st Value: **4.000**
2nd Value:
Value Percent:
Continuous Index:
Within 8" of Joint:
Remarks:

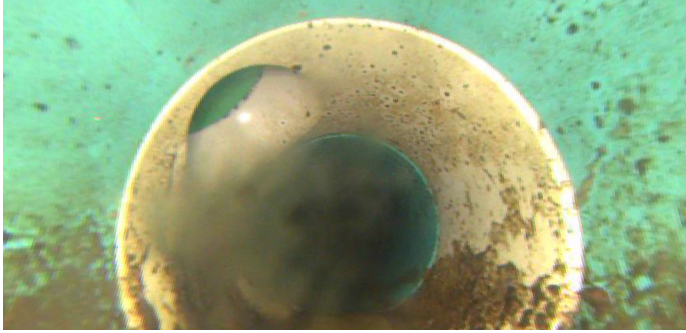
Code: **TF**
Description: **Tap Factory**

Distance (ft): **312.6**
Structural Grade: **0**
O&M Grade: **0**
Clock Start/From: **10**
Clock To:
1st Value: **4.000**
2nd Value:
Value Percent:
Continuous Index:
Within 8" of Joint:
Remarks:

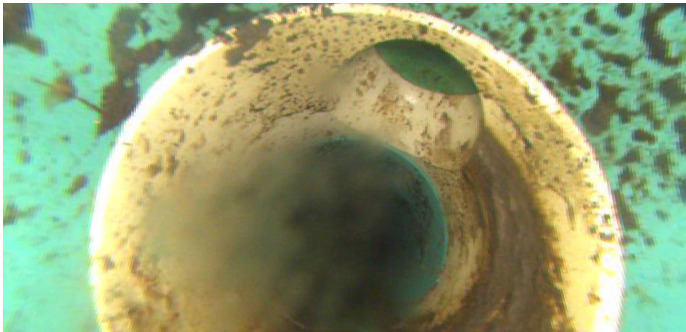
Code: **TF**
Description: **Tap Factory**

Distance (ft): **315.1**
Structural Grade: **0**
O&M Grade: **0**
Clock Start/From: **2**
Clock To:
1st Value: **4.000**
2nd Value:
Value Percent:
Continuous Index:
Within 8" of Joint:
Remarks:

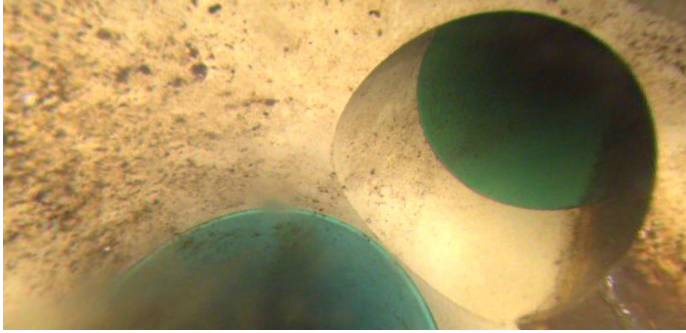
Code: **TFA**
Description: **Tap Factory Active**

Distance (ft): **353.9**
Structural Grade: **0**
O&M Grade: **0**
Clock Start/From: **2**
Clock To:
1st Value: **4.000**
2nd Value:
Value Percent:
Continuous Index:
Within 8" of Joint:
Remarks:

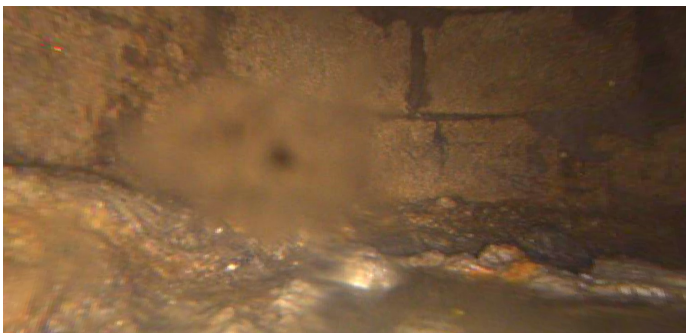
Code: **AMH**
Description: **Manhole**

Distance (ft): **401.5**
Structural Grade: **0**
O&M Grade: **0**
Clock Start/From:
Clock To:
1st Value:
2nd Value:
Value Percent:
Continuous Index:
Within 8" of Joint: **NO**
Remarks: **M-504-043**
