Profile/Photo Observation Report

Date:	04/18/2018	Weather:		Coding:	PACP 6.0
Pipe Length (ft):	159.0	Owner:	NA	Pre Clean:	Not Known
P.O.#:		Surveyor:	Byrd Fitzgerald	PSR:	P-504-046-045
Customer:		Clean Date:	01/01/1900	Shape:	C

Location Details:		Direction of Survey:	Downstream
US MH:	M-504-045	DS MH:	M-504-046
		Total Length Surveyed (ft):	101.7

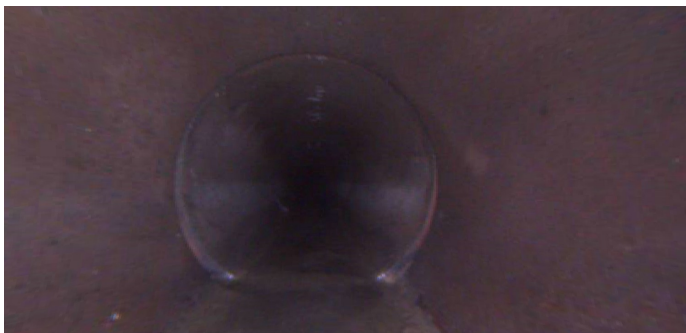
Code: **AMH**
Description: **Manhole**

Distance (ft): **.0**
Structural Grade: **0**
O&M Grade: **0**
Clock Start/From:
Clock To:
1st Value:
2nd Value:
Value Percent:
Continuous Index:
Within 8" of Joint: **NO**
Remarks: **M-504-045**

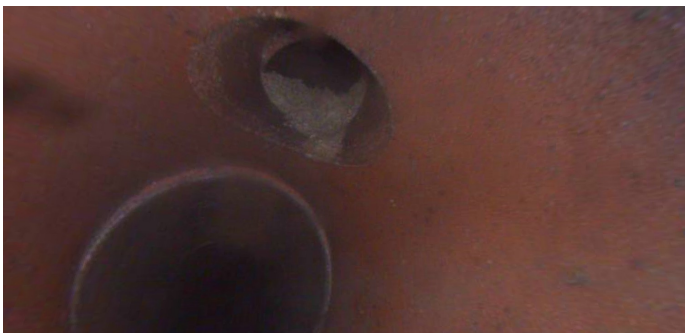
Code: **TF**
Description: **Tap Factory**

Distance (ft): **35.7**
Structural Grade: **0**
O&M Grade: **0**
Clock Start/From: **11**
Clock To:
1st Value: **4.000**
2nd Value:
Value Percent:
Continuous Index:
Within 8" of Joint:
Remarks:

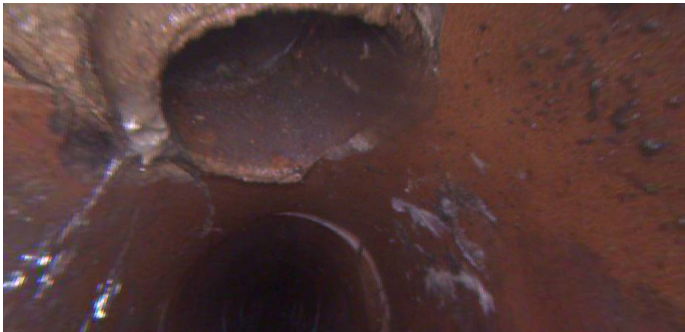
Code: **TBI**
Description: **Tap Break-in Intruding**

Distance (ft): **47.9**
Structural Grade: **0**
O&M Grade: **2**
Clock Start/From: **12**
Clock To:
1st Value: **4.000**
2nd Value: **1.000**
Value Percent:
Continuous Index:
Within 8" of Joint:
Remarks:

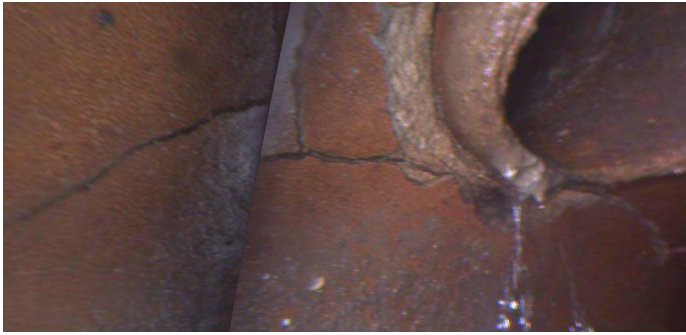
Code: **FM**
Description: **Fracture Multiple**

Distance (ft): **47.9**
Structural Grade: **4**
O&M Grade: **0**
Clock Start/From: **7**
Clock To: **11**
1st Value:
2nd Value:
Value Percent:
Continuous Index:
Within 8" of Joint: **YES**
Remarks:

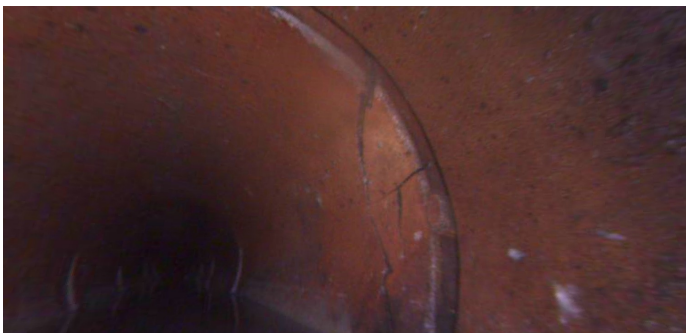
Code: **FM**
Description: **Fracture Multiple**

Distance (ft): **49.0**
Structural Grade: **4**
O&M Grade: **0**
Clock Start/From: **2**
Clock To: **4**
1st Value:
2nd Value:
Value Percent:
Continuous Index:
Within 8" of Joint: **YES**
Remarks:

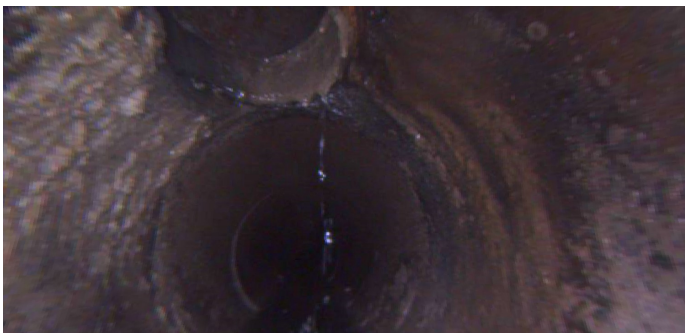
Code: **DAGS**
Description: **Deposits Attached Grease**

Distance (ft): **64.0**
Structural Grade: **0**
O&M Grade: **2**
Clock Start/From: **7**
Clock To: **5**
1st Value:
2nd Value:
Value Percent: **5.000**
Continuous Index:
Within 8" of Joint: **NO**
Remarks:

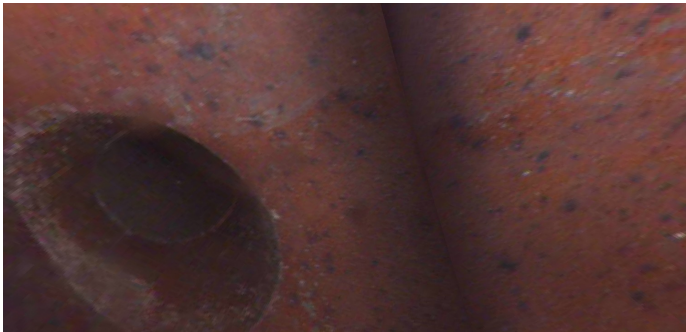
Code: **TF**
Description: **Tap Factory**

Distance (ft): **74.8**
Structural Grade: **0**
O&M Grade: **0**
Clock Start/From: **11**
Clock To:
1st Value: **4.000**
2nd Value:
Value Percent:
Continuous Index:
Within 8" of Joint: **YES**
Remarks:

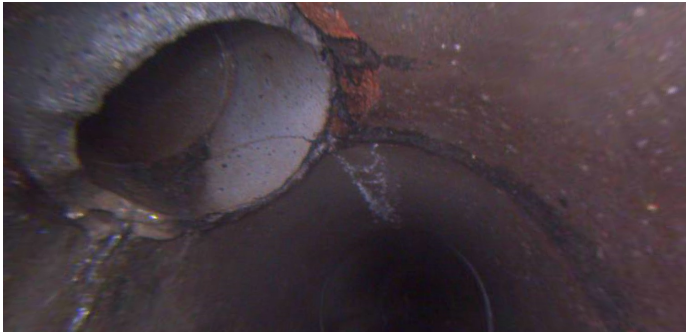
Code: **TBI**
Description: **Tap Break-in Intruding**

Distance (ft): **76.1**
Structural Grade: **0**
O&M Grade: **2**
Clock Start/From: **10**
Clock To:
1st Value: **4.000**
2nd Value: **1.000**
Value Percent:
Continuous Index:
Within 8" of Joint:
Remarks: **active**

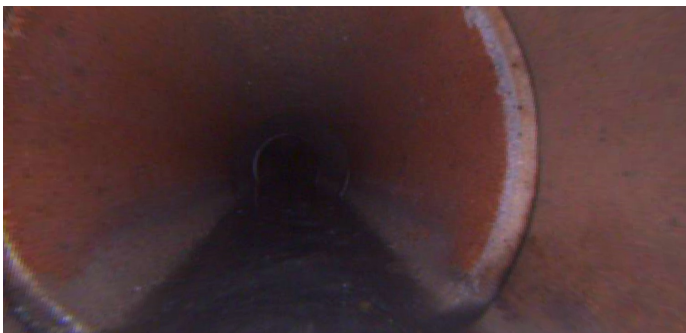
Code: **MSA**
Description: **Abandoned Survey**

Distance (ft): **101.7**
Structural Grade: **0**
O&M Grade: **0**
Clock Start/From:
Clock To:
1st Value:
2nd Value:
Value Percent:
Continuous Index:
Within 8" of Joint: **NO**
Remarks: **no blockage**
