Profile/Photo Observation Report

Date:	04/18/2018	Weather:		Coding:	PACP 6.0
Pipe Length (ft):	206.0	Owner:	NA	Pre Clean:	Not Known
P.O.#:		Surveyor:	Byrd Fitzgerald	PSR:	P-504-048-046
Customer:		Clean Date:	01/01/1900	Shape:	C

Location Details:		Direction of Survey:	Downstream
US MH:	M-504-046	DS MH:	M-504-048
		Total Length Surveyed (ft):	4.5

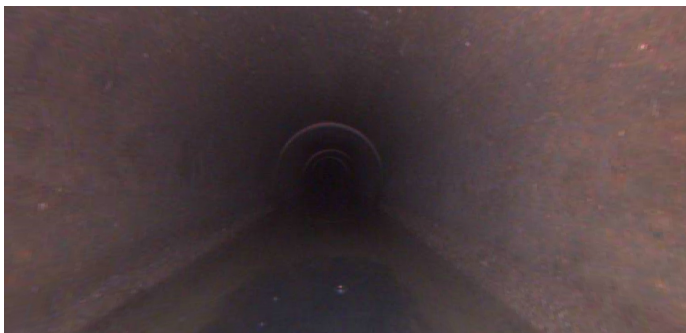
Code: **AMH**
Description: **Manhole**

Distance (ft): **.0**
Structural Grade: **0**
O&M Grade: **0**
Clock Start/From:
Clock To:
1st Value:
2nd Value:
Value Percent:
Continuous Index:
Within 8" of Joint: **NO**
Remarks: **M-504-046**

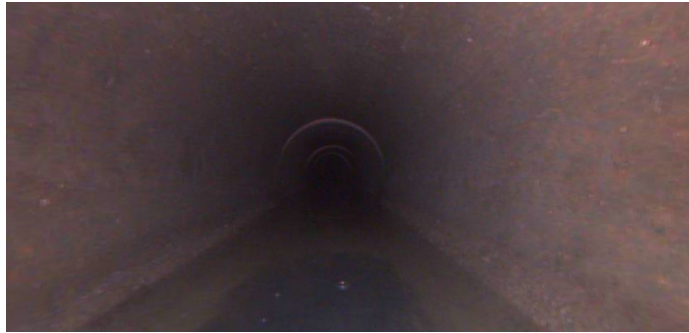
Code: **MWL**
Description: **Water Level**

Distance (ft): **.0**
Structural Grade: **0**
O&M Grade: **0**
Clock Start/From:
Clock To:
1st Value:
2nd Value:
Value Percent: **5.000**
Continuous Index:
Within 8" of Joint: **NO**
Remarks:

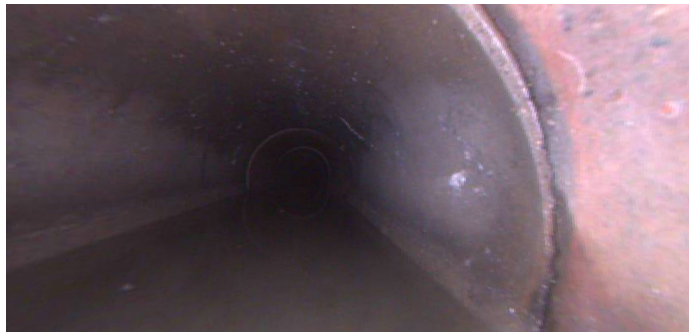
Code: **MSA**
Description: **Abandoned Survey**

Distance (ft): **4.5**
Structural Grade: **0**
O&M Grade: **0**
Clock Start/From:
Clock To:
1st Value:
2nd Value:
Value Percent:
Continuous Index:
Within 8" of Joint: **NO**
Remarks: **no blockage**
