Profile/Photo Observation Report

Street:	Summerlin	Flow Control:	Not Controlled
City:	Hobart, IN	Year Renewed:	
Location:	Light Highway	Tape/Media #:	
Purpose:	Not Known	Dia/Height:	12"
Use:	Sanitary	Material:	VCP
Drain Area:	NA	Lining:	
Category:	NA		
Comment:

Location Details:		Direction of Survey:	Upstream
US MH:	M-504-046	DS MH:	M-504-048
		Total Length Surveyed (ft):	11.3

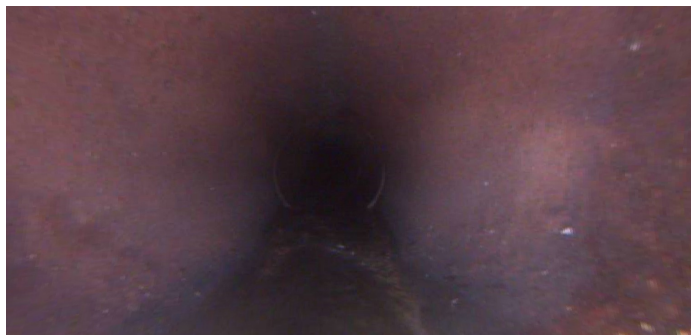
Code: **AMH**
Description: **Manhole**

Distance (ft): **.0**
Structural Grade: **0**
O&M Grade: **0**
Clock Start/From:
Clock To:
1st Value:
2nd Value:
Value Percent:
Continuous Index:
Within 8" of Joint: **NO**
Remarks: **M-504-046**

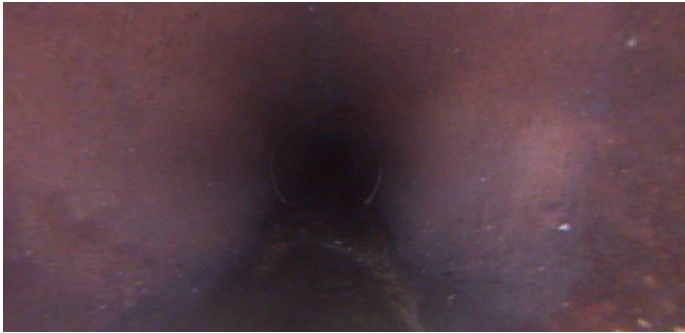
Code:	MWL
Description:	Water Level

Distance (ft):	.0
Structural Grade:	0
O&M Grade:	0
Clock Start/From:	
Clock To:	
1st Value:	
2nd Value:	
Value Percent:	5.000
Continuous Index:	
Within 8" of Joint:	NO
Remarks:

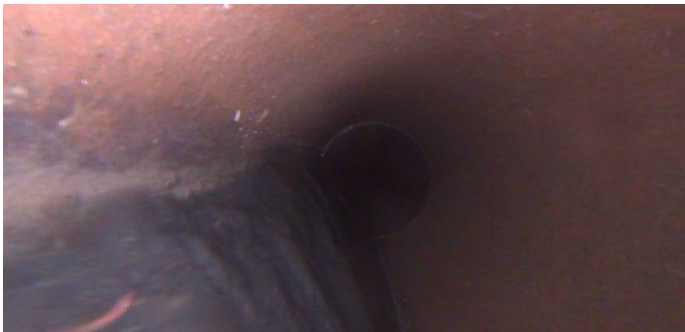
Code:	MSA
Description:	Abandoned Survey

Distance (ft):	11.3
Structural Grade:	0
O&M Grade:	0
Clock Start/From:	
Clock To:	
1st Value:	
2nd Value:	
Value Percent:	
Continuous Index:	
Within 8" of Joint:	NO
Remarks:	camera flipped
