Profile/Photo Observation Report

Street:	N COLORADO ST	Flow Control:	Not Controlled
City:	Hobart, IN	Year Renewed:	
Location:	Light Highway	Tape/Media #:	
Purpose:	Not Known	Dia/Height:	10"
Use:	Sanitary	Material:	VCP
Drain Area:	NA	Lining:	
Category:	NA		
Comment:

Location Details:		Direction of Survey:	Downstream
US MH:	M-504-048	DS MH:	M-504-049
		Total Length Surveyed (ft):	198.5

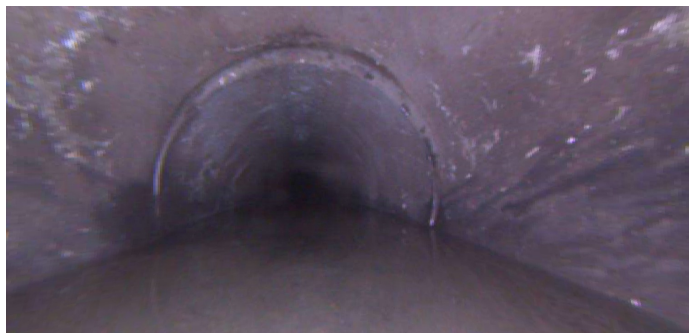
Code: **AMH**
 Description: **Manhole**
 Distance (ft): **.0**
 Structural Grade: **0**
 O&M Grade: **0**
 Clock Start/From:
 Clock To:
 1st Value:
 2nd Value:
 Value Percent:
 Continuous Index:
 Within 8" of Joint: **NO**
 Remarks: **M-504-048**

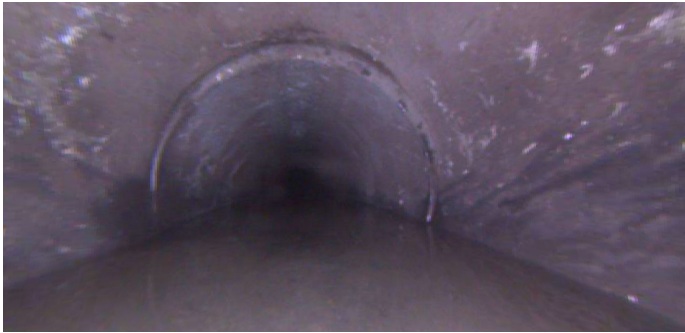
Code:	MWL
Description:	Water Level

Distance (ft):	.0
Structural Grade:	0
O&M Grade:	0
Clock Start/From:	
Clock To:	
1st Value:	
2nd Value:	
Value Percent:	5.000
Continuous Index:	
Within 8" of Joint:	NO
Remarks:

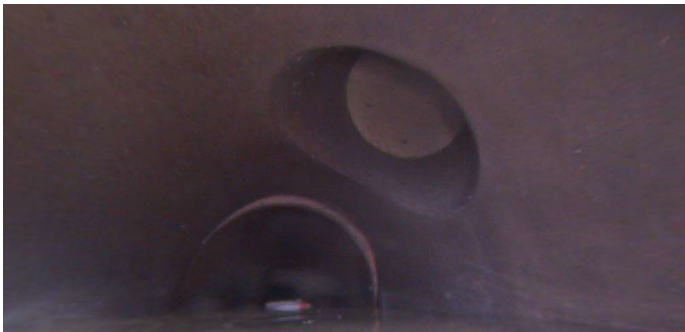
Code:	TFC
Description:	Tap Factory Capped

Distance (ft):	13.1
Structural Grade:	0
O&M Grade:	0
Clock Start/From:	1
Clock To:	
1st Value:	4.000
2nd Value:	
Value Percent:	
Continuous Index:	
Within 8" of Joint:	YES
Remarks:

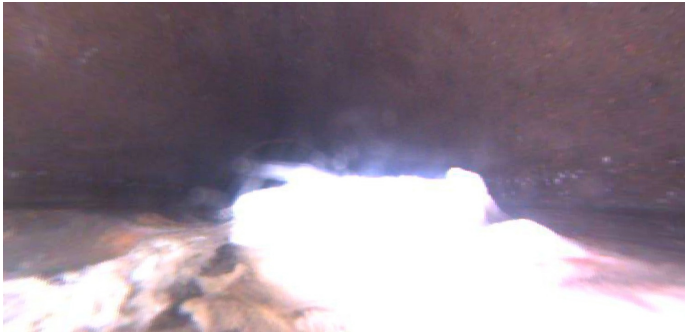
Code: **DSZ**
Description: **Deposits Settled Other**

Distance (ft): **14.9**
Structural Grade: **0**
O&M Grade: **2**
Clock Start/From: **6**
Clock To:
1st Value:
2nd Value:
Value Percent: **10.000**
Continuous Index:
Within 8" of Joint: **NO**
Remarks: **debris**

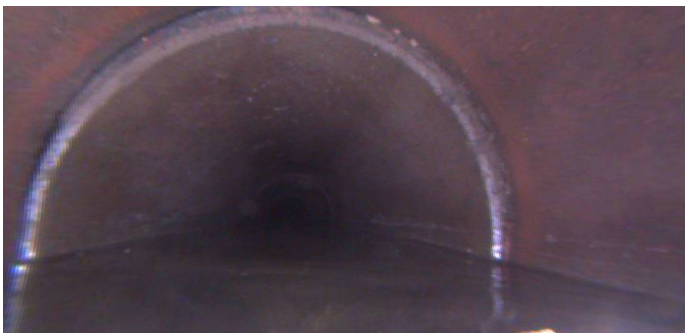
Code: **MWL**
Description: **Water Level**

Distance (ft): **19.1**
Structural Grade: **0**
O&M Grade: **0**
Clock Start/From:
Clock To:
1st Value:
2nd Value:
Value Percent: **25.000**
Continuous Index:
Within 8" of Joint: **NO**
Remarks:

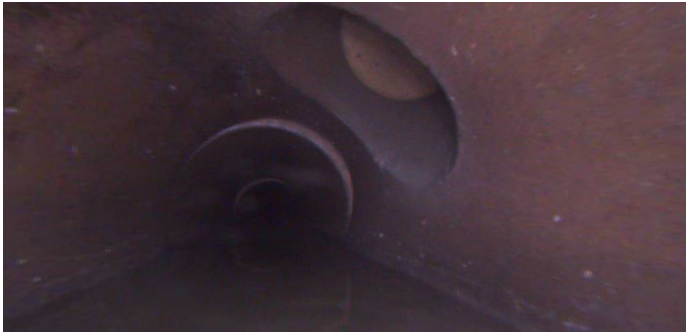
Code: **TFC**
Description: **Tap Factory Capped**

Distance (ft): **38.2**
Structural Grade: **0**
O&M Grade: **0**
Clock Start/From: **1**
Clock To:
1st Value: **4.000**
2nd Value:
Value Percent:
Continuous Index:
Within 8" of Joint: **YES**
Remarks:

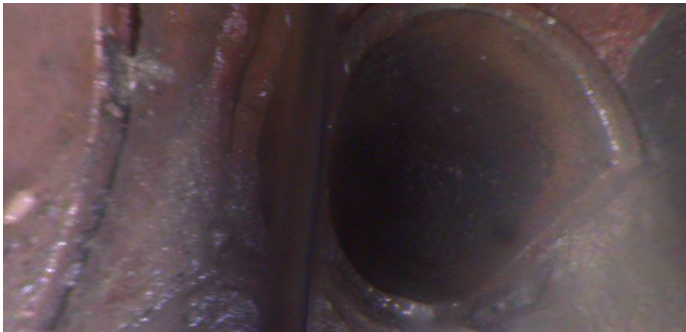
Code: **TBI**
Description: **Tap Break-in Intruding**

Distance (ft): **52.3**
Structural Grade: **0**
O&M Grade: **2**
Clock Start/From: **2**
Clock To:
1st Value: **4.000**
2nd Value: **1.000**
Value Percent:
Continuous Index:
Within 8" of Joint: **YES**
Remarks:

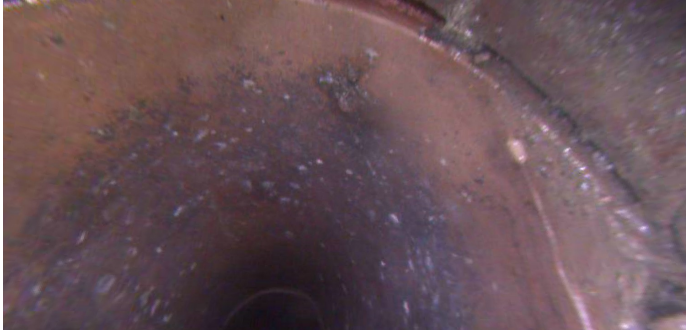
Code: **RFJ**
Description: **Roots Fine Joint**

Distance (ft): **52.3**
Structural Grade: **0**
O&M Grade: **1**
Clock Start/From: **1**
Clock To:
1st Value:
2nd Value:
Value Percent:
Continuous Index:
Within 8" of Joint: **YES**
Remarks:

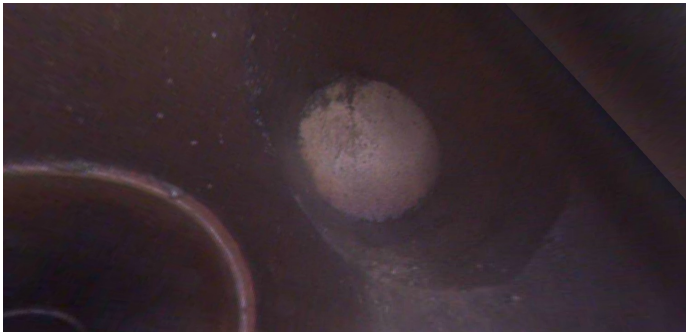
Code: **TFC**
Description: **Tap Factory Capped**

Distance (ft): **64.0**
Structural Grade: **0**
O&M Grade: **0**
Clock Start/From: **1**
Clock To:
1st Value: **4.000**
2nd Value:
Value Percent:
Continuous Index:
Within 8" of Joint: **YES**
Remarks:

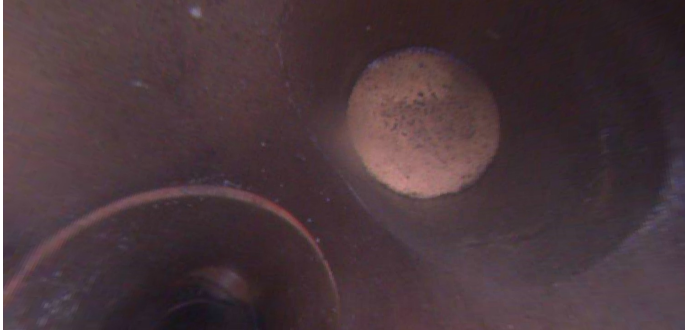
Code: **TFC**
Description: **Tap Factory Capped**

Distance (ft): **89.1**
Structural Grade: **0**
O&M Grade: **0**
Clock Start/From: **1**
Clock To:
1st Value: **4.000**
2nd Value:
Value Percent:
Continuous Index:
Within 8" of Joint: **YES**
Remarks:

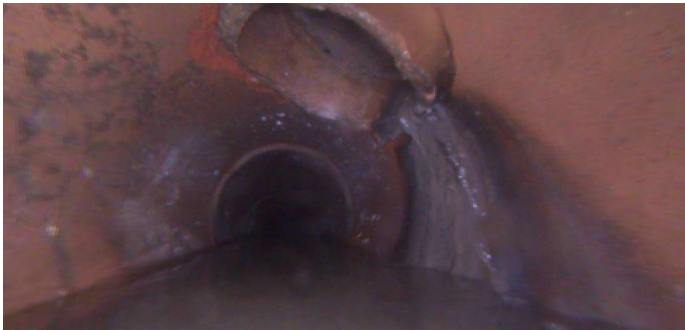
Code: **TBI**
Description: **Tap Break-in Intruding**

Distance (ft): **90.8**
Structural Grade: **0**
O&M Grade: **2**
Clock Start/From: **1**
Clock To:
1st Value: **4.000**
2nd Value: **1.000**
Value Percent:
Continuous Index:
Within 8" of Joint:
Remarks:

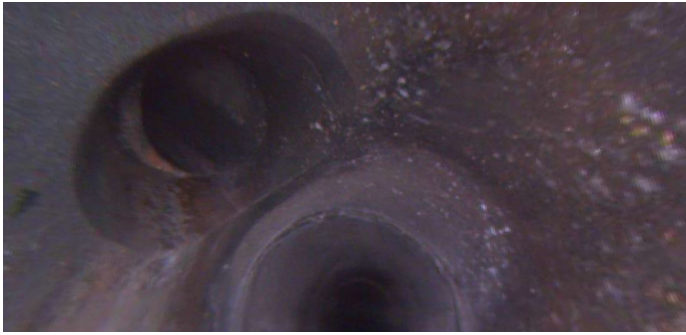
Code: **TF**
Description: **Tap Factory**

Distance (ft): **106.4**
Structural Grade: **0**
O&M Grade: **0**
Clock Start/From: **11**
Clock To:
1st Value: **4.000**
2nd Value:
Value Percent:
Continuous Index:
Within 8" of Joint: **YES**
Remarks:

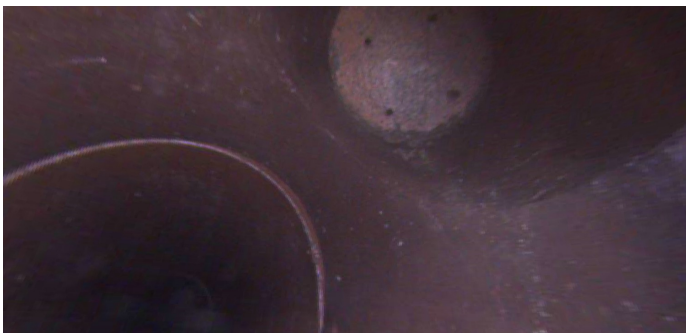
Code: **TFC**
Description: **Tap Factory Capped**

Distance (ft): **114.0**
Structural Grade: **0**
O&M Grade: **0**
Clock Start/From: **1**
Clock To:
1st Value: **4.000**
2nd Value:
Value Percent:
Continuous Index:
Within 8" of Joint: **YES**
Remarks:

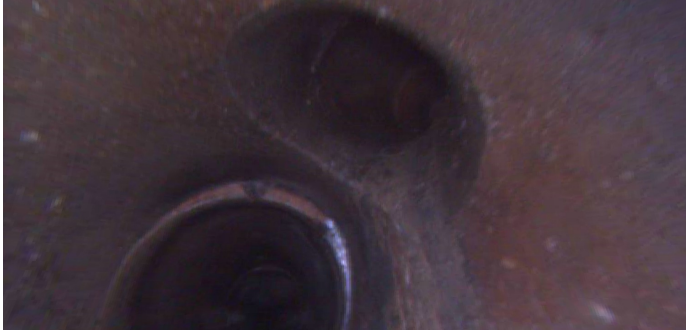
Code: **TF**
Description: **Tap Factory**

Distance (ft): **138.8**
Structural Grade: **0**
O&M Grade: **0**
Clock Start/From: **1**
Clock To:
1st Value: **4.000**
2nd Value:
Value Percent:
Continuous Index:
Within 8" of Joint: **YES**
Remarks:

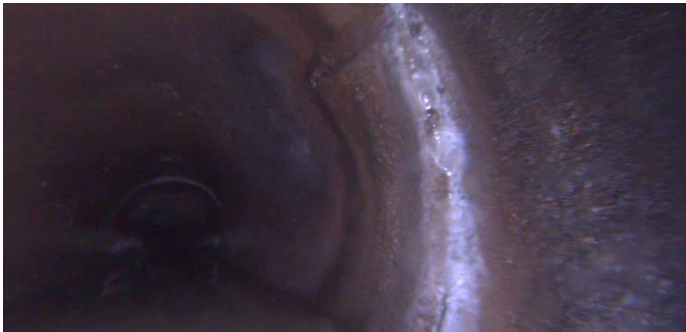
Code: **IW**
Description: **Infil Weeper**

Distance (ft): **139.8**
Structural Grade: **0**
O&M Grade: **2**
Clock Start/From: **2**
Clock To: **4**
1st Value:
2nd Value:
Value Percent:
Continuous Index:
Within 8" of Joint: **YES**
Remarks:

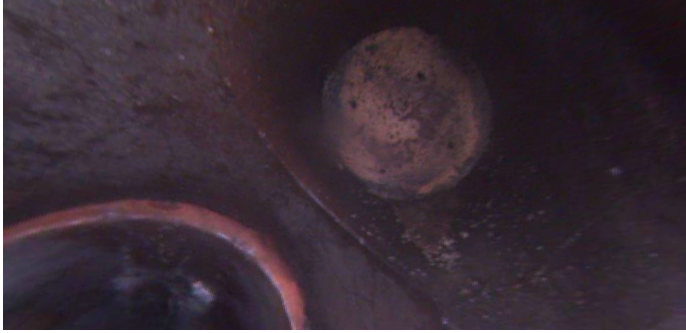
Code: **TFC**
Description: **Tap Factory Capped**

Distance (ft): **167.0**
Structural Grade: **0**
O&M Grade: **0**
Clock Start/From: **1**
Clock To:
1st Value: **4.000**
2nd Value:
Value Percent:
Continuous Index:
Within 8" of Joint: **YES**
Remarks:

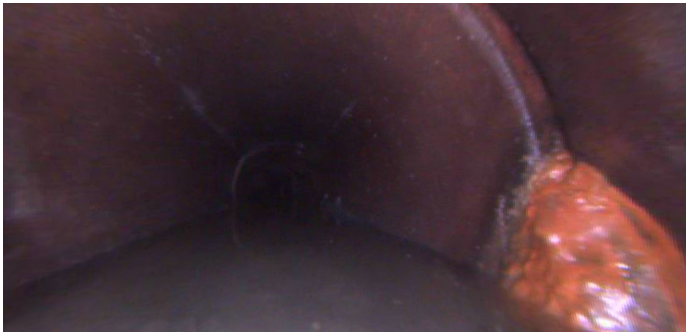
Code: **DAE**
Description: **Deposits Attached Encrustation**

Distance (ft): **175.2**
Structural Grade: **0**
O&M Grade: **2**
Clock Start/From: **8**
Clock To: **4**
1st Value:
2nd Value:
Value Percent: **5.000**
Continuous Index:
Within 8" of Joint: **YES**
Remarks:

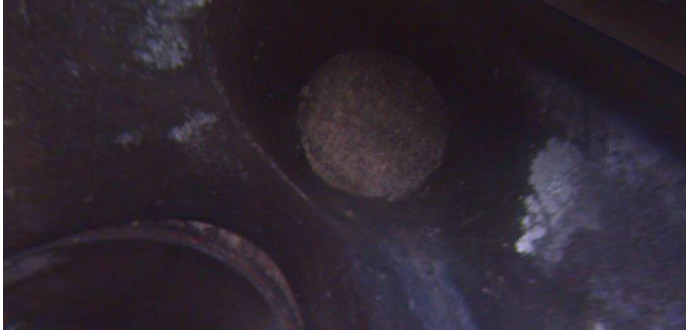
Code: **TFC**
Description: **Tap Factory Capped**

Distance (ft): **189.8**
Structural Grade: **0**
O&M Grade: **0**
Clock Start/From: **1**
Clock To:
1st Value: **4.000**
2nd Value:
Value Percent:
Continuous Index:
Within 8" of Joint: **YES**
Remarks:

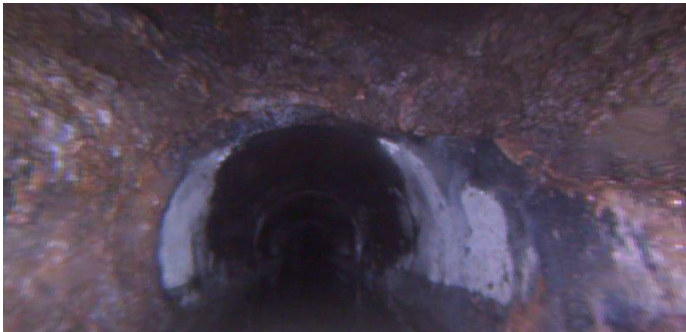
Code: **AMH**
Description: **Manhole**

Distance (ft): **198.5**
Structural Grade: **0**
O&M Grade: **0**
Clock Start/From:
Clock To:
1st Value:
2nd Value:
Value Percent:
Continuous Index:
Within 8" of Joint: **NO**
Remarks: **M-504-049**
