Profile/Photo Observation Report

| Street: | Summerlin | Flow Control: | Not Controlled |
| City: | Hobart, IN | Year Renewed: | |

| US MH: | M-504-048 | DS MH: | M-504-049 |

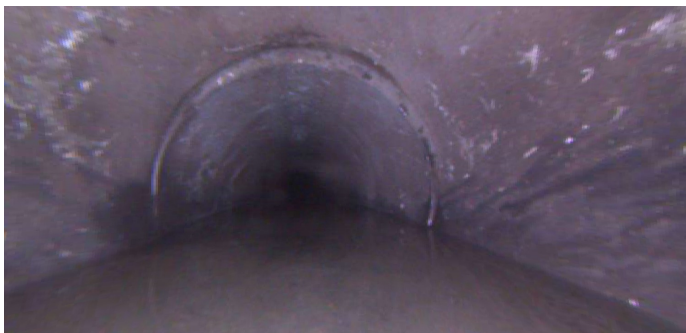
Code: **AMH**
Description: **Manhole**

Distance (ft): **.0**
Structural Grade: **0**
O&M Grade: **0**
Clock Start/From:
Clock To:
1st Value:
2nd Value:
Value Percent:
Continuous Index:
Within 8" of Joint: **NO**
Remarks: **M-504-048**

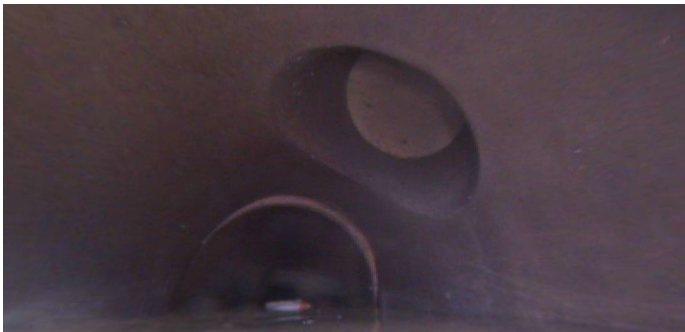
| Code: | TFC |
| Description: | Tap Factory Capped |

| Distance (ft): | 13.1 |

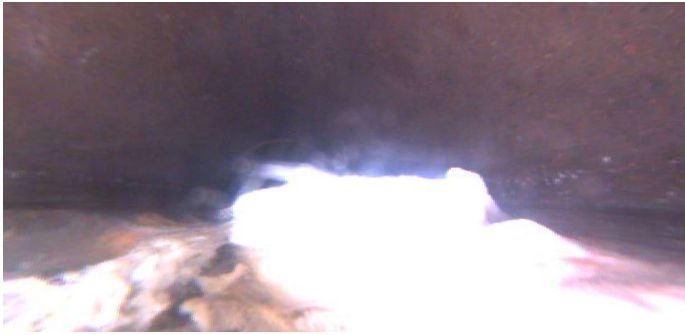
Code: **DSZ**
Description: **Deposits Settled Other**

Distance (ft): **14.9**
Structural Grade: **0**
O&M Grade: **2**
Clock Start/From: **6**
Clock To:
1st Value:
2nd Value:
Value Percent: **10.000**
Continuous Index:
Within 8" of Joint: **NO**
Remarks: **debris**

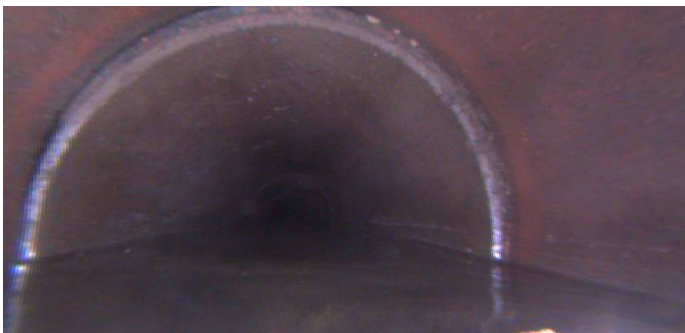
Code: **MWL**
Description: **Water Level**

Distance (ft): **19.1**
Structural Grade: **0**
O&M Grade: **0**
Clock Start/From:
Clock To:
1st Value:
2nd Value:
Value Percent: **25.000**
Continuous Index:
Within 8" of Joint: **NO**
Remarks:

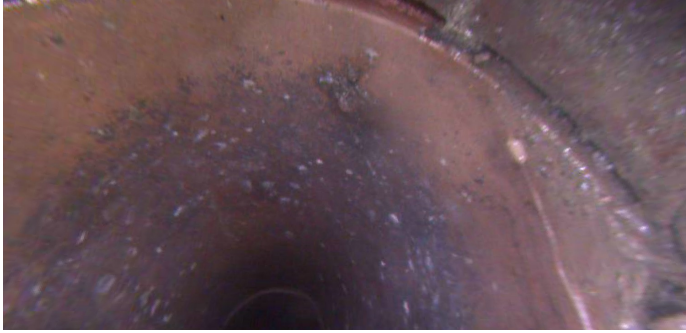
Code: **RFJ**
Description: **Roots Fine Joint**

Distance (ft): **52.3**
Structural Grade: **0**
O&M Grade: **1**
Clock Start/From: **1**
Clock To:
1st Value:
2nd Value:
Value Percent:
Continuous Index:
Within 8" of Joint: **YES**
Remarks:

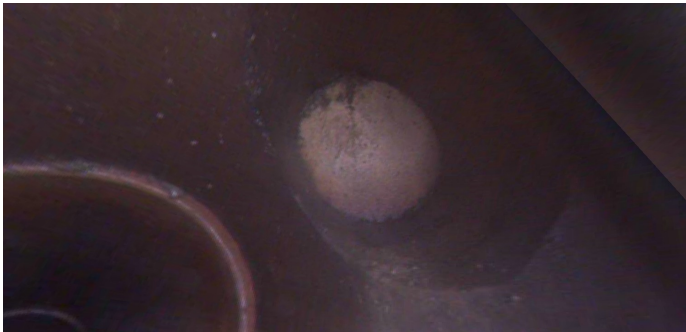
Code: **TFC**
Description: **Tap Factory Capped**

Distance (ft): **64.0**
Structural Grade: **0**
O&M Grade: **0**
Clock Start/From: **1**
Clock To:
1st Value: **4.000**
2nd Value:
Value Percent:
Continuous Index:
Within 8" of Joint: **YES**
Remarks:

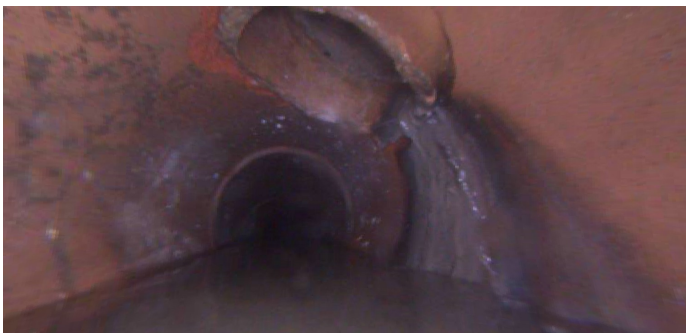
Code: **TBI**
Description: **Tap Break-in Intruding**

Distance (ft): **90.8**
Structural Grade: **0**
O&M Grade: **2**
Clock Start/From: **1**
Clock To:
1st Value: **4.000**
2nd Value: **1.000**
Value Percent:
Continuous Index:
Within 8" of Joint:
Remarks:

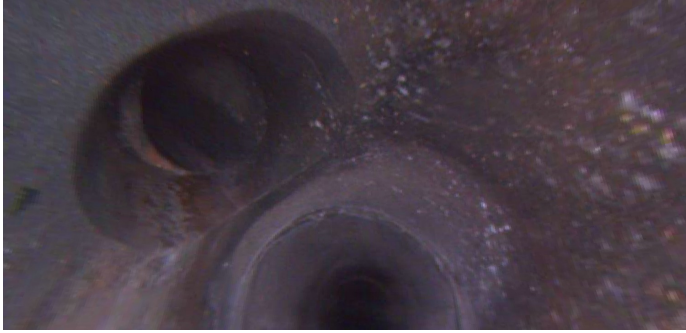
Code: **TF**
Description: **Tap Factory**

Distance (ft): **106.4**
Structural Grade: **0**
O&M Grade: **0**
Clock Start/From: **11**
Clock To:
1st Value: **4.000**
2nd Value:
Value Percent:
Continuous Index:
Within 8" of Joint: **YES**
Remarks:

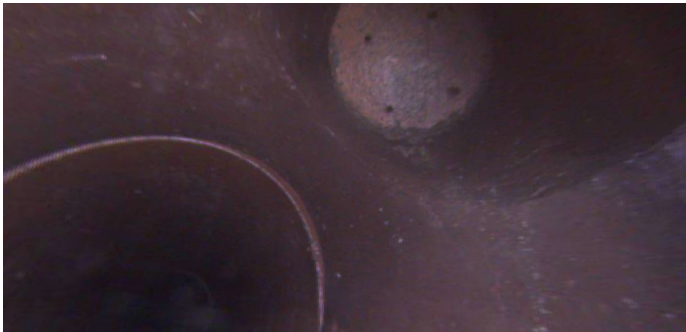
Code: **TFC**
Description: **Tap Factory Capped**

Distance (ft): **114.0**
Structural Grade: **0**
O&M Grade: **0**
Clock Start/From: **1**
Clock To:
1st Value: **4.000**
2nd Value:
Value Percent:
Continuous Index:
Within 8" of Joint: **YES**
Remarks:

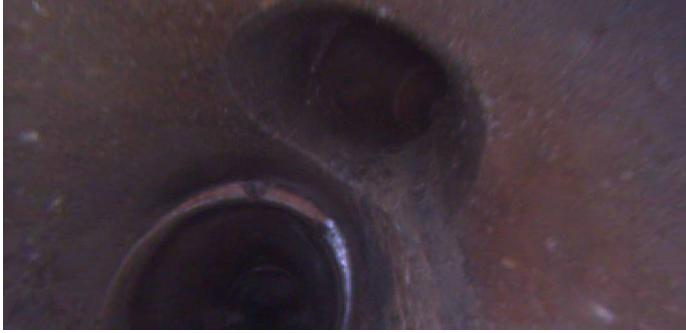
Code: **TF**
Description: **Tap Factory**

Distance (ft): **138.8**
Structural Grade: **0**
O&M Grade: **0**
Clock Start/From: **1**
Clock To:
1st Value: **4.000**
2nd Value:
Value Percent:
Continuous Index:
Within 8" of Joint: **YES**
Remarks:

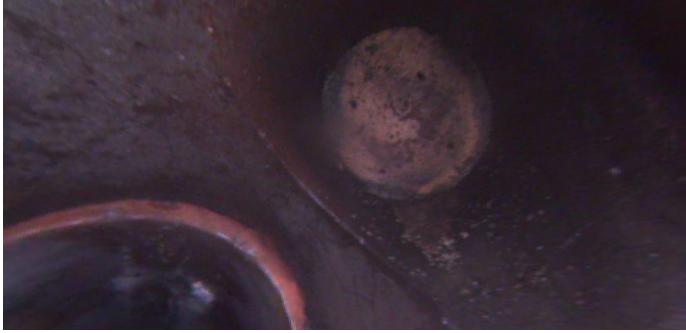
Code: **TFC**
Description: **Tap Factory Capped**

Distance (ft): **167.0**
Structural Grade: **0**
O&M Grade: **0**
Clock Start/From: **1**
Clock To:
1st Value: **4.000**
2nd Value:
Value Percent:
Continuous Index:
Within 8" of Joint: **YES**
Remarks:

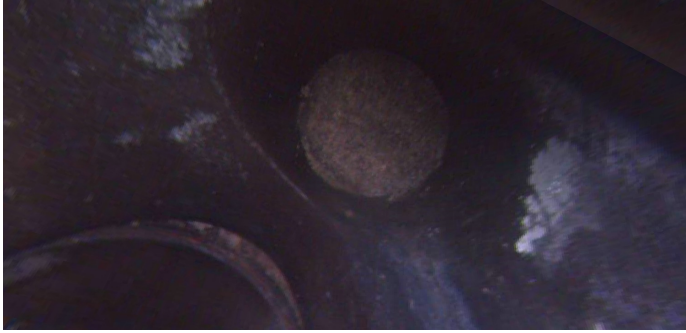
Code: **TFC**
Description: **Tap Factory Capped**

Distance (ft): **189.8**
Structural Grade: **0**
O&M Grade: **0**
Clock Start/From: **1**
Clock To:
1st Value: **4.000**
2nd Value:
Value Percent:
Continuous Index:
Within 8" of Joint: **YES**
Remarks:

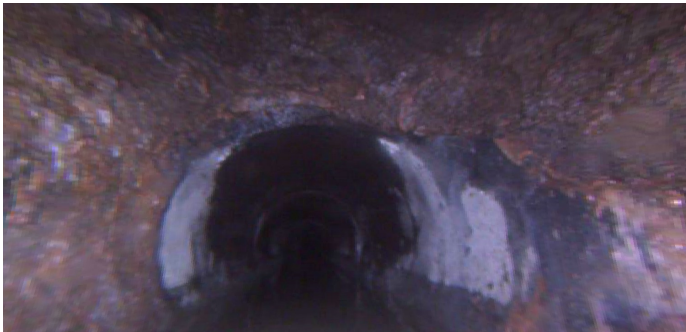
Code: **AMH**
Description: **Manhole**

Distance (ft): **198.5**
Structural Grade: **0**
O&M Grade: **0**
Clock Start/From:
Clock To:
1st Value:
2nd Value:
Value Percent:
Continuous Index:
Within 8" of Joint: **NO**
Remarks: **M-504-049**
