## Profile/Photo Observation Report

Date:	09/14/2021	Weather:		Coding:	PACP 7.0
Pipe Length (ft):	166.0	Owner:	City of Hobart	Pre Clean:	Light Cleaning
P.O.#:	YES502259	Surveyor:	S. Bucklin	PSR:	P-504-050-049
Customer:	City of Hobart	Clean Date:	09/10/2021	Shape:	C

Street:	North Cavender Street	Flow Control:	Not Controlled
City:	Hobart, IN	Year Renewed:	
Location:	Alley	Tape/Media #:	
Purpose:	Routine Assessment	Dia/Height:	10"
Use:	Sanitary Sewage Pipe	Material:	VCP
Drain Area:		Lining:	None
Category:	NA		
Comment:			
Location Details:		Direction of Survey:	Downstream
US MH:	M-504-049	DS MH:	M-504-050
		Total Length Surveyed (ft):	63.3

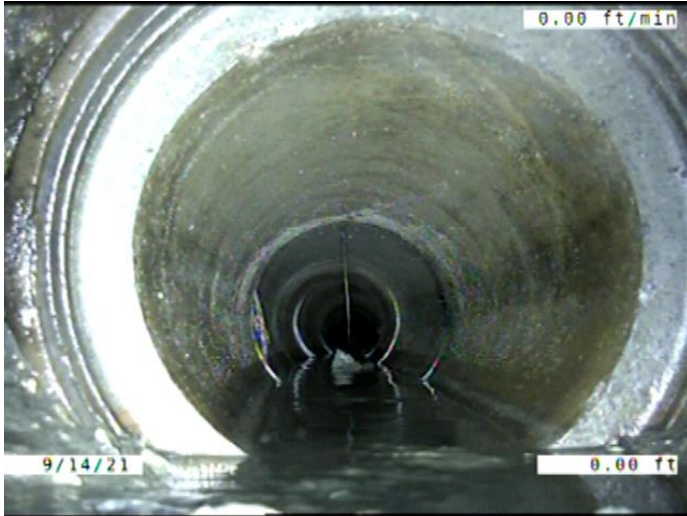
Code: **MWL**  
Description: **Miscellaneous Water Level**

Distance (ft): **.0**  
Structural Grade: **0**  
O&M Grade: **0**  
Clock Start/From:  
Clock To:  
1st Value:  
2nd Value:  
Value Percent: **5.000**  
Continuous Index:  
Within 8" of Joint: **NO**  
Remarks:

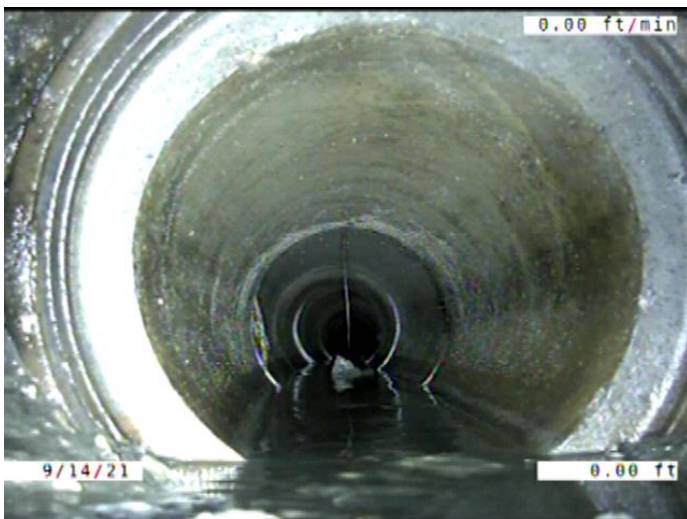
Code: **DSF**  
Description: **Deposits Settled Fine**

Distance (ft): **.0**  
Structural Grade: **0**  
O&M Grade: **2**  
Clock Start/From: **5**  
Clock To: **7**  
1st Value:  
2nd Value:  
Value Percent: **5.000**  
Continuous Index: **S01**  
Within 8" of Joint: **YES**  
Remarks:

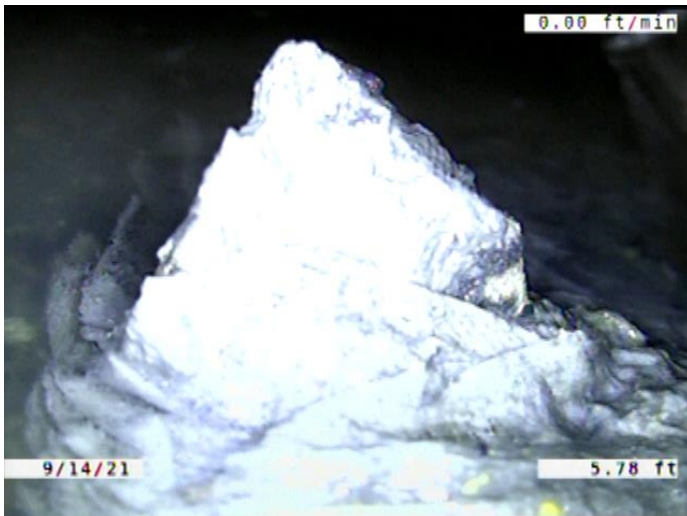
Code: **OBN**  
Description: **Obstruction Construction Debris**

Distance (ft): **5.8**  
Structural Grade: **0**  
O&M Grade: **2**  
Clock Start/From: **6**  
Clock To:  
1st Value:  
2nd Value:  
Value Percent: **5.000**  
Continuous Index:  
Within 8" of Joint: **NO**  
Remarks:

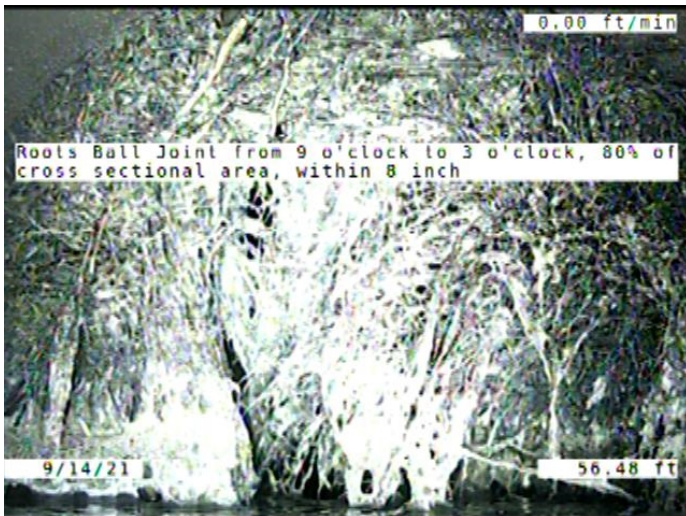
Code: **RBJ**  
 Description: **Roots Ball Joint**

Distance (ft): **56.5**  
 Structural Grade: **0**  
 O&M Grade: **4**  
 Clock Start/From: **9**  
 Clock To: **3**  
 1st Value:  
 2nd Value:  
 Value Percent: **80.000**  
 Continuous Index:  
 Within 8" of Joint: **YES**  
 Remarks:

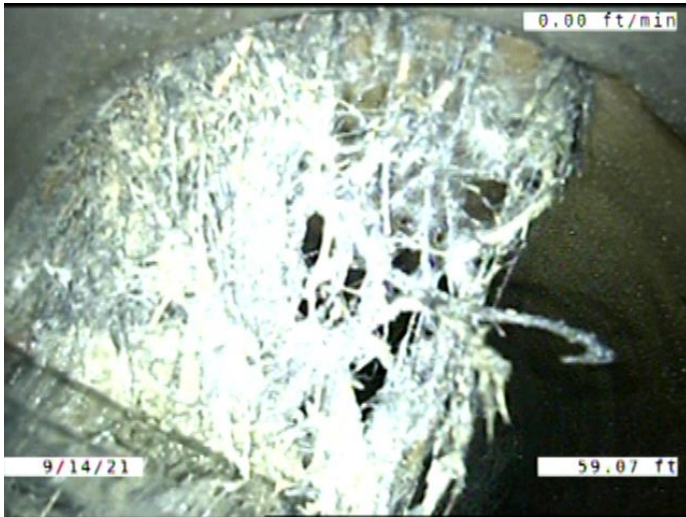
Code: **RMJ**  
 Description: **Roots Medium Joint**

Distance (ft): **59.1**  
 Structural Grade: **0**  
 O&M Grade: **3**  
 Clock Start/From: **9**  
 Clock To: **12**  
 1st Value:  
 2nd Value:  
 Value Percent: **40.000**  
 Continuous Index:  
 Within 8" of Joint: **YES**  
 Remarks:
