## Profile/Photo Observation Report

Street:	<b>North Cavender Street</b>	Flow Control:	<b>Not Controlled</b>
City:	<b>Hobart, IN</b>	Year Renewed:	
Location:	<b>Alley</b>	Tape/Media #:	
Purpose:	<b>Routine Assessment</b>	Dia/Height:	<b>10"</b>
Use:	<b>Sanitary Sewage Pipe</b>	Material:	<b>VCP</b>
Drain Area:		Lining:	<b>None</b>
Category:	<b>NA</b>		
Comment:

Location Details:		Direction of Survey:	<b>Downstream</b>
US MH:	<b>M-504-049</b>	DS MH:	<b>M-504-050</b>
		Total Length Surveyed (ft):	<b>63.3</b>

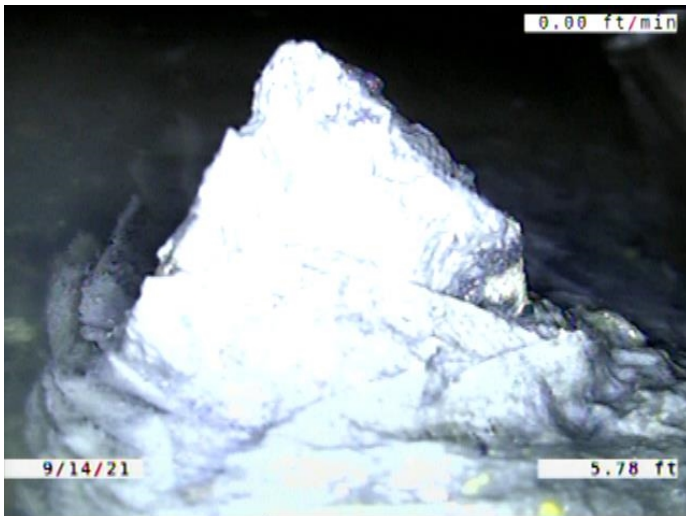
Code: **OBN**  
 Description: **Obstruction Construction Debris**

Distance (ft): **5.8**  
 Structural Grade: **0**  
 O&M Grade: **2**  
 Clock Start/From: **6**  
 Clock To:  
 1st Value:  
 2nd Value:  
 Value Percent: **5.000**  
 Continuous Index:  
 Within 8" of Joint: **NO**  
 Remarks:

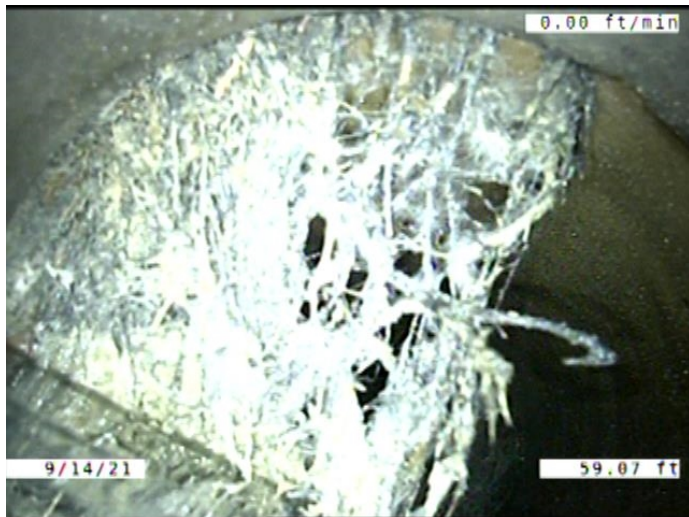
Code: **RMJ**  
 Description: **Roots Medium Joint**

Distance (ft): **59.1**  
 Structural Grade: **0**  
 O&M Grade: **3**  
 Clock Start/From: **9**  
 Clock To: **12**  
 1st Value:  
 2nd Value:  
 Value Percent: **40.000**  
 Continuous Index:  
 Within 8" of Joint: **YES**  
 Remarks:
