Profile/Photo Observation Report

| Street: | Summerlin | Flow Control: | Not Controlled |

| US MH: | M-504-050 | DS MH: | M-504-051 |

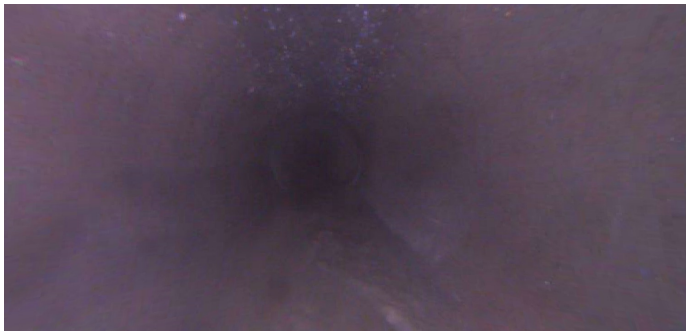
Code: **AMH**
Description: **Manhole**

Distance (ft): **.0**
Structural Grade: **0**
O&M Grade: **0**
Clock Start/From:
Clock To:
1st Value:
2nd Value:
Value Percent:
Continuous Index:
Within 8" of Joint: **NO**
Remarks: **M-504-050**

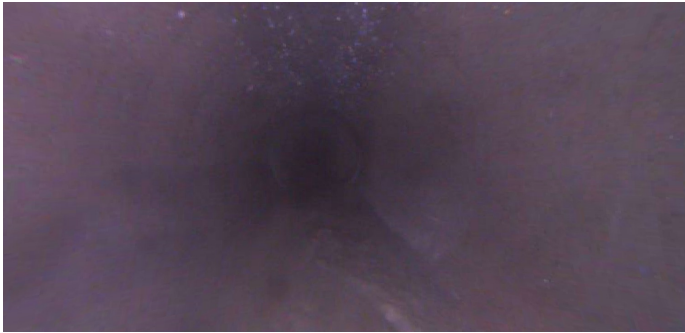
| Code: | MWL |
| Description: | Water Level |

| Value Percent: | 5.000 |

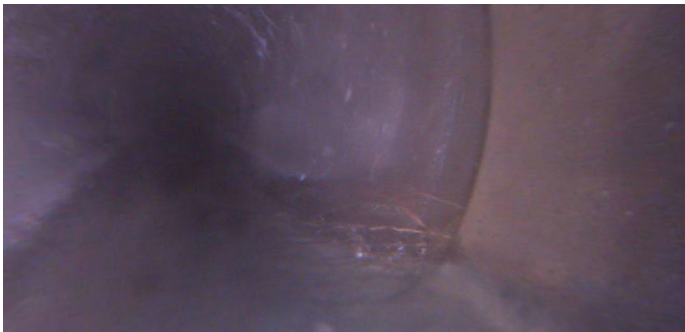
| Code: | RFJ |
| Description: | Roots Fine Joint |

| Distance (ft): | 3.7 |
| O&M Grade: | 1 |
| Clock Start/From: | 7 |
| Clock To: | 5 |
| Within 8" of Joint: | YES |
| Remarks: | wandering |

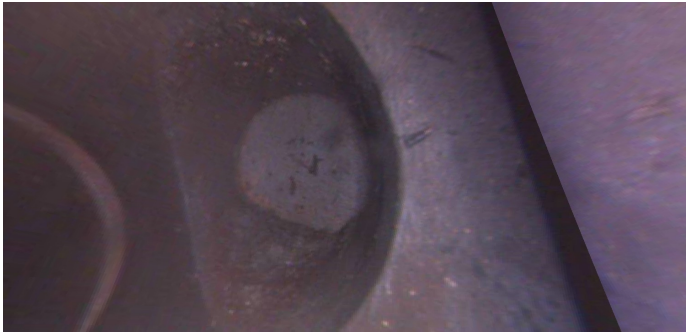
Code: **TFC**
Description: **Tap Factory Capped**

Distance (ft): **17.7**
Structural Grade: **0**
O&M Grade: **0**
Clock Start/From: **10**
Clock To:
1st Value: **4.000**
2nd Value:
Value Percent:
Continuous Index:
Within 8" of Joint: **YES**
Remarks:

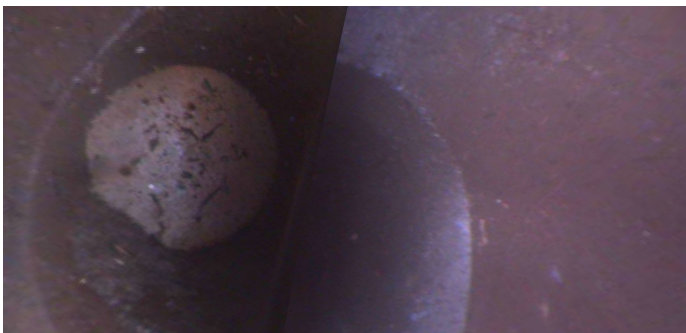
Code: **TFC**
Description: **Tap Factory Capped**

Distance (ft): **42.7**
Structural Grade: **0**
O&M Grade: **0**
Clock Start/From: **10**
Clock To:
1st Value: **4.000**
2nd Value:
Value Percent:
Continuous Index:
Within 8" of Joint: **YES**
Remarks:

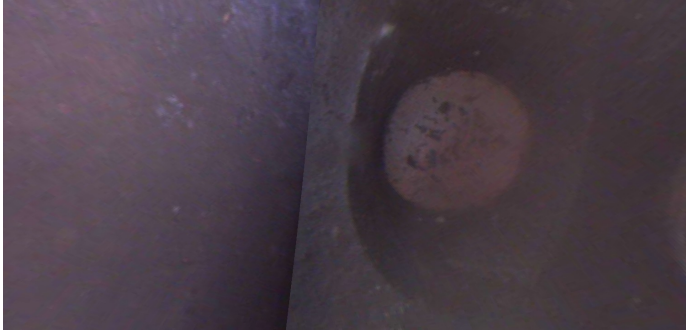
Code: **TFC**
Description: **Tap Factory Capped**

Distance (ft): **65.0**
Structural Grade: **0**
O&M Grade: **0**
Clock Start/From: **2**
Clock To:
1st Value: **4.000**
2nd Value:
Value Percent:
Continuous Index:
Within 8" of Joint: **YES**
Remarks:

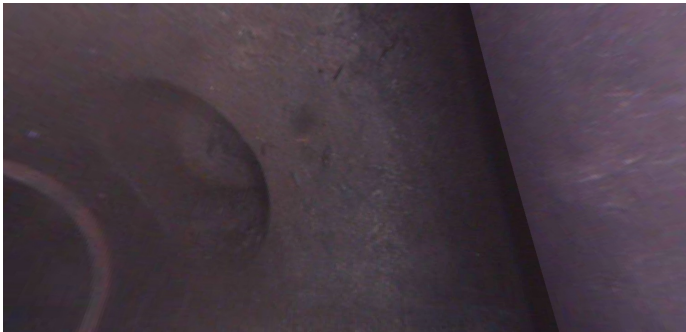
Code: **TFC**
Description: **Tap Factory Capped**

Distance (ft): **67.5**
Structural Grade: **0**
O&M Grade: **0**
Clock Start/From: **11**
Clock To:
1st Value: **4.000**
2nd Value:
Value Percent:
Continuous Index:
Within 8" of Joint: **YES**
Remarks:

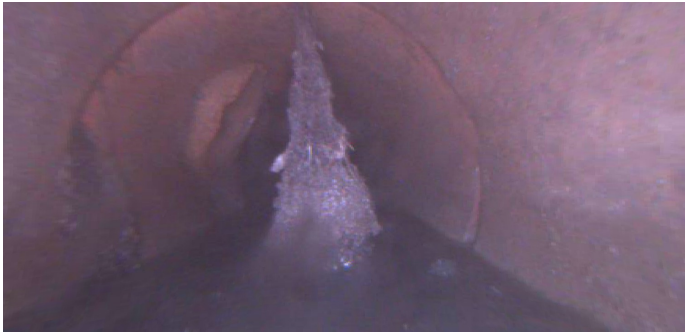
Code: **RMJ**
Description: **Roots Medium Joint**

Distance (ft): **67.5**
Structural Grade: **0**
O&M Grade: **3**
Clock Start/From: **12**
Clock To:
1st Value:
2nd Value:
Value Percent: **10.000**
Continuous Index:
Within 8" of Joint: **YES**
Remarks:

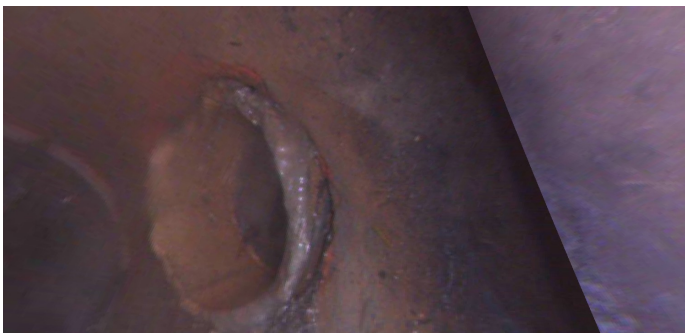
Code: **TB**
Description: **Tap Break-in**

Distance (ft): **69.3**
Structural Grade: **0**
O&M Grade: **0**
Clock Start/From: **10**
Clock To:
1st Value: **4.000**
2nd Value:
Value Percent:
Continuous Index:
Within 8" of Joint: **YES**
Remarks:

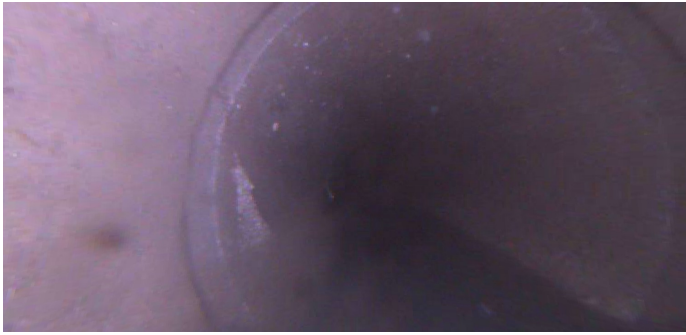
Code: **MSA**
Description: **Abandoned Survey**

Distance (ft): **72.6**
Structural Grade: **0**
O&M Grade: **0**
Clock Start/From:
Clock To:
1st Value:
2nd Value:
Value Percent:
Continuous Index:
Within 8" of Joint: **NO**
Remarks: **stuck on wall**

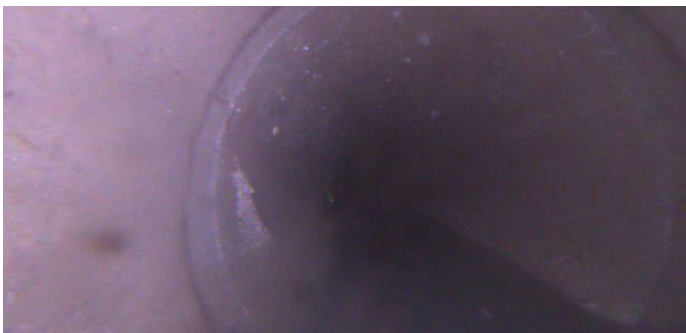
Code: **RFJ**
Description: **Roots Fine Joint**

Distance (ft): **72.6**
Structural Grade: **0**
O&M Grade: **1**
Clock Start/From: **7**
Clock To: **5**
1st Value:
2nd Value:
Value Percent:
Continuous Index: **F01**
Within 8" of Joint: **YES**
Remarks: **wandering**
