Profile/Photo Observation Report

Street:	North Cavender Street	Flow Control:	Not Controlled
City:	Hobart, IN	Year Renewed:	
Location:	Alley	Tape/Media #:	
Purpose:	Routine Assessment	Dia/Height:	10"
Use:	Sanitary Sewage Pipe	Material:	VCP
Drain Area:		Lining:	None
Category:	NA

US MH: **M-504-050** DS MH: **M-504-051** Total Length Surveyed (ft): **128.3**

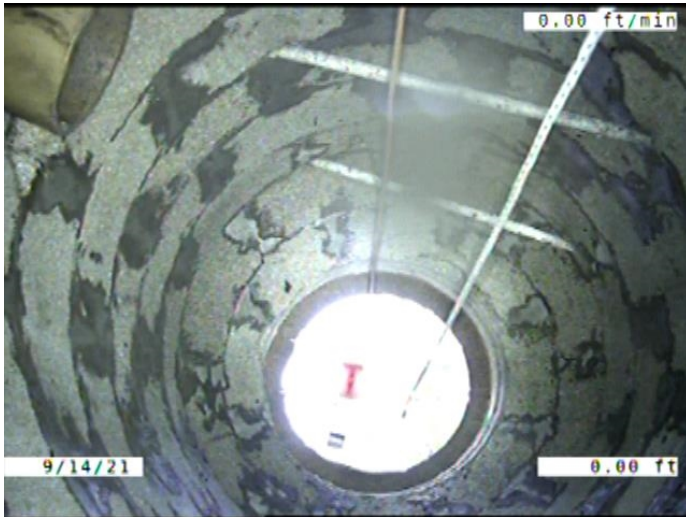
Code: **AMH**
 Description: **Manhole**

Distance (ft): **.0**
 Structural Grade: **0**
 O&M Grade: **0**
 Clock Start/From:
 Clock To:
 1st Value:
 2nd Value:
 Value Percent:
 Continuous Index:
 Within 8" of Joint: **NO**
 Remarks: **M-504-050**

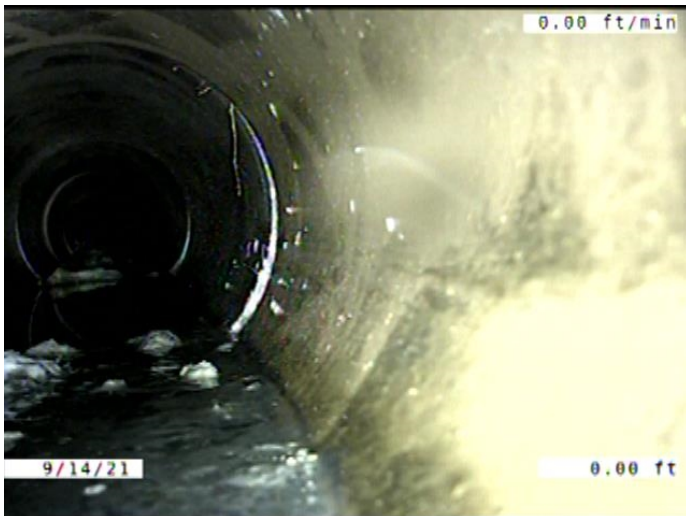
Code: **MWL**
 Description: **Miscellaneous Water Level**

Distance (ft): **.0**
 Structural Grade: **0**
 O&M Grade: **0**
 Clock Start/From:
 Clock To:
 1st Value:
 2nd Value:
 Value Percent: **5.000**
 Continuous Index:
 Within 8" of Joint: **NO**
 Remarks:

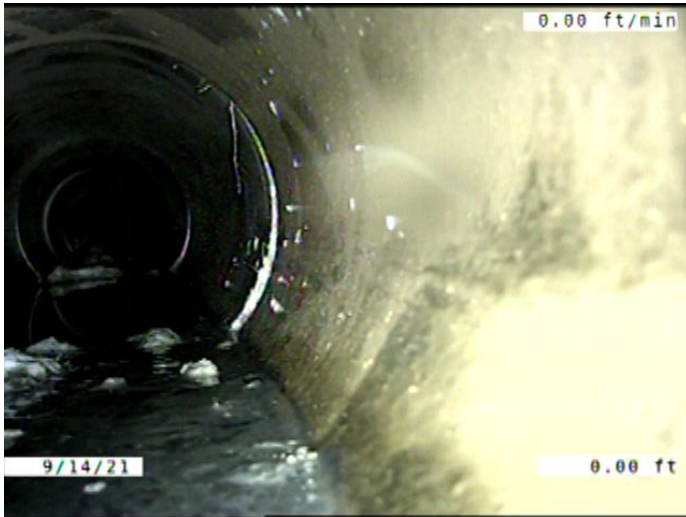
Code: **DSF**
 Description: **Deposits Settled Fine**

Distance (ft): **.0**
 Structural Grade: **0**
 O&M Grade: **2**
 Clock Start/From: **5**
 Clock To: **7**
 1st Value:
 2nd Value:
 Value Percent: **5.000**
 Continuous Index: **S01**
 Within 8" of Joint: **YES**
 Remarks:

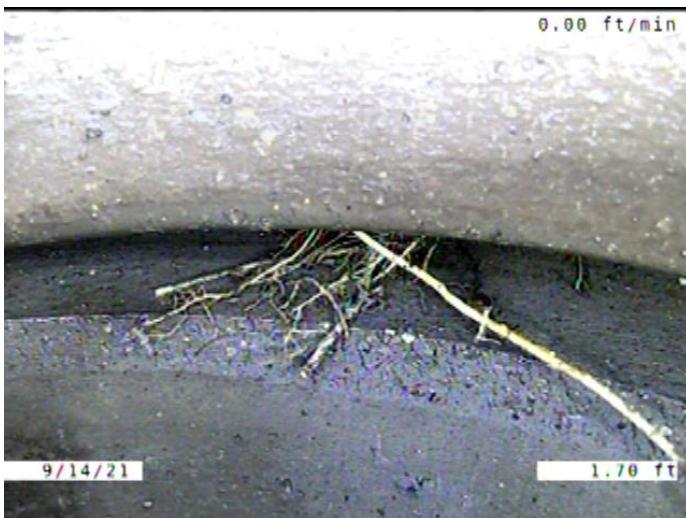
Code: **RFJ**
 Description: **Roots Fine Joint**

Distance (ft): **1.7**
 Structural Grade: **0**
 O&M Grade: **1**
 Clock Start/From: **1**
 Clock To:
 1st Value:
 2nd Value:
 Value Percent:
 Continuous Index:
 Within 8" of Joint: **YES**
 Remarks:

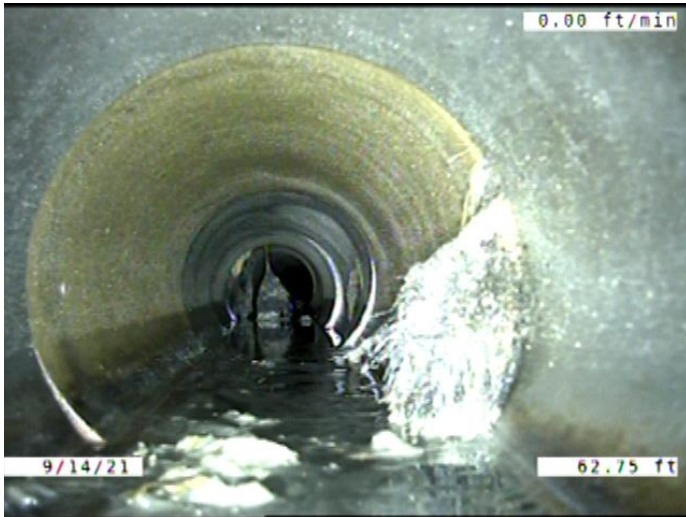
Code: **RMJ**
 Description: **Roots Medium Joint**

Distance (ft): **62.7**
 Structural Grade: **0**
 O&M Grade: **3**
 Clock Start/From: **2**
 Clock To: **4**
 1st Value:
 2nd Value:
 Value Percent: **5.000**
 Continuous Index:
 Within 8" of Joint: **YES**
 Remarks:

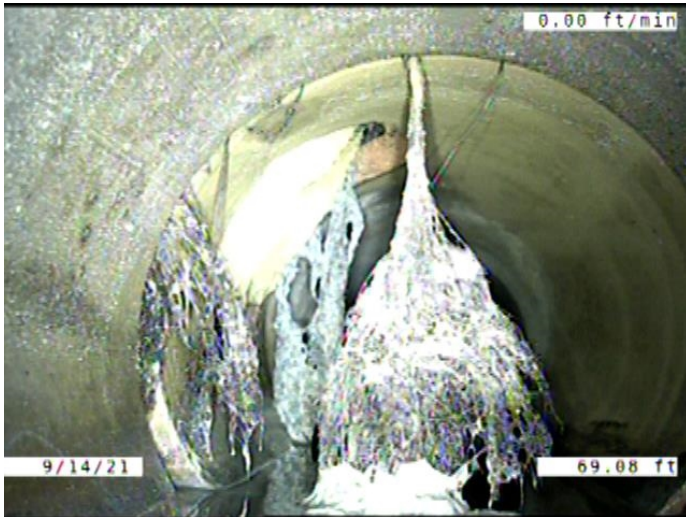
Code: **RMJ**
 Description: **Roots Medium Joint**

Distance (ft): **69.1**
 Structural Grade: **0**
 O&M Grade: **3**
 Clock Start/From: **9**
 Clock To: **1**
 1st Value:
 2nd Value:
 Value Percent: **10.000**
 Continuous Index:
 Within 8" of Joint: **YES**
 Remarks:

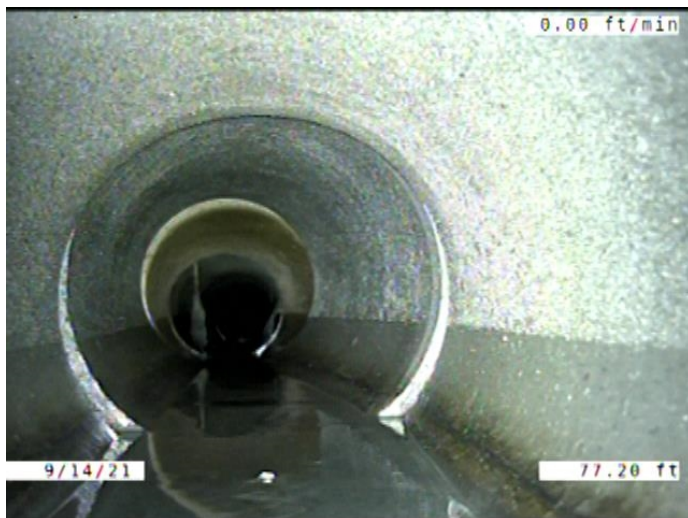
Code: **DSGV**
 Description: **Deposits Settled Gravel**

Distance (ft): **77.2**
 Structural Grade: **0**
 O&M Grade: **2**
 Clock Start/From: **4**
 Clock To: **8**
 1st Value:
 2nd Value:
 Value Percent: **5.000**
 Continuous Index: **F02**
 Within 8" of Joint: **YES**
 Remarks:

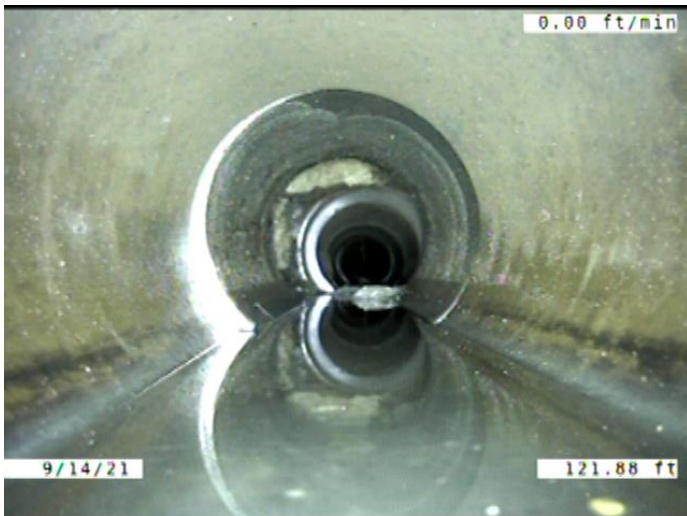
Code: **RFJ**
 Description: **Roots Fine Joint**

Distance (ft): **121.9**
 Structural Grade: **0**
 O&M Grade: **1**
 Clock Start/From: **9**
 Clock To: **3**
 1st Value:
 2nd Value:
 Value Percent:
 Continuous Index: **F04**
 Within 8" of Joint: **YES**
 Remarks:

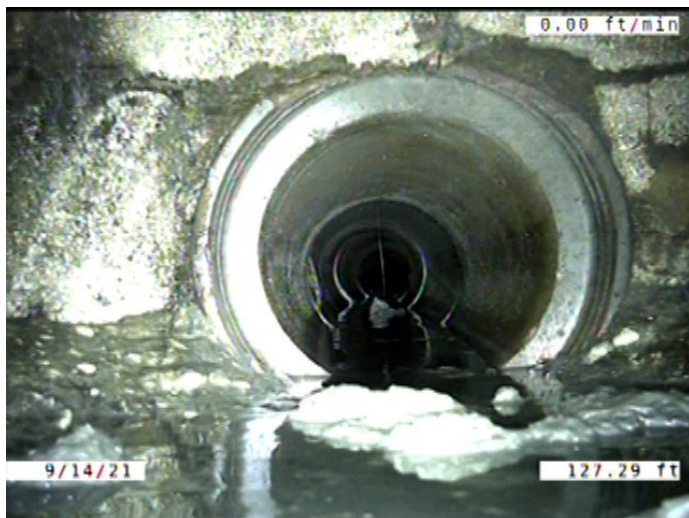
Code: **DSF**
Description: **Deposits Settled Fine**

Distance (ft): **127.3**
Structural Grade: **0**
O&M Grade: **2**
Clock Start/From: **5**
Clock To: **7**
1st Value:
2nd Value:
Value Percent: **5.000**
Continuous Index: **F01**
Within 8" of Joint: **YES**
Remarks:
