M-504-134

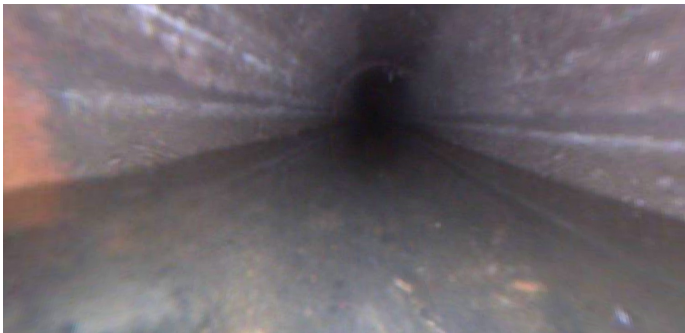
Code: **AMH**
Description: **Manhole**

Distance (ft): **.0**
Structural Grade: **0**
O&M Grade: **0**
Clock Start/From:
Clock To:
1st Value:
2nd Value:
Value Percent:
Continuous Index:
Within 8" of Joint: **NO**
Remarks: **M-504-050**

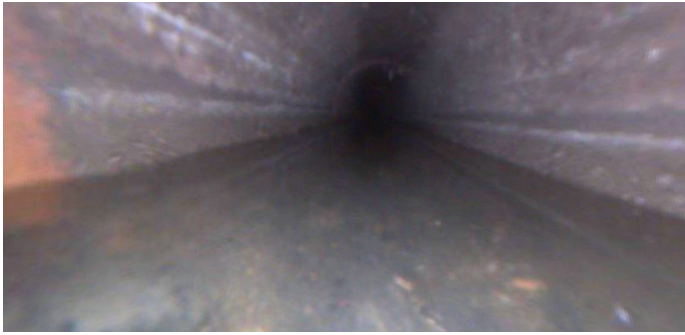
Code: **MWL**
Description: **Water Level**

Distance (ft): **.0**
Structural Grade: **0**
O&M Grade: **0**
Clock Start/From:
Clock To:
1st Value:
2nd Value:
Value Percent: **20.000**
Continuous Index:
Within 8" of Joint: **NO**
Remarks:

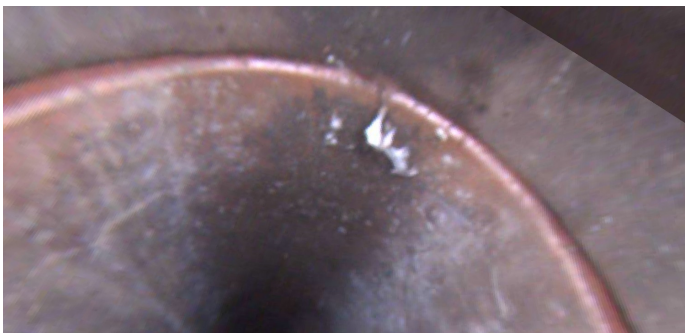
Code: **RFJ**
Description: **Roots Fine Joint**

Distance (ft): **3.8**
Structural Grade: **0**
O&M Grade: **1**
Clock Start/From: **1**
Clock To:
1st Value:
2nd Value:
Value Percent:
Continuous Index:
Within 8" of Joint: **YES**
Remarks:

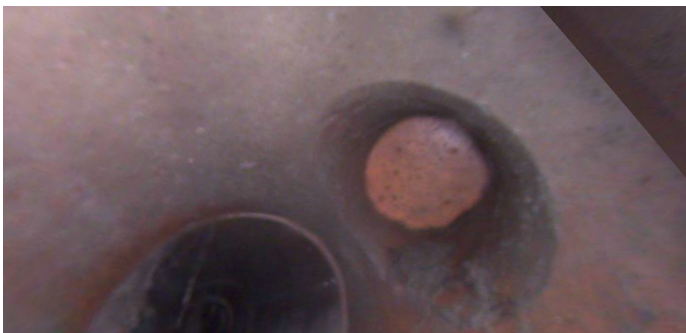
Code: **TFC**
Description: **Tap Factory Capped**

Distance (ft): **20.9**
Structural Grade: **0**
O&M Grade: **0**
Clock Start/From: **1**
Clock To:
1st Value: **4.000**
2nd Value:
Value Percent:
Continuous Index:
Within 8" of Joint: **YES**
Remarks:

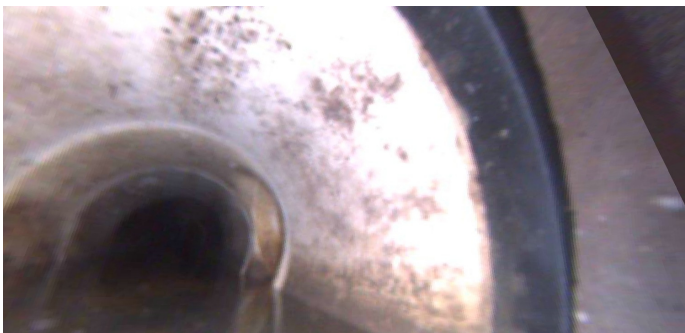
Code: **MMC**
Description: **Material Change**

Distance (ft): **27.1**
Structural Grade: **0**
O&M Grade: **0**
Clock Start/From:
Clock To:
1st Value:
2nd Value:
Value Percent:
Continuous Index:
Within 8" of Joint: **NO**
Remarks: **pvc**

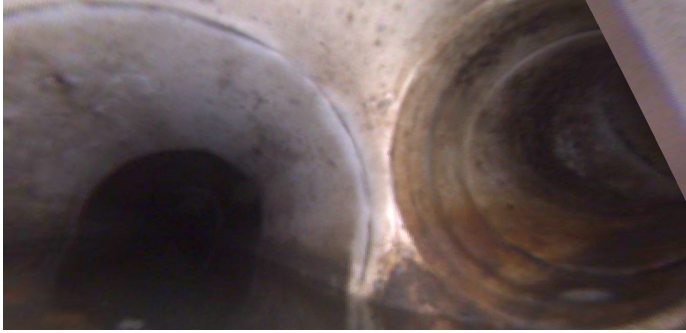
Code: **TF**
Description: **Tap Factory**

Distance (ft): **28.3**
Structural Grade: **0**
O&M Grade: **0**
Clock Start/From: **3**
Clock To:
1st Value: **4.000**
2nd Value:
Value Percent:
Continuous Index:
Within 8" of Joint: **YES**
Remarks:

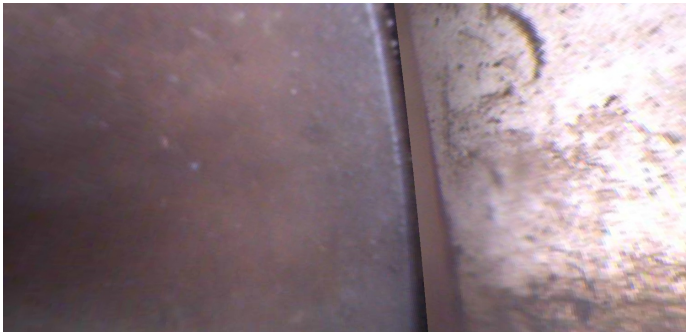
Code: **MMC**
Description: **Material Change**

Distance (ft): **30.2**
Structural Grade: **0**
O&M Grade: **0**
Clock Start/From:
Clock To:
1st Value:
2nd Value:
Value Percent:
Continuous Index:
Within 8" of Joint: **NO**
Remarks: **vcp**

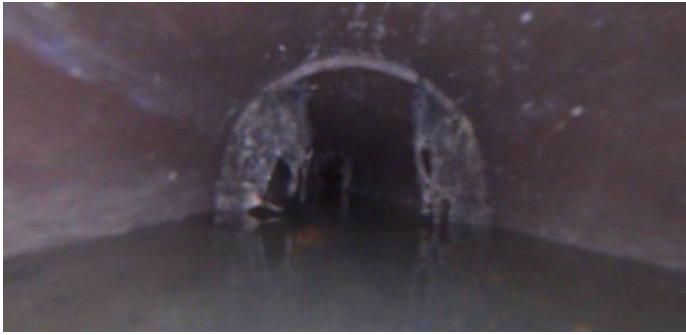
Code: **RMJ**
Description: **Roots Medium Joint**

Distance (ft): **40.0**
Structural Grade: **0**
O&M Grade: **3**
Clock Start/From: **8**
Clock To: **4**
1st Value:
2nd Value:
Value Percent: **5.000**
Continuous Index: **S02**
Within 8" of Joint: **YES**
Remarks: **wandering**

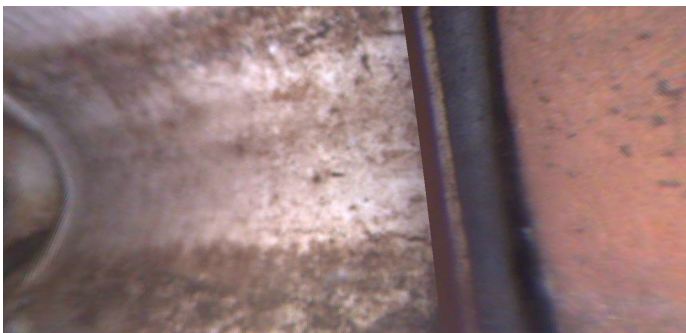
Code: **MMC**
Description: **Material Change**

Distance (ft): **49.2**
Structural Grade: **0**
O&M Grade: **0**
Clock Start/From:
Clock To:
1st Value:
2nd Value:
Value Percent:
Continuous Index:
Within 8" of Joint: **NO**
Remarks: **pvc**

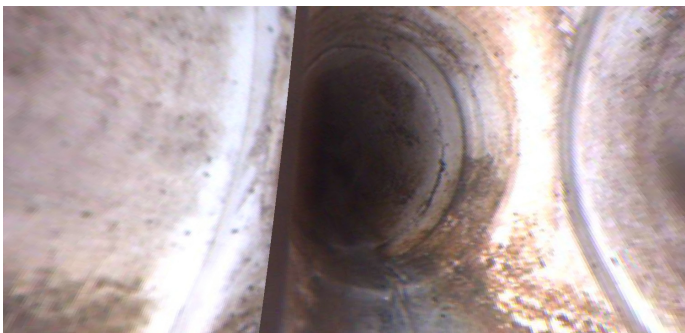
Code: **TF**
Description: **Tap Factory**

Distance (ft): **51.1**
Structural Grade: **0**
O&M Grade: **0**
Clock Start/From: **2**
Clock To:
1st Value: **4.000**
2nd Value:
Value Percent:
Continuous Index:
Within 8" of Joint: **YES**
Remarks:

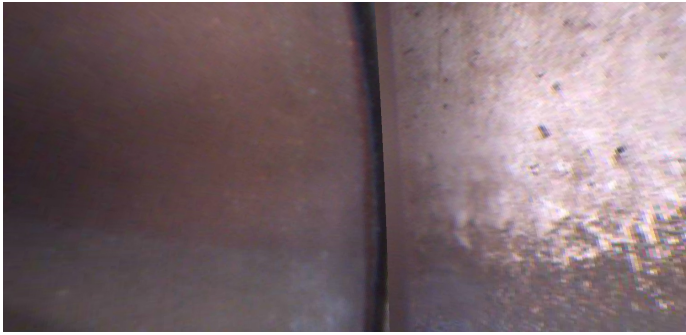
Code: **MMC**
Description: **Material Change**

Distance (ft): **52.3**
Structural Grade: **0**
O&M Grade: **0**
Clock Start/From:
Clock To:
1st Value:
2nd Value:
Value Percent:
Continuous Index:
Within 8" of Joint: **NO**
Remarks: **vcp**

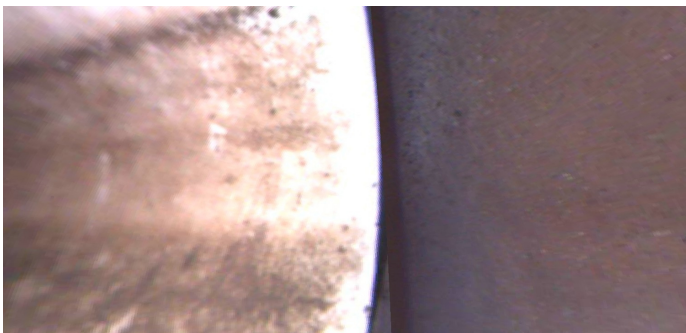
Code: **MMC**
Description: **Material Change**

Distance (ft): **56.6**
Structural Grade: **0**
O&M Grade: **0**
Clock Start/From:
Clock To:
1st Value:
2nd Value:
Value Percent:
Continuous Index:
Within 8" of Joint: **NO**
Remarks: **pvc**

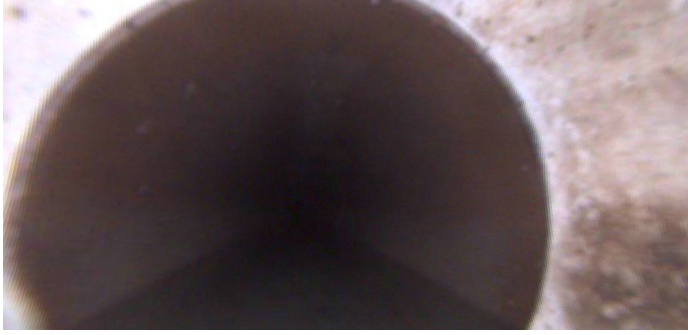
Code:	MMC
Description:	Material Change
Distance (ft):	64.0
Structural Grade:	0
O&M Grade:	0
Clock Start/From:	
Clock To:	
1st Value:	
2nd Value:	
Value Percent:	
Continuous Index:	
Within 8" of Joint:	NO
Remarks:	vcp

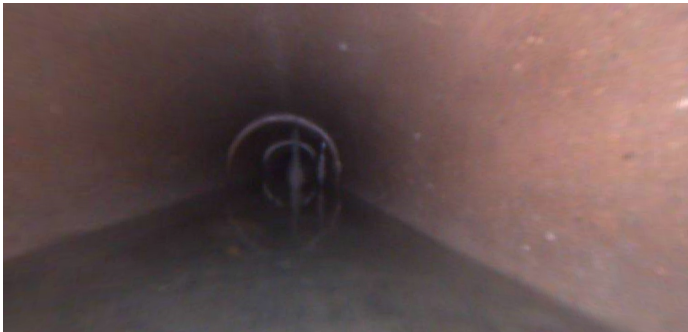
Code:	MWL
Description:	Water Level
Distance (ft):	72.9
Structural Grade:	0
O&M Grade:	0
Clock Start/From:	
Clock To:	
1st Value:	
2nd Value:	
Value Percent:	25.000
Continuous Index:	
Within 8" of Joint:	NO
Remarks:

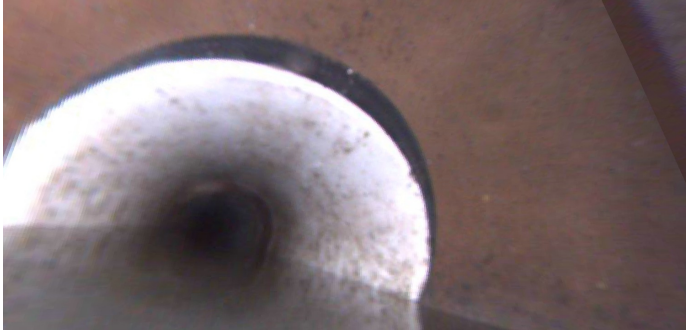
Code: **MMC**
Description: **Material Change**

Distance (ft): **77.0**
Structural Grade: **0**
O&M Grade: **0**
Clock Start/From:
Clock To:
1st Value:
2nd Value:
Value Percent:
Continuous Index:
Within 8" of Joint: **NO**
Remarks: **pvc**

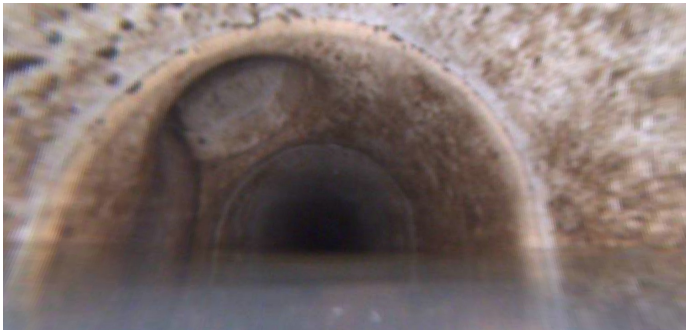
Code: **TF**
Description: **Tap Factory**

Distance (ft): **79.0**
Structural Grade: **0**
O&M Grade: **0**
Clock Start/From: **11**
Clock To:
1st Value: **4.000**
2nd Value:
Value Percent:
Continuous Index:
Within 8" of Joint: **YES**
Remarks:

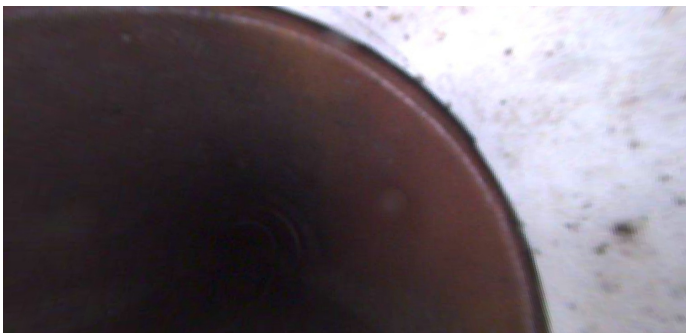
Code: **MMC**
Description: **Material Change**

Distance (ft): **88.1**
Structural Grade: **0**
O&M Grade: **0**
Clock Start/From:
Clock To:
1st Value:
2nd Value:
Value Percent:
Continuous Index:
Within 8" of Joint: **NO**
Remarks: **vcp**

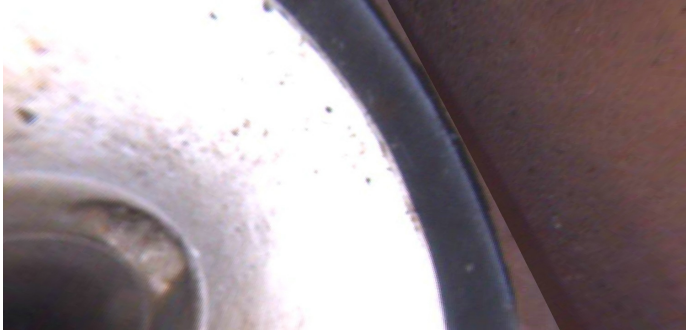
Code: **MMC**
Description: **Material Change**

Distance (ft): **124.9**
Structural Grade: **0**
O&M Grade: **0**
Clock Start/From:
Clock To:
1st Value:
2nd Value:
Value Percent:
Continuous Index:
Within 8" of Joint: **NO**
Remarks: **pvc**

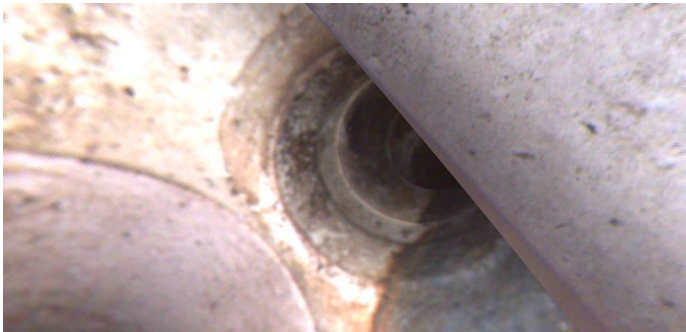
Code: **TF**
Description: **Tap Factory**

Distance (ft): **126.1**
Structural Grade: **0**
O&M Grade: **0**
Clock Start/From: **1**
Clock To:
1st Value: **4.000**
2nd Value:
Value Percent:
Continuous Index:
Within 8" of Joint: **YES**
Remarks:

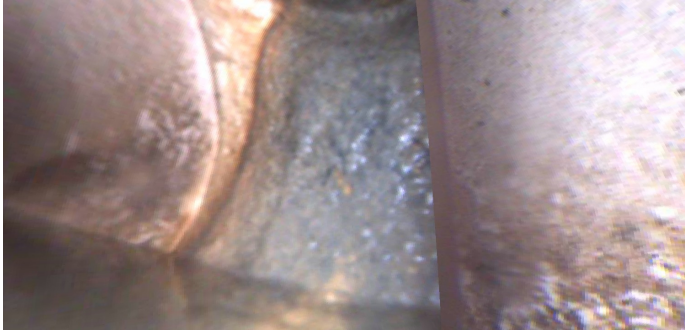
Code: **DAGS**
Description: **Deposits Attached Grease**

Distance (ft): **126.1**
Structural Grade: **0**
O&M Grade: **2**
Clock Start/From: **2**
Clock To: **5**
1st Value:
2nd Value:
Value Percent: **5.000**
Continuous Index:
Within 8" of Joint: **NO**
Remarks:

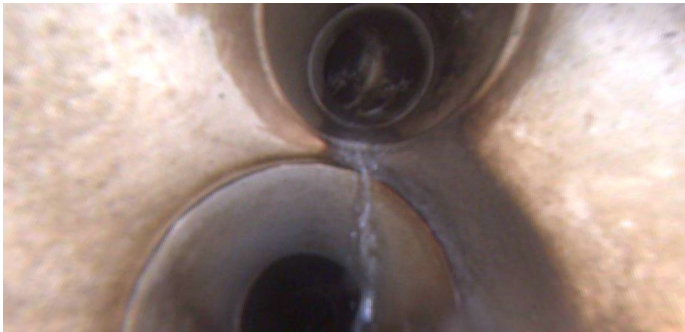
Code: **TFA**
Description: **Tap Factory Active**

Distance (ft): **131.2**
Structural Grade: **0**
O&M Grade: **0**
Clock Start/From: **12**
Clock To:
1st Value: **4.000**
2nd Value:
Value Percent:
Continuous Index:
Within 8" of Joint: **YES**
Remarks:

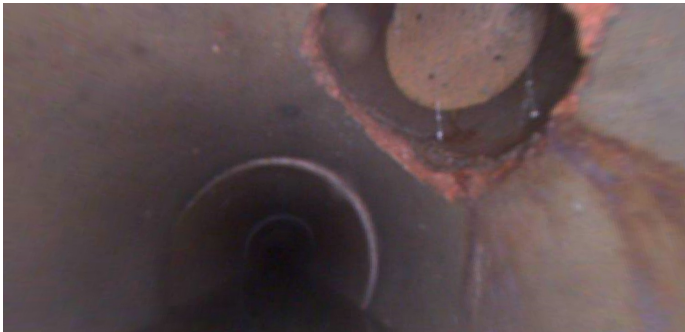
Code: **TBC**
Description: **Tap Break-in Capped**

Distance (ft): **134.7**
Structural Grade: **0**
O&M Grade: **2**
Clock Start/From: **1**
Clock To:
1st Value: **4.000**
2nd Value:
Value Percent:
Continuous Index:
Within 8" of Joint: **YES**
Remarks:

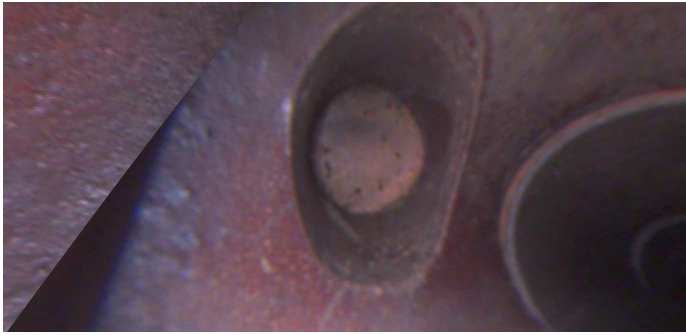
Code: **TFC**
Description: **Tap Factory Capped**

Distance (ft): **150.3**
Structural Grade: **0**
O&M Grade: **0**
Clock Start/From: **10**
Clock To:
1st Value: **4.000**
2nd Value:
Value Percent:
Continuous Index:
Within 8" of Joint: **YES**
Remarks:

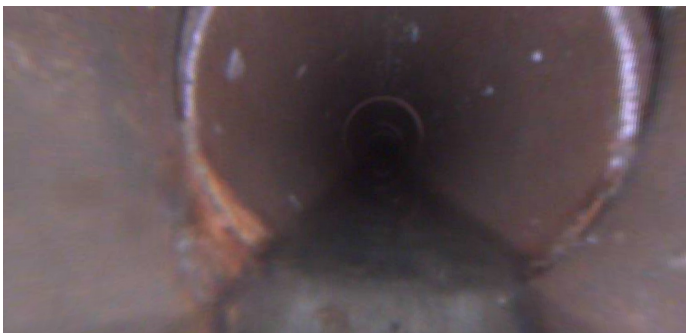
Code: **IS**
Description: **Infil Stain**

Distance (ft): **161.7**
Structural Grade: **0**
O&M Grade: **0**
Clock Start/From: **7**
Clock To: **8**
1st Value:
2nd Value:
Value Percent:
Continuous Index:
Within 8" of Joint: **YES**
Remarks:

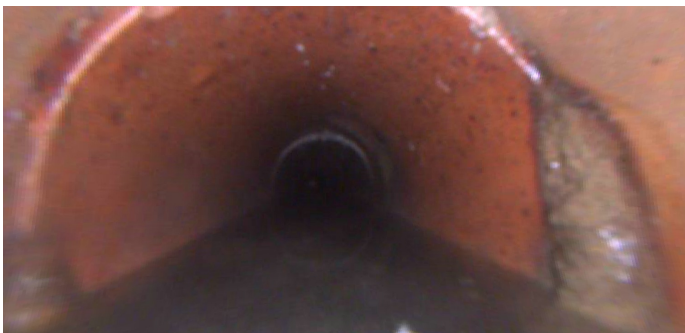
Code: **DAZ**
Description: **Deposits Attached Other**

Distance (ft): **172.6**
Structural Grade: **0**
O&M Grade: **2**
Clock Start/From: **2**
Clock To: **8**
1st Value:
2nd Value:
Value Percent: **5.000**
Continuous Index:
Within 8" of Joint: **YES**
Remarks:

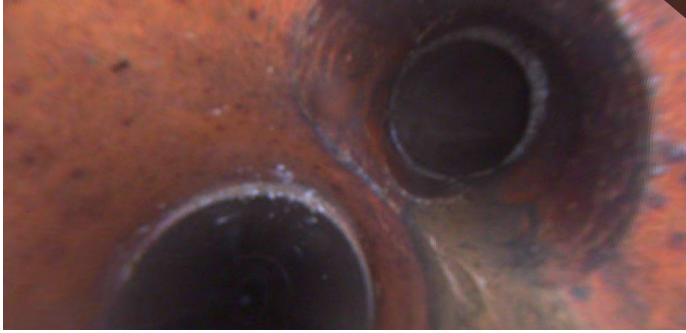
Code: **TF**
Description: **Tap Factory**

Distance (ft): **173.9**
Structural Grade: **0**
O&M Grade: **0**
Clock Start/From: **1**
Clock To:
1st Value: **4.000**
2nd Value:
Value Percent:
Continuous Index:
Within 8" of Joint: **YES**
Remarks:

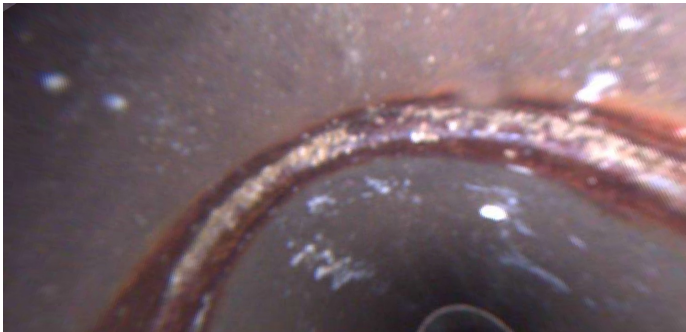
Code: **IS**
Description: **Infil Stain**

Distance (ft): **180.1**
Structural Grade: **0**
O&M Grade: **0**
Clock Start/From: **8**
Clock To: **4**
1st Value:
2nd Value:
Value Percent:
Continuous Index:
Within 8" of Joint: **YES**
Remarks:

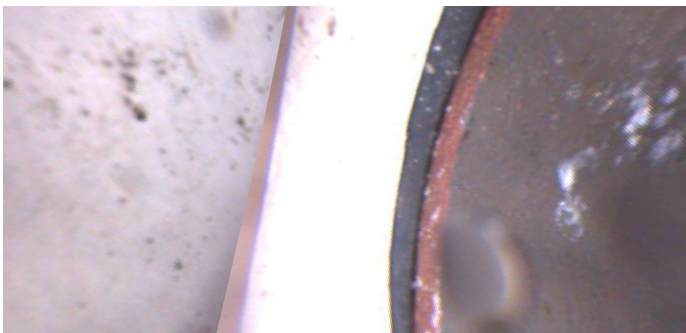
Code: **MMC**
Description: **Material Change**

Distance (ft): **183.1**
Structural Grade: **0**
O&M Grade: **0**
Clock Start/From:
Clock To:
1st Value:
2nd Value:
Value Percent:
Continuous Index:
Within 8" of Joint: **NO**
Remarks: **pvc**

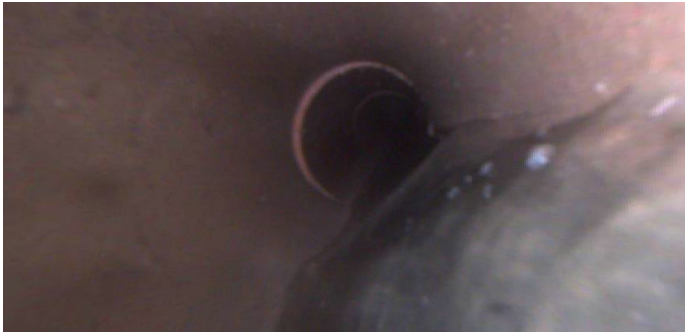
Code: **MSA**
Description: **Abandoned Survey**

Distance (ft): **205.5**
Structural Grade: **0**
O&M Grade: **0**
Clock Start/From:
Clock To:
1st Value:
2nd Value:
Value Percent:
Continuous Index:
Within 8" of Joint: **NO**
Remarks: **camera flipped**

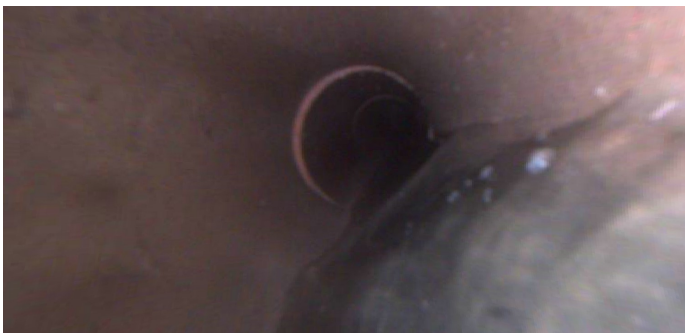
Code: **RFJ**
Description: **Roots Fine Joint**

Distance (ft): **205.5**
Structural Grade: **0**
O&M Grade: **1**
Clock Start/From: **7**
Clock To: **5**
1st Value:
2nd Value:
Value Percent:
Continuous Index: **F01**
Within 8" of Joint: **YES**
Remarks: **wandering**

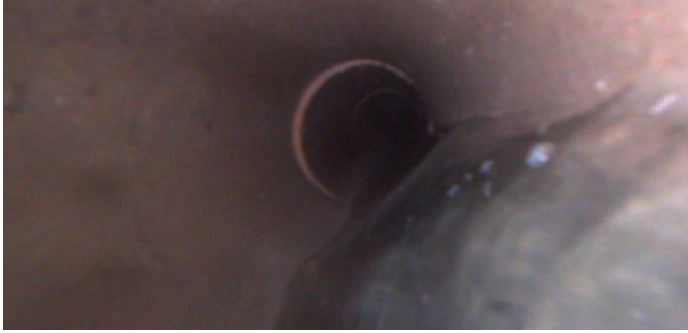
Code:	RMJ
Description:	Roots Medium Joint
Distance (ft):	205.5
Structural Grade:	0
O&M Grade:	3
Clock Start/From:	8
Clock To:	4
1st Value:	
2nd Value:	
Value Percent:	5.000
Continuous Index:	F02
Within 8" of Joint:	YES
Remarks:	wandering
