Profile/Photo Observation Report

Date:	04/19/2018	Weather:		Coding:	PACP 6.0
Pipe Length (ft):	252.8	Owner:	NA	Pre Clean:	Not Known
P.O.#:		Surveyor:	Byrd Fitzgerald	PSR:	P-504-134-050
Customer:		Clean Date:	01/01/1900	Shape:	C

Street:	Summerlin	Flow Control:	Not Controlled
City:	Hobart, IN	Year Renewed:	
Location:	Light Highway	Tape/Media #:	
Purpose:	Not Known	Dia/Height:	10"
Use:	Sanitary	Material:	VCP
Drain Area:	NA	Lining:	
Category:	NA		
Comment:			
Location Details:		Direction of Survey:	Downstream
US MH:	M-504-050	DS MH:	M-504-134
		Total Length Surveyed (ft):	205.5

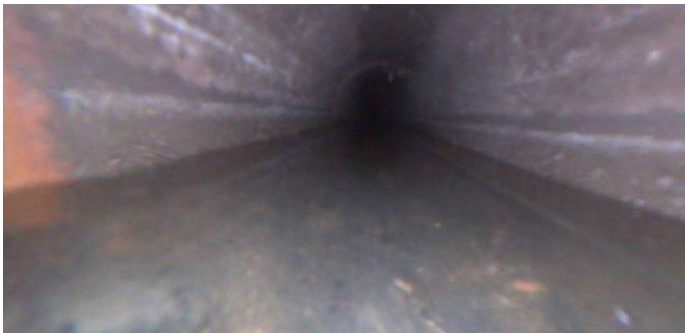
Code: **AMH**
Description: **Manhole**

Distance (ft): **.0**
Structural Grade: **0**
O&M Grade: **0**
Clock Start/From:
Clock To:
1st Value:
2nd Value:
Value Percent:
Continuous Index:
Within 8" of Joint: **NO**
Remarks: **M-504-050**

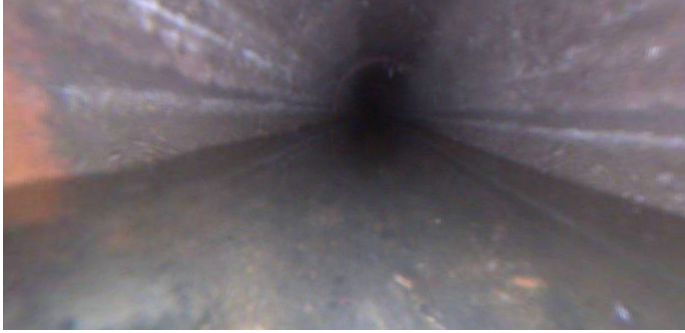
Code: **MWL**
Description: **Water Level**

Distance (ft): **.0**
Structural Grade: **0**
O&M Grade: **0**
Clock Start/From:
Clock To:
1st Value:
2nd Value:
Value Percent: **20.000**
Continuous Index:
Within 8" of Joint: **NO**
Remarks:

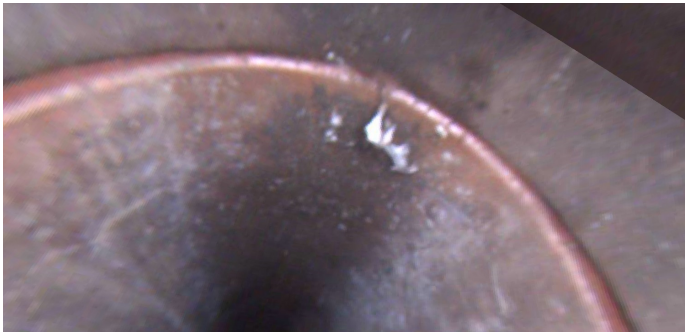
Code: **RFJ**
Description: **Roots Fine Joint**

Distance (ft): **3.8**
Structural Grade: **0**
O&M Grade: **1**
Clock Start/From: **1**
Clock To:
1st Value:
2nd Value:
Value Percent:
Continuous Index:
Within 8" of Joint: **YES**
Remarks:

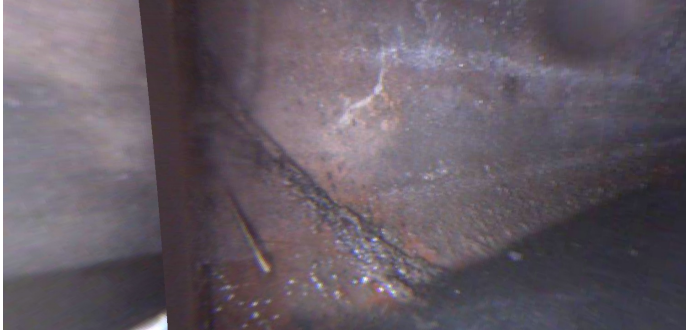
Code: **RFJ**
Description: **Roots Fine Joint**

Distance (ft): **6.8**
Structural Grade: **0**
O&M Grade: **1**
Clock Start/From: **7**
Clock To: **5**
1st Value:
2nd Value:
Value Percent:
Continuous Index: **S01**
Within 8" of Joint: **YES**
Remarks: **wandering**

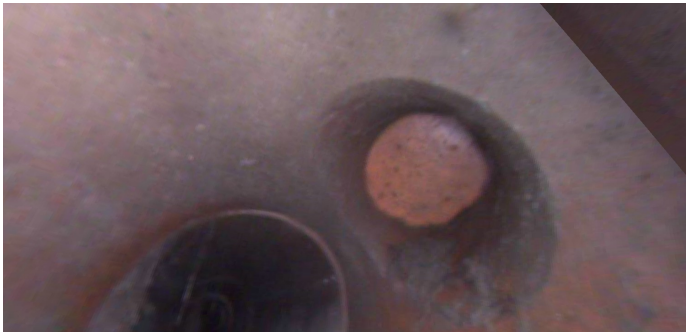
Code: **TFC**
Description: **Tap Factory Capped**

Distance (ft): **20.9**
Structural Grade: **0**
O&M Grade: **0**
Clock Start/From: **1**
Clock To:
1st Value: **4.000**
2nd Value:
Value Percent:
Continuous Index:
Within 8" of Joint: **YES**
Remarks:

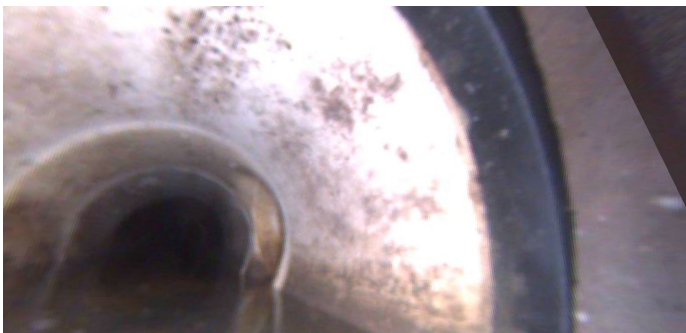
Code: **MMC**
Description: **Material Change**

Distance (ft): **27.1**
Structural Grade: **0**
O&M Grade: **0**
Clock Start/From:
Clock To:
1st Value:
2nd Value:
Value Percent:
Continuous Index:
Within 8" of Joint: **NO**
Remarks: **pvc**

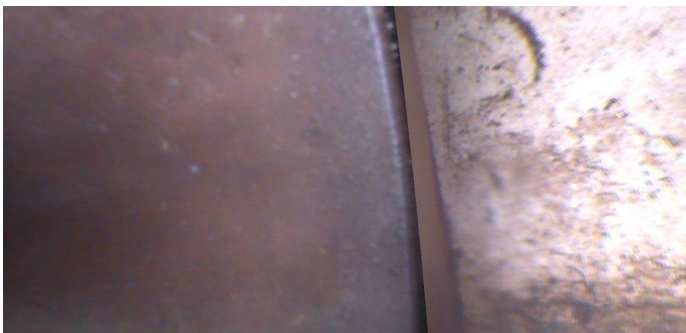
Code: **MMC**
Description: **Material Change**

Distance (ft): **30.2**
Structural Grade: **0**
O&M Grade: **0**
Clock Start/From:
Clock To:
1st Value:
2nd Value:
Value Percent:
Continuous Index:
Within 8" of Joint: **NO**
Remarks: **vcp**

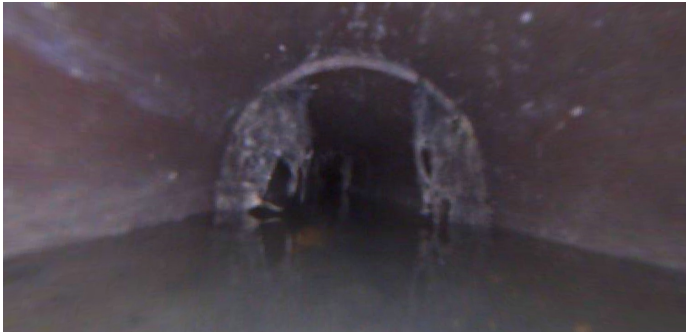
Code: **RMJ**
Description: **Roots Medium Joint**

Distance (ft): **40.0**
Structural Grade: **0**
O&M Grade: **3**
Clock Start/From: **8**
Clock To: **4**
1st Value:
2nd Value:
Value Percent: **5.000**
Continuous Index: **S02**
Within 8" of Joint: **YES**
Remarks: **wandering**

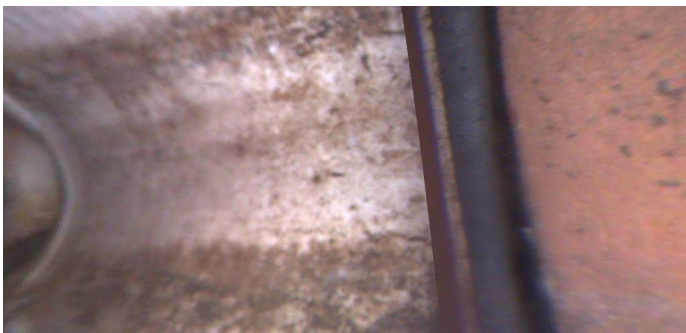
Code: **MMC**
Description: **Material Change**

Distance (ft): **49.2**
Structural Grade: **0**
O&M Grade: **0**
Clock Start/From:
Clock To:
1st Value:
2nd Value:
Value Percent:
Continuous Index:
Within 8" of Joint: **NO**
Remarks: **pvc**

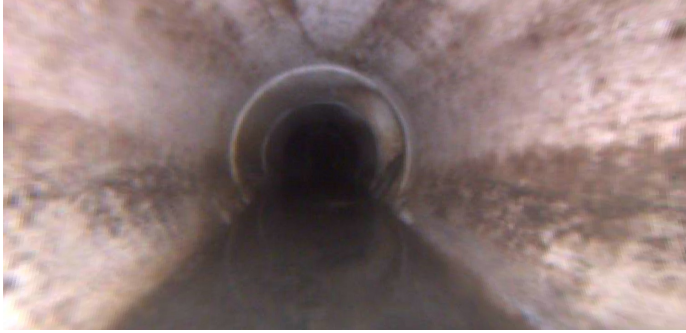
Code: **MWL**
Description: **Water Level**

Distance (ft): **49.2**
Structural Grade: **0**
O&M Grade: **0**
Clock Start/From:
Clock To:
1st Value:
2nd Value:
Value Percent: **5.000**
Continuous Index:
Within 8" of Joint: **NO**
Remarks:

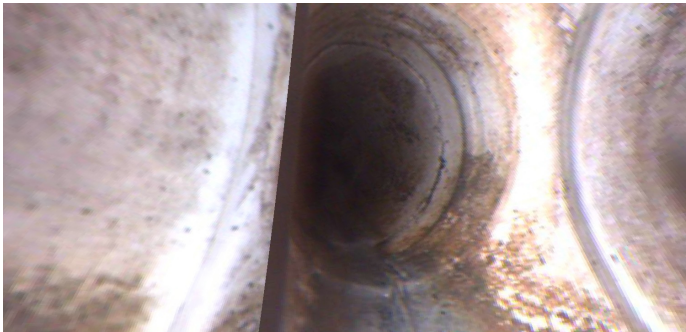
Code: **TF**
Description: **Tap Factory**

Distance (ft): **51.1**
Structural Grade: **0**
O&M Grade: **0**
Clock Start/From: **2**
Clock To:
1st Value: **4.000**
2nd Value:
Value Percent:
Continuous Index:
Within 8" of Joint: **YES**
Remarks:

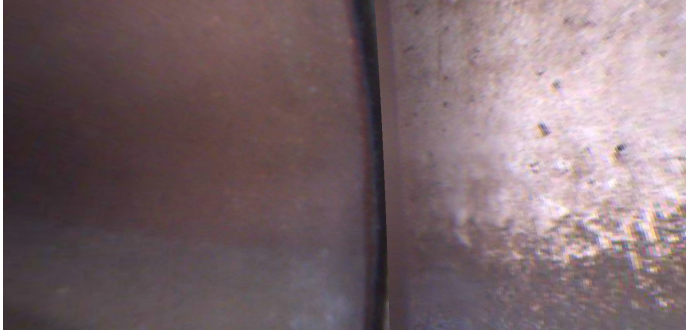
Code: **MMC**
Description: **Material Change**

Distance (ft): **52.3**
Structural Grade: **0**
O&M Grade: **0**
Clock Start/From:
Clock To:
1st Value:
2nd Value:
Value Percent:
Continuous Index:
Within 8" of Joint: **NO**
Remarks: **vcp**

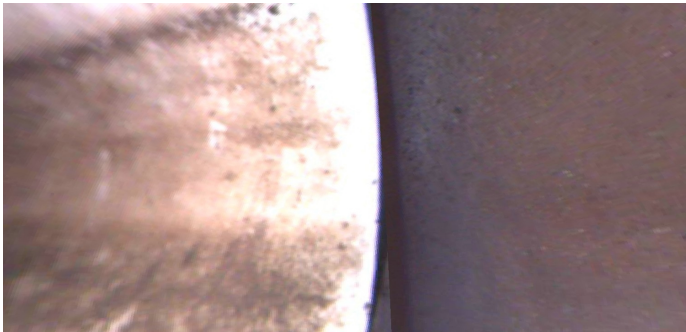
Code: **MMC**
Description: **Material Change**

Distance (ft): **56.6**
Structural Grade: **0**
O&M Grade: **0**
Clock Start/From:
Clock To:
1st Value:
2nd Value:
Value Percent:
Continuous Index:
Within 8" of Joint: **NO**
Remarks: **pvc**

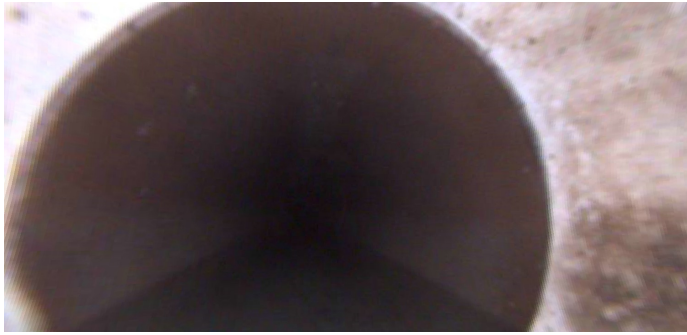
Code:	MMC
Description:	Material Change
Distance (ft):	64.0
Structural Grade:	0
O&M Grade:	0
Clock Start/From:	
Clock To:	
1st Value:	
2nd Value:	
Value Percent:	
Continuous Index:	
Within 8" of Joint:	NO
Remarks:	vcp

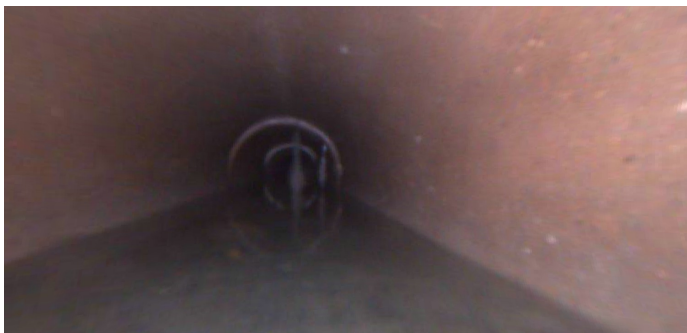
Code:	MWL
Description:	Water Level
Distance (ft):	72.9
Structural Grade:	0
O&M Grade:	0
Clock Start/From:	
Clock To:	
1st Value:	
2nd Value:	
Value Percent:	25.000
Continuous Index:	
Within 8" of Joint:	NO
Remarks:

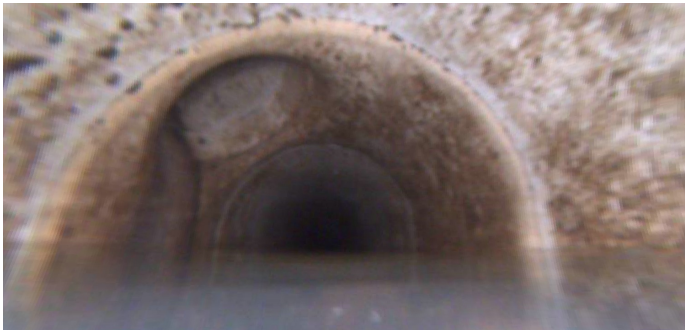
Code: **TF**
Description: **Tap Factory**

Distance (ft): **79.0**
Structural Grade: **0**
O&M Grade: **0**
Clock Start/From: **11**
Clock To:
1st Value: **4.000**
2nd Value:
Value Percent:
Continuous Index:
Within 8" of Joint: **YES**
Remarks:

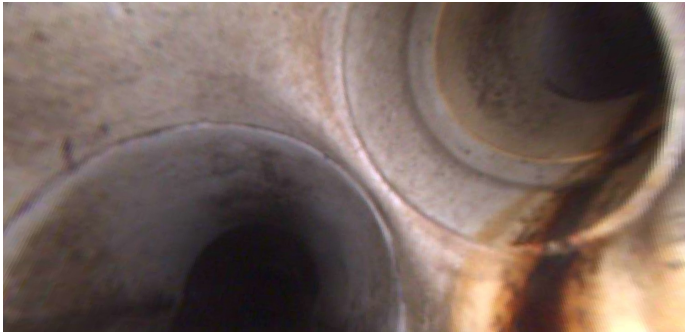
Code: **TF**
Description: **Tap Factory**

Distance (ft): **86.3**
Structural Grade: **0**
O&M Grade: **0**
Clock Start/From: **2**
Clock To:
1st Value: **4.000**
2nd Value:
Value Percent:
Continuous Index:
Within 8" of Joint: **YES**
Remarks:

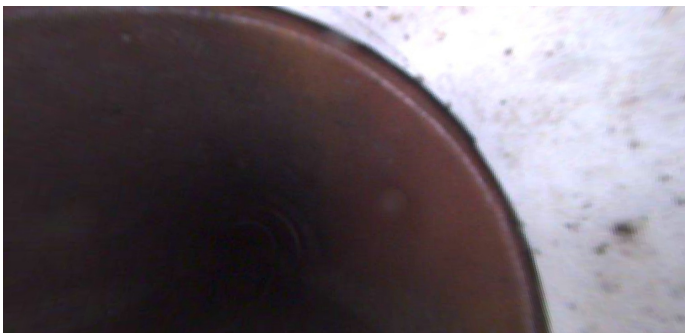
Code: **MMC**
Description: **Material Change**

Distance (ft): **88.1**
Structural Grade: **0**
O&M Grade: **0**
Clock Start/From:
Clock To:
1st Value:
2nd Value:
Value Percent:
Continuous Index:
Within 8" of Joint: **NO**
Remarks: **vcp**

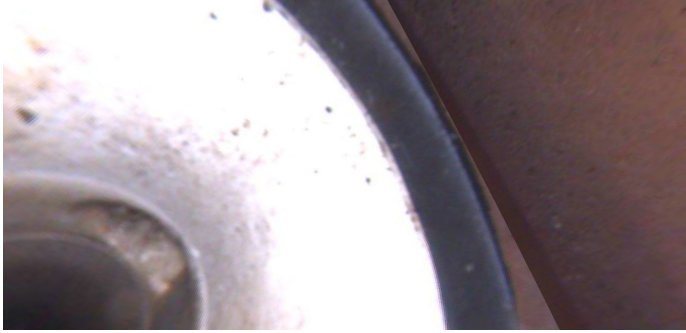
Code: **MMC**
Description: **Material Change**

Distance (ft): **124.9**
Structural Grade: **0**
O&M Grade: **0**
Clock Start/From:
Clock To:
1st Value:
2nd Value:
Value Percent:
Continuous Index:
Within 8" of Joint: **NO**
Remarks: **pvc**

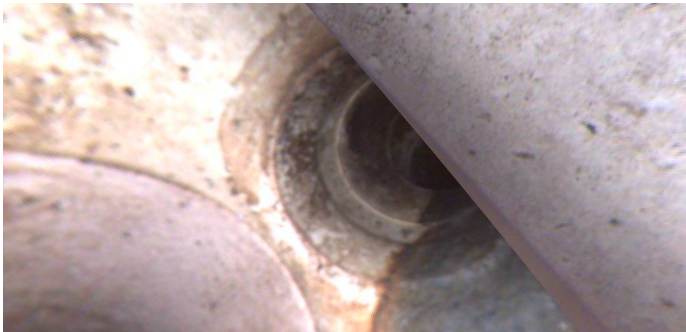
Code: **TF**
Description: **Tap Factory**

Distance (ft): **126.1**
Structural Grade: **0**
O&M Grade: **0**
Clock Start/From: **1**
Clock To:
1st Value: **4.000**
2nd Value:
Value Percent:
Continuous Index:
Within 8" of Joint: **YES**
Remarks:

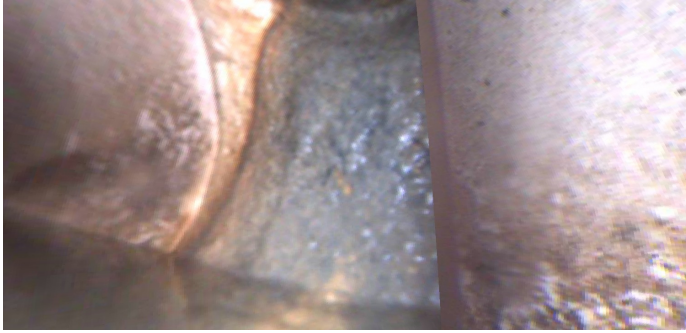
Code: **DAGS**
Description: **Deposits Attached Grease**

Distance (ft): **126.1**
Structural Grade: **0**
O&M Grade: **2**
Clock Start/From: **2**
Clock To: **5**
1st Value:
2nd Value:
Value Percent: **5.000**
Continuous Index:
Within 8" of Joint: **NO**
Remarks:

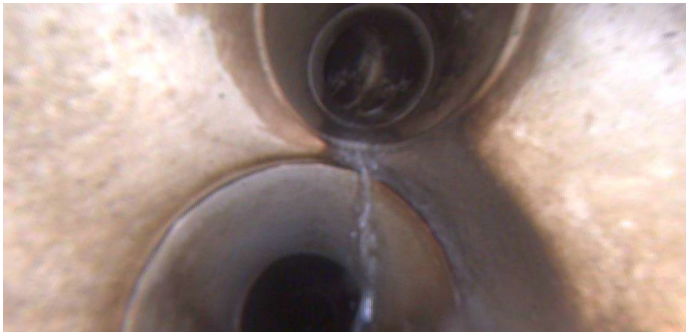
Code: **TFA**
Description: **Tap Factory Active**

Distance (ft): **131.2**
Structural Grade: **0**
O&M Grade: **0**
Clock Start/From: **12**
Clock To:
1st Value: **4.000**
2nd Value:
Value Percent:
Continuous Index:
Within 8" of Joint: **YES**
Remarks:

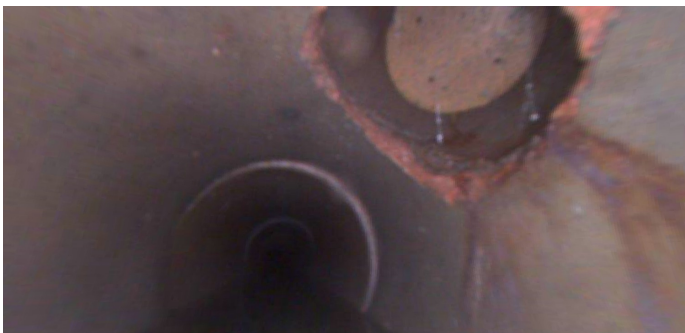
Code: **TBC**
Description: **Tap Break-in Capped**

Distance (ft): **134.7**
Structural Grade: **0**
O&M Grade: **2**
Clock Start/From: **1**
Clock To:
1st Value: **4.000**
2nd Value:
Value Percent:
Continuous Index:
Within 8" of Joint: **YES**
Remarks:

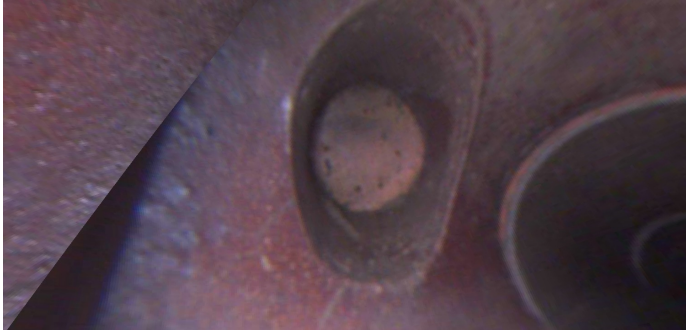
Code: **TFC**
Description: **Tap Factory Capped**

Distance (ft): **150.3**
Structural Grade: **0**
O&M Grade: **0**
Clock Start/From: **10**
Clock To:
1st Value: **4.000**
2nd Value:
Value Percent:
Continuous Index:
Within 8" of Joint: **YES**
Remarks:

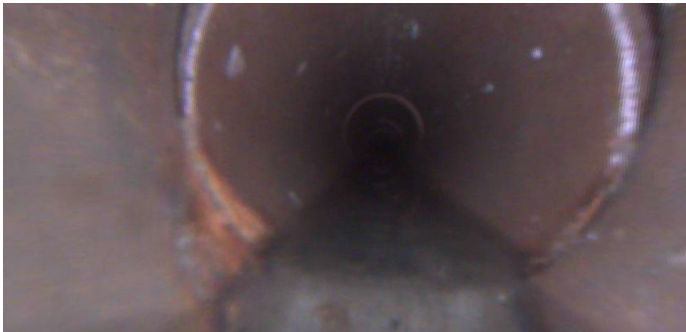
Code: **IS**
Description: **Infil Stain**

Distance (ft): **161.7**
Structural Grade: **0**
O&M Grade: **0**
Clock Start/From: **7**
Clock To: **8**
1st Value:
2nd Value:
Value Percent:
Continuous Index:
Within 8" of Joint: **YES**
Remarks:

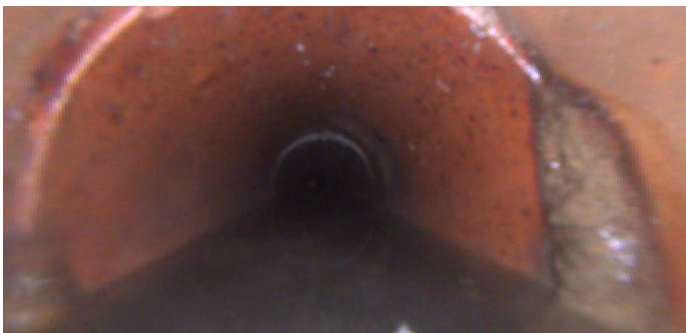
Code: **DAZ**
Description: **Deposits Attached Other**

Distance (ft): **172.6**
Structural Grade: **0**
O&M Grade: **2**
Clock Start/From: **2**
Clock To: **8**
1st Value:
2nd Value:
Value Percent: **5.000**
Continuous Index:
Within 8" of Joint: **YES**
Remarks:

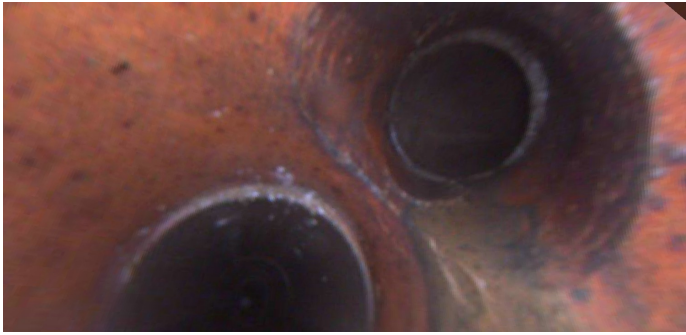
Code: **TF**
Description: **Tap Factory**

Distance (ft): **173.9**
Structural Grade: **0**
O&M Grade: **0**
Clock Start/From: **1**
Clock To:
1st Value: **4.000**
2nd Value:
Value Percent:
Continuous Index:
Within 8" of Joint: **YES**
Remarks:

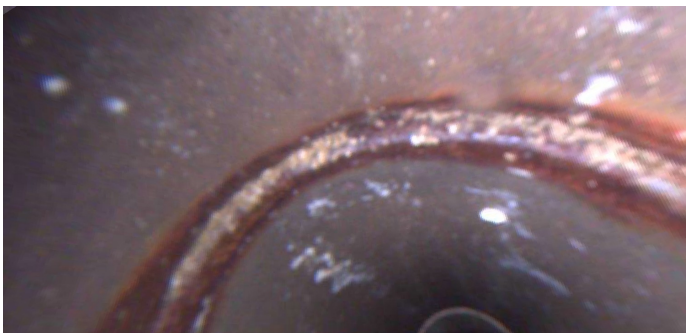
Code: **IS**
Description: **Infil Stain**

Distance (ft): **180.1**
Structural Grade: **0**
O&M Grade: **0**
Clock Start/From: **8**
Clock To: **4**
1st Value:
2nd Value:
Value Percent:
Continuous Index:
Within 8" of Joint: **YES**
Remarks:

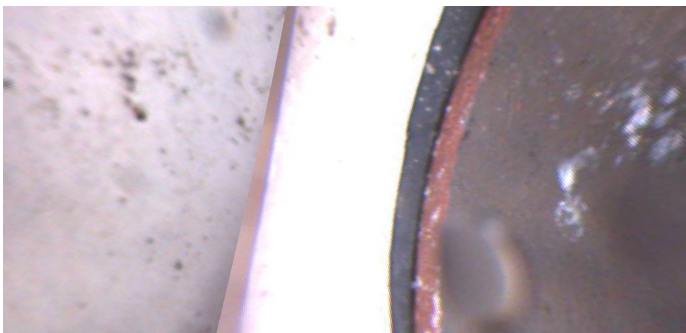
Code: **MMC**
Description: **Material Change**

Distance (ft): **183.1**
Structural Grade: **0**
O&M Grade: **0**
Clock Start/From:
Clock To:
1st Value:
2nd Value:
Value Percent:
Continuous Index:
Within 8" of Joint: **NO**
Remarks: **pvc**

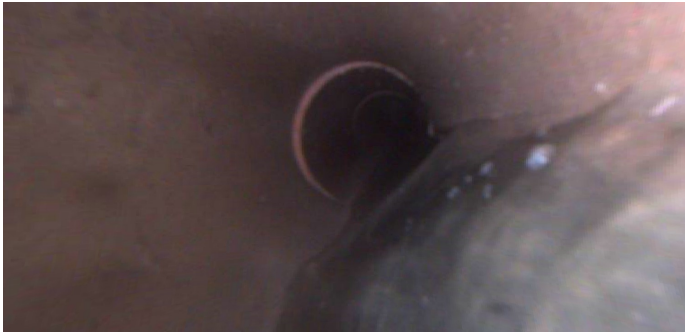
Code: **MSA**
Description: **Abandoned Survey**

Distance (ft): **205.5**
Structural Grade: **0**
O&M Grade: **0**
Clock Start/From:
Clock To:
1st Value:
2nd Value:
Value Percent:
Continuous Index:
Within 8" of Joint: **NO**
Remarks: **camera flipped**

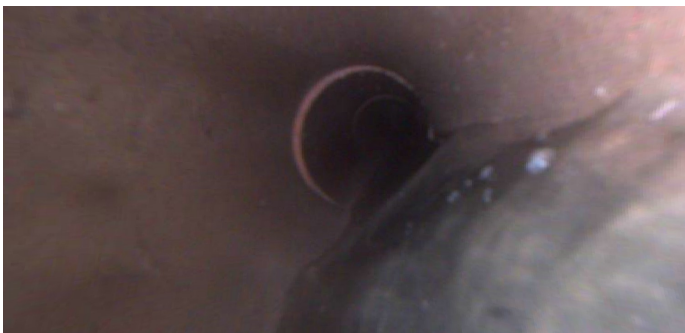
Code: **RFJ**
Description: **Roots Fine Joint**

Distance (ft): **205.5**
Structural Grade: **0**
O&M Grade: **1**
Clock Start/From: **7**
Clock To: **5**
1st Value:
2nd Value:
Value Percent:
Continuous Index: **F01**
Within 8" of Joint: **YES**
Remarks: **wandering**

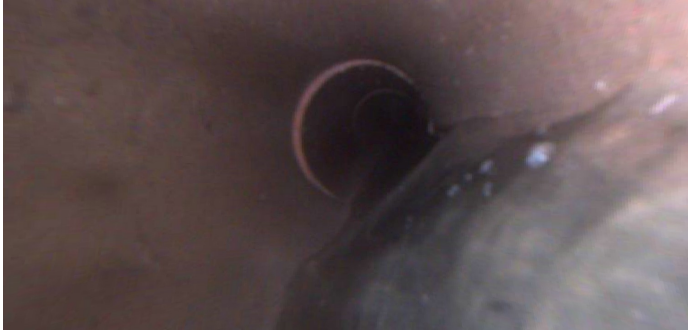
Code:	RMJ
Description:	Roots Medium Joint
Distance (ft):	205.5
Structural Grade:	0
O&M Grade:	3
Clock Start/From:	8
Clock To:	4
1st Value:	
2nd Value:	
Value Percent:	5.000
Continuous Index:	F02
Within 8" of Joint:	YES
Remarks:	wandering
