Profile/Photo Observation Report

Date:	09/15/2021	Weather:		Coding:	PACP 7.0
Pipe Length (ft):	255.2	Owner:	City of Hobart	Pre Clean:	Light Cleaning
P.O.#:	YES502259	Surveyor:	S. Bucklin	PSR:	P-504-134-050
Customer:	City of Hobart	Clean Date:	09/10/2021	Shape:	C

Street:	North Cavender Street	Flow Control:	Not Controlled
City:	Hobart, IN	Year Renewed:	
Location:	Alley	Tape/Media #:	
Purpose:	Routine Assessment	Dia/Height:	10"
Use:	Sanitary Sewage Pipe	Material:	VCP
Drain Area:		Lining:	None
Category:	NA		
Comment:			
Location Details:		Direction of Survey:	Upstream
US MH:	M-504-050	DS MH:	M-504-134
		Total Length Surveyed (ft):	255.2

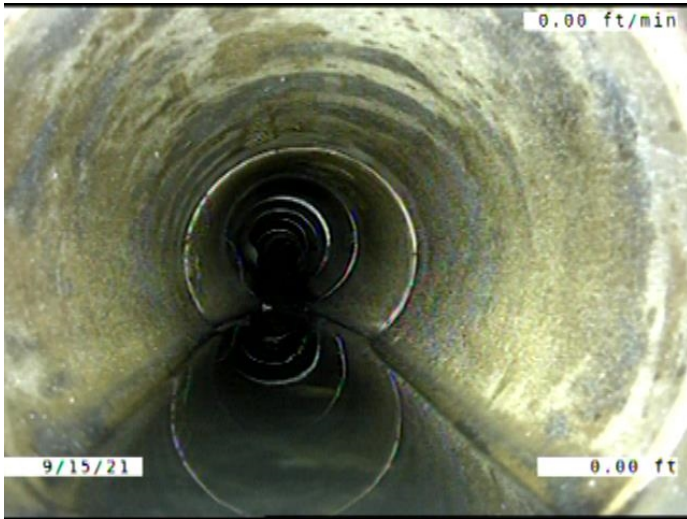
Code: **MWL**
Description: **Miscellaneous Water Level**

Distance (ft): **.0**
Structural Grade: **0**
O&M Grade: **0**
Clock Start/From:
Clock To:
1st Value:
2nd Value:
Value Percent: **5.000**
Continuous Index:
Within 8" of Joint: **NO**
Remarks:

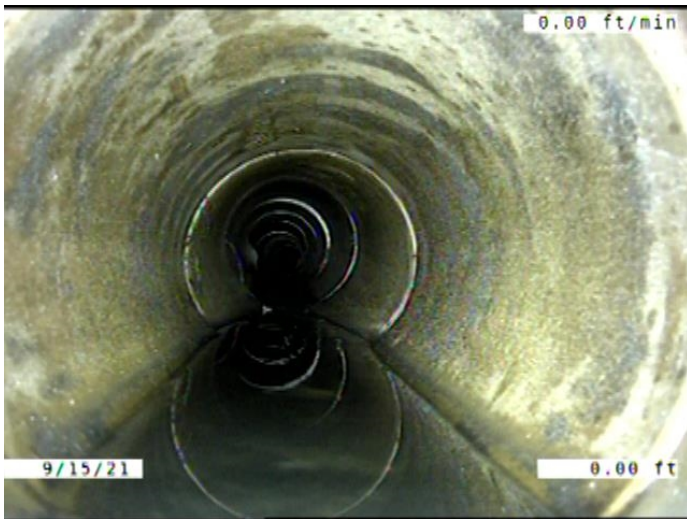
Code: **MGO**
Description: **Miscellaneous General Observation**

Distance (ft): **1.5**
Structural Grade: **0**
O&M Grade: **0**
Clock Start/From:
Clock To:
1st Value:
2nd Value:
Value Percent:
Continuous Index:
Within 8" of Joint: **NO**
Remarks: **DROP INTO THE MANHOLE. HAD TO START IN THE PIPE.**

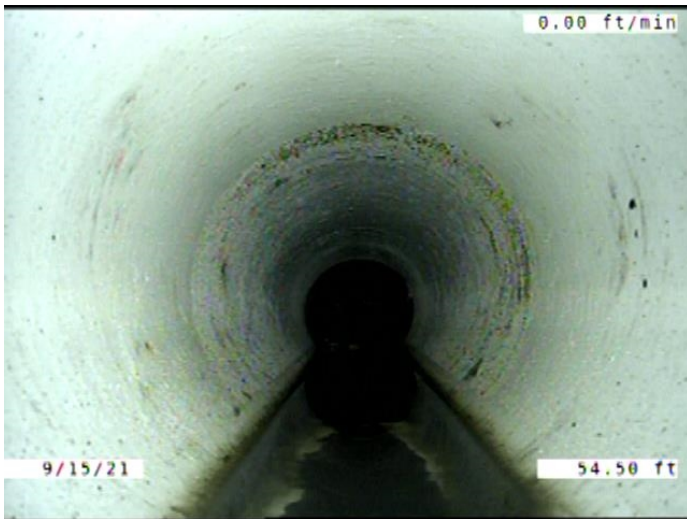
Code: **MWLS**
Description: **Miscellaneous Water Level Sag**

Distance (ft): **54.5**
Structural Grade: **2**
O&M Grade: **0**
Clock Start/From:
Clock To:
1st Value:
2nd Value:
Value Percent: **5.000**
Continuous Index: **F03**
Within 8" of Joint: **NO**
Remarks:

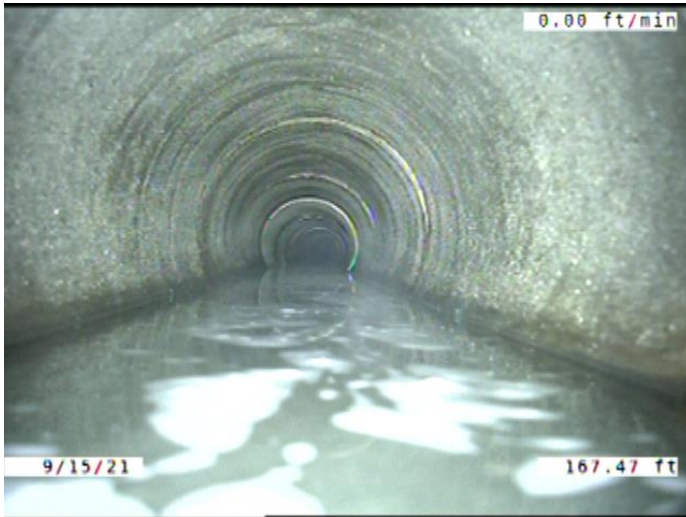
Code: **DAE**
Description: **Deposits Attached Encrustation**

Distance (ft): **167.5**
Structural Grade: **0**
O&M Grade: **2**
Clock Start/From: **8**
Clock To: **10**
1st Value:
2nd Value:
Value Percent: **5.000**
Continuous Index: **F06**
Within 8" of Joint: **YES**
Remarks:

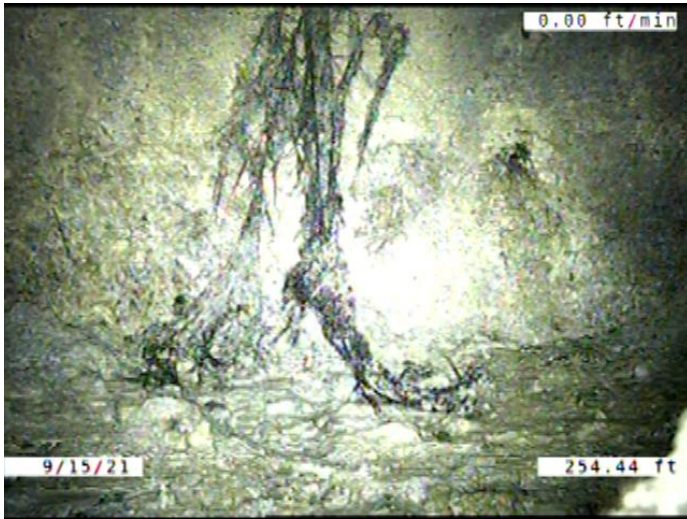
Code: **DSGV**
Description: **Deposits Settled Gravel**

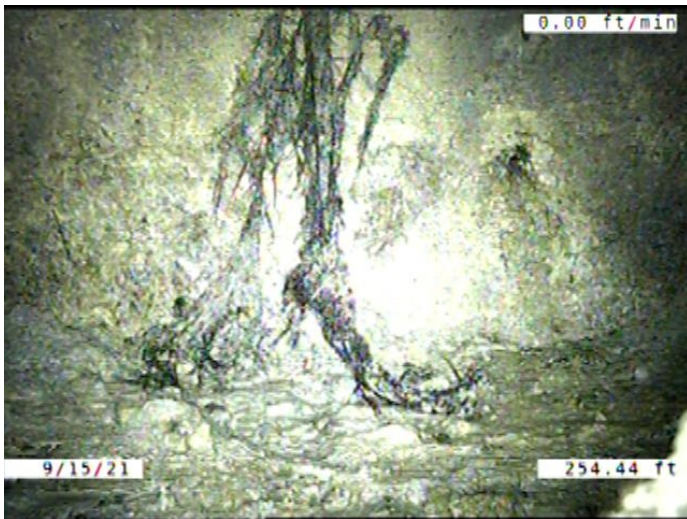
Code: **DSF**
Description: **Deposits Settled Fine**
